**HISTORIC STRUCTURE ASSESSMENT  
MOFFAT COMMUNITY CHURCH  
MOFFAT, COLORADO**

FOR  
**THE TOWN OF MOFFAT, COLORADO**  
AND THE  
**MOFFAT COMMUNITY CENTER COMMITTEE**

PREPARED BY  
**MARK M. JONES ASSOCIATES, ARCHITECTS, LLC**  
1085 GRAND AVENUE  
DEL NORTE, COLORADO 81132  
(719) 657-2070 FAX (719) 657-2072

HISTORIC STRUCTURE ASSESSMENT  
State Historical Fund Project # 2003-HA-061  
September 24, 2003

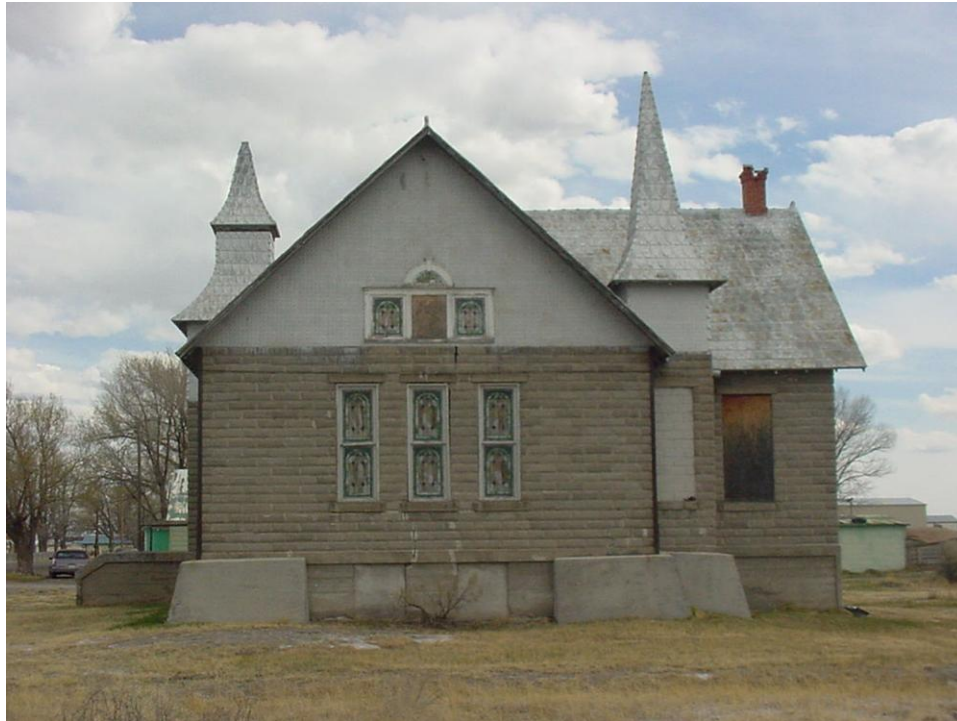
*Side (north) elevation. Note buttresses at corners.*

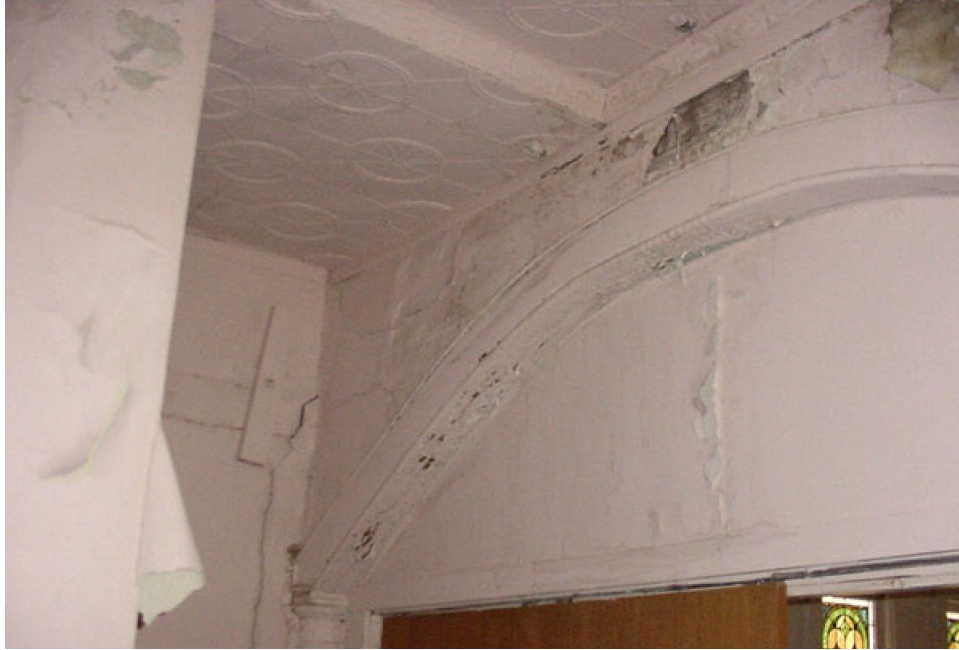
*Above: Arch defining edge of sanctuary to chancel. Note later plaster infill.*

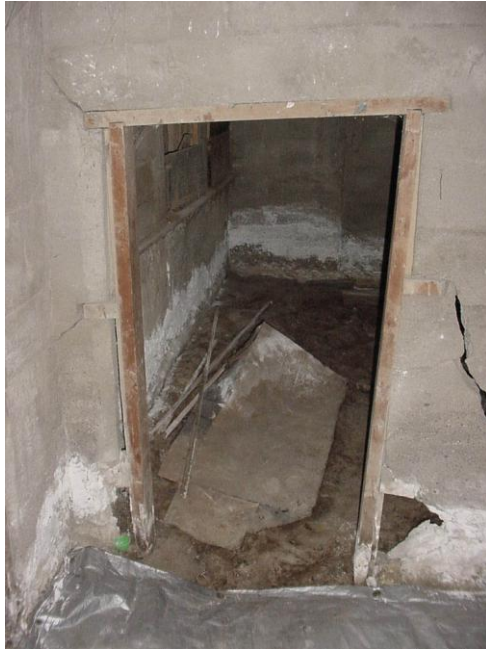
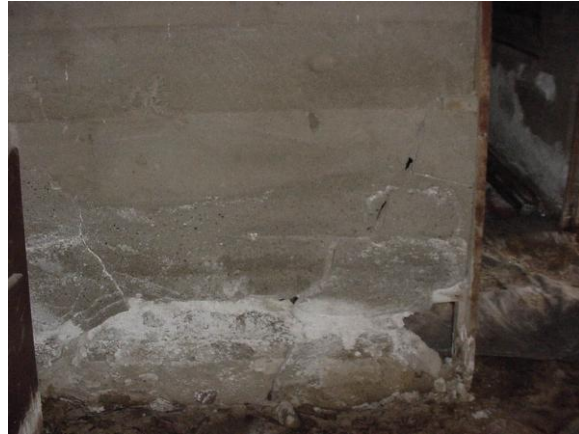
*Above: Alkali damaged concrete wall.  
Left: Interior stem wall at passage.*

The foundation walls at the perimeter appear to have succumbed to settling, water damage, and deterioration from alkali soils. The weight of the concrete block upon the unreinforced concrete foundation has caused increasingly strong thrust upon the perimeter concrete foundation walls. The interior stem walls have also failed, having been eroded and cracked at their bases from exposure to water and alkali soil. Backfill appears to be properly compacted and undisturbed on the exterior. The cellar dirt floor seeps moisture regularly.

Demolish portions of exterior foundation walls that have been eroded by alkali soil. Approximately twenty linear feet of foundation walls have been affected. Patch the affected areas with concrete patching compound. Install concrete grade beams around the entire interior perimeter. Thicken the concrete walls at the entire perimeter approximately eight inches. The walls should be thickened by forming and pouring new sections of concrete wall with steel reinforcement in both directions. Join the new interior wall to the existing concrete perimeter walls with hilti expansion anchor bolts as depicted in the proposed schematic structural wall section detail that follows. Also, reinforce the existing plinth with a steel channel and steel plate bolted together through the wall. The channels and plates should be welded or bolted together to form a continuous steel band around the building. The thickened and reinforced walls and the steel channels and plates will effectively act together as a tension ring inside the entire perimeter. Install concrete grade beams and additional pads where interior stem walls once stood. These will create bearing support for eight steel columns. Support the floor joists above the internal concrete stem walls with temporary shoring. Remove these concrete stem walls. Install steel I-beams and two square steel tube columns for each beam to support the first floor loads. Bear the ends of these beams on the new concrete interior reinforcement walls.

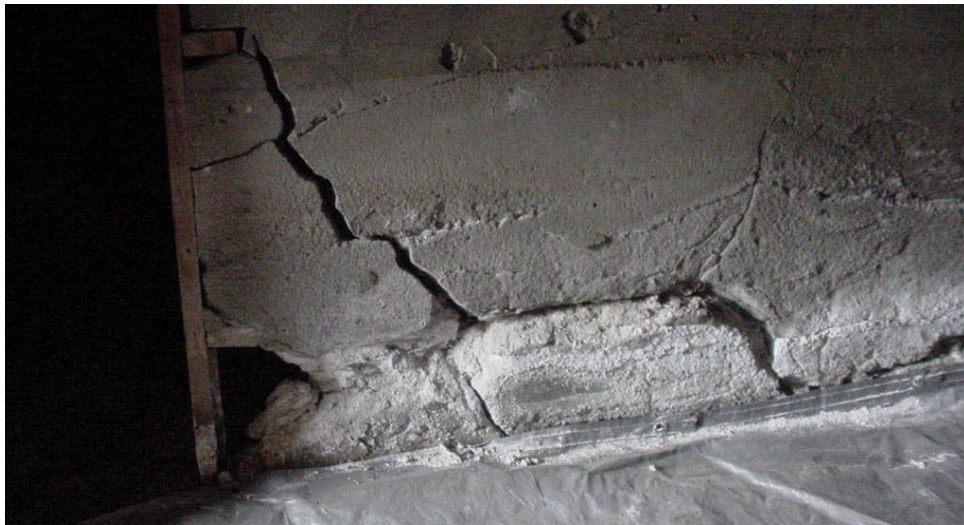
*Above: Southeast corner of stem wall, with large cracks and crumbling.*

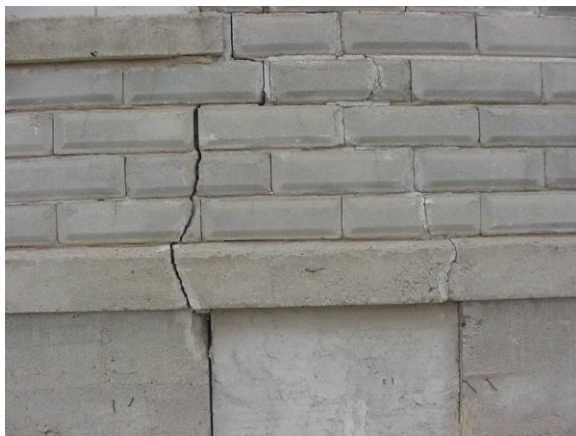
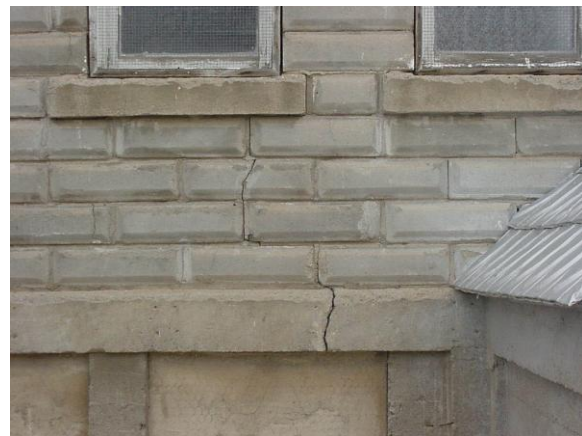
*Exterior plinth and cracked masonry above.*

Cracks are evidenced in block throughout the building. They are especially pronounced just above the concrete plinth above each basement window, above the second floor windows, and at the northwest and southwest steeples.

Reinforce the first masonry course which sets on the basement wall with steel channel members bolted together through the masonry course. The steel channels should be bolted or welded together at the building corners to provide a continuous tension support around the outside lower level of the building. As mentioned in section 3.3 Foundations above, install additional reinforced concrete around the entire inside of the building at the cellar level. See schematic structural section 'A' on page 40 of this report.

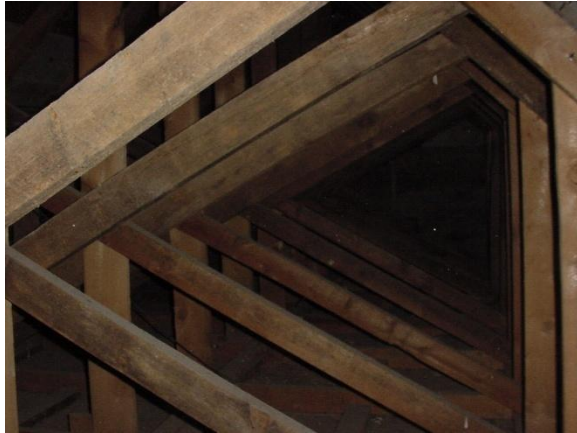
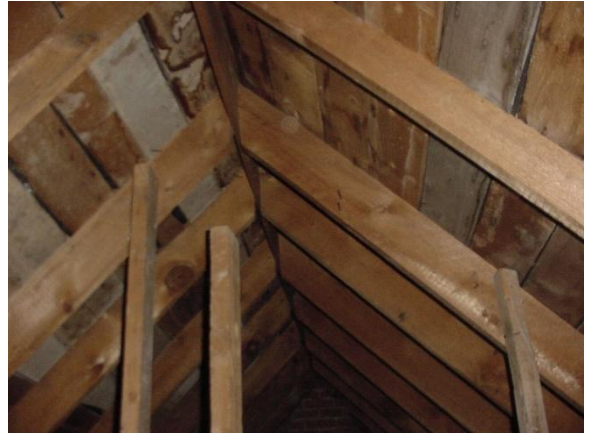
*Roof framing in attic area. Note that some roof sheathing boards show evidence of cement, and were most likely recycled form boards.*

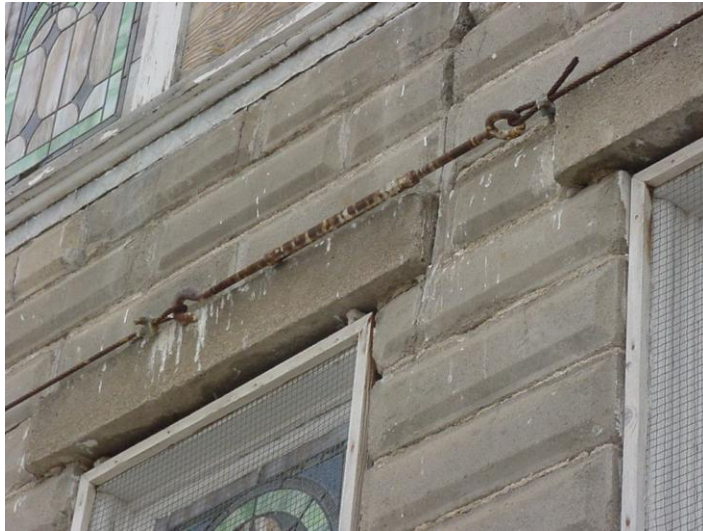
The concrete block walls are pulling away from the roof structure at the northwest corner. This has been temporarily halted by the threaded steel rods, wire, and turnbuckle at the north end of the structure. Another temporary measure to thwart further block expansion has been the furnishing in the mid-1980s of wide concrete buttresses at the northwest and northeast corner. Based on thorough structural analysis, it has been determined that the blocks are failing due to a combination of factors. Block failure is a function of the lack of horizontal reinforcement between the blocks and a lack of vertical reinforcement within the open cells of the blocks, but also of the weak construction of the concrete foundation plinth, which was also poured without steel reinforcement. The brick chimney has been almost completely destroyed by alkali soils.

*Turnbuckle at north elevation face.*

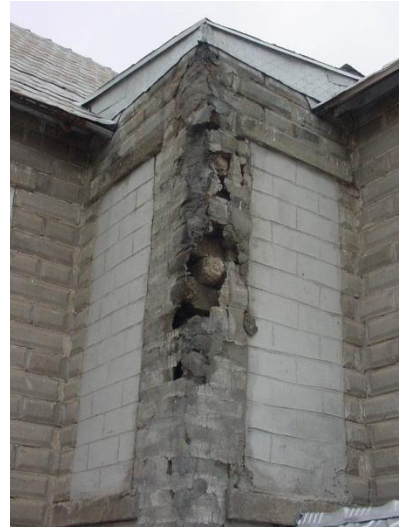
*Southwest steeple detail.*

The design of the steeples and their spires was, as noted earlier, inherently deficient. The steeples located at the northwest and southwest corners were constructed in the valleys of the building roof gables. This directed rain, snow, and ice to the sides of the steeples and the spires. No crickets were built in the roofing system to channel the elements away from the steeples. At the southwest corner steeple the spire has been completely removed from the structure. The whereabouts of the missing spire are unknown at this time. The removal of the spire has exposed the top courses of the concrete block at this steeple to be exposed to the weather, and water splashing from the roof above. Rainwater and freeze-thaw cycles have completely eroded the block at this location, and numerous blocks have been lost.

Once the northwest steeple has had its damaged blocks replaced and the southwest steeple is rebuilt and solidly reinforced, the spire on the northwest steeple should be measured in place and replicated for placement on the southwest steeple. Each spire should be firmly mechanically attached to the top of each steeple.

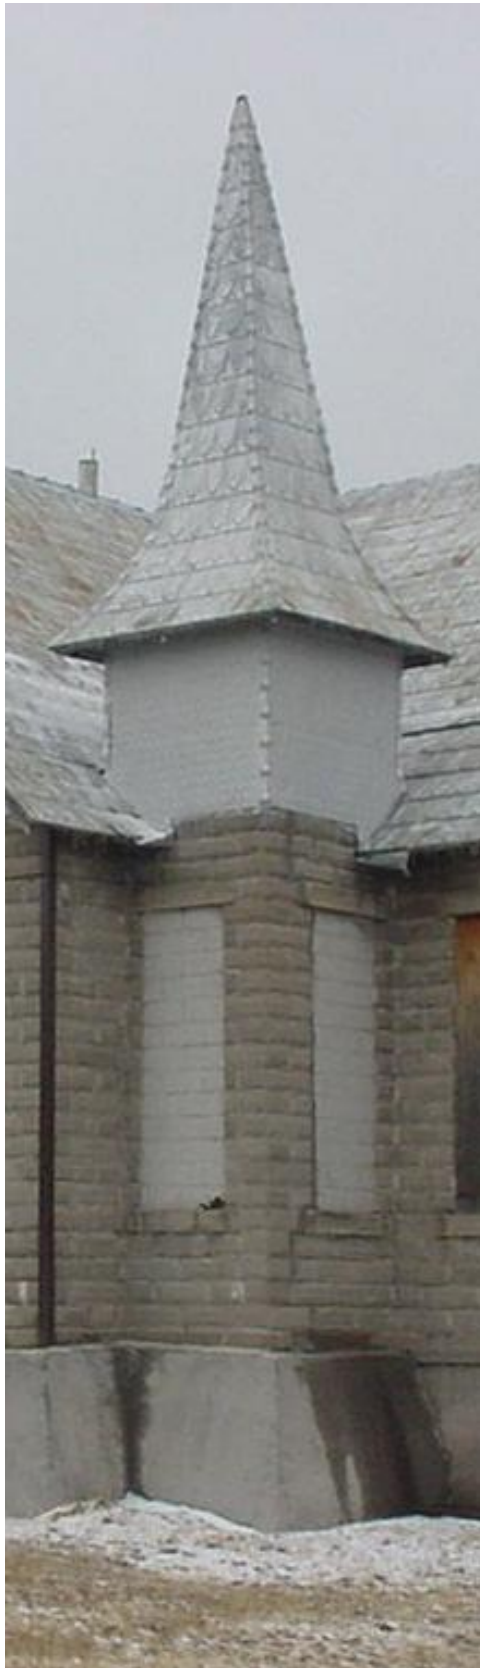
Left: Steeple at northwest corner. Note fully intact spire and later angled concrete buttress at base.

The concrete block steeples are pulling away from the roof structure above. The northwest steeple is in reparable

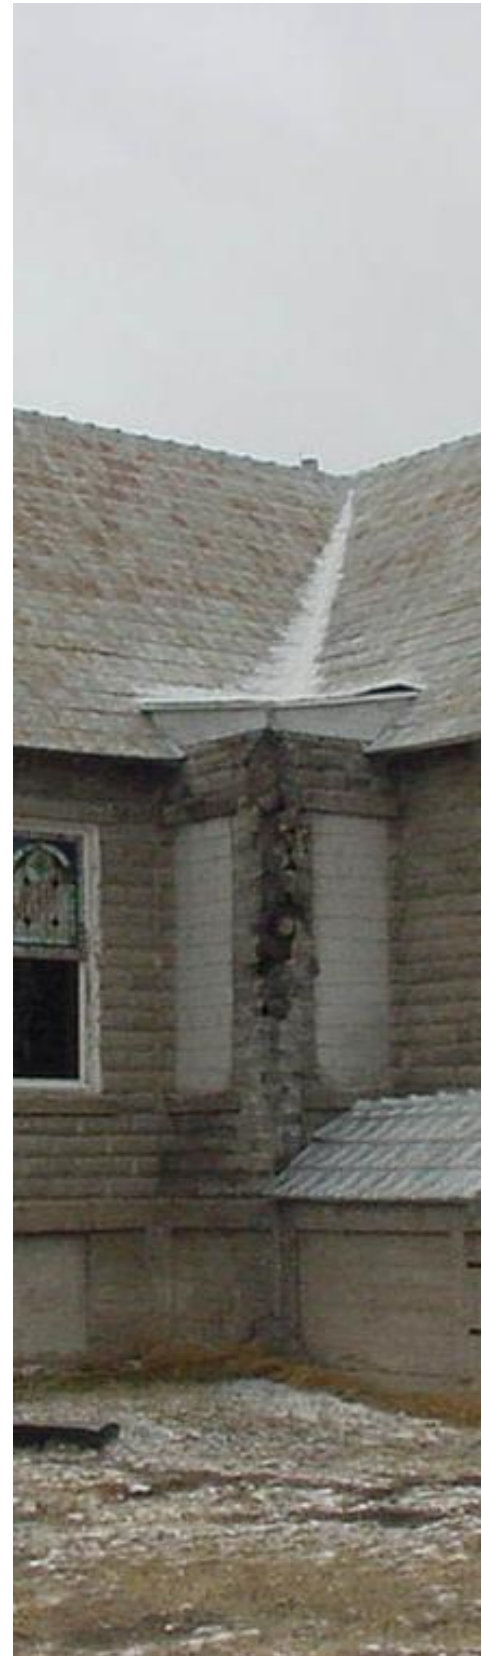
Right: Steeple at southwest corner. Note missing spire, improvised tin cricket, and severe deterioration of decorative concrete block.

condition, whereas the southwest steeple is deteriorated by weather and in very poor condition. The steeples were poorly designed to begin with. The bodies of the steeples were composed with two large windows with minimal amounts of masonry at each side. Simply not enough structure is present to bear the roof dead and snow loads, and none of the structure is reinforced. The windows were later filled in with studs and finished at the exterior with stucco

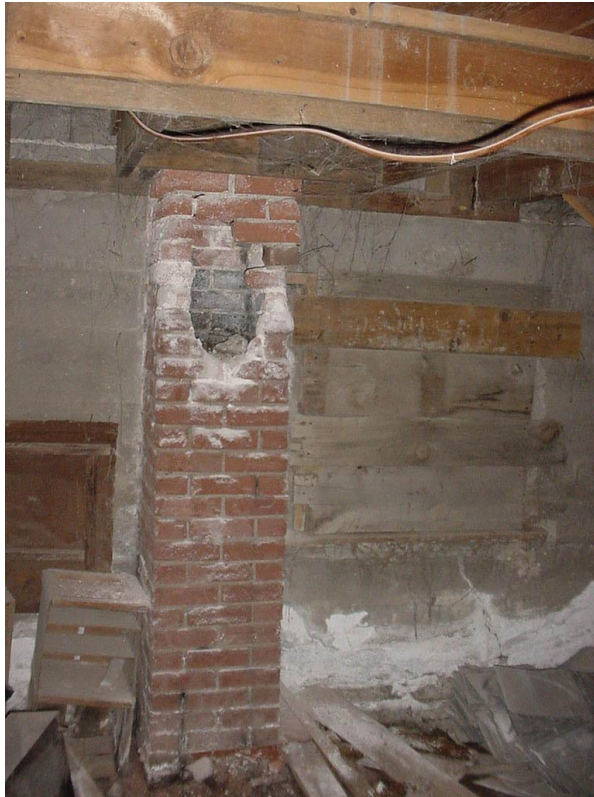
Left: Chimney at basement, deteriorated by alkali and exposure to air.

The severely deteriorated brick chimney should be demolished at the lower level, but retained on the main and upper levels. The floor beneath the chimney on the main level should be adequately reinforced with additional timber members to carry the load of the chimney. The brick should be cleaned and repointed to restore its historic appearance.

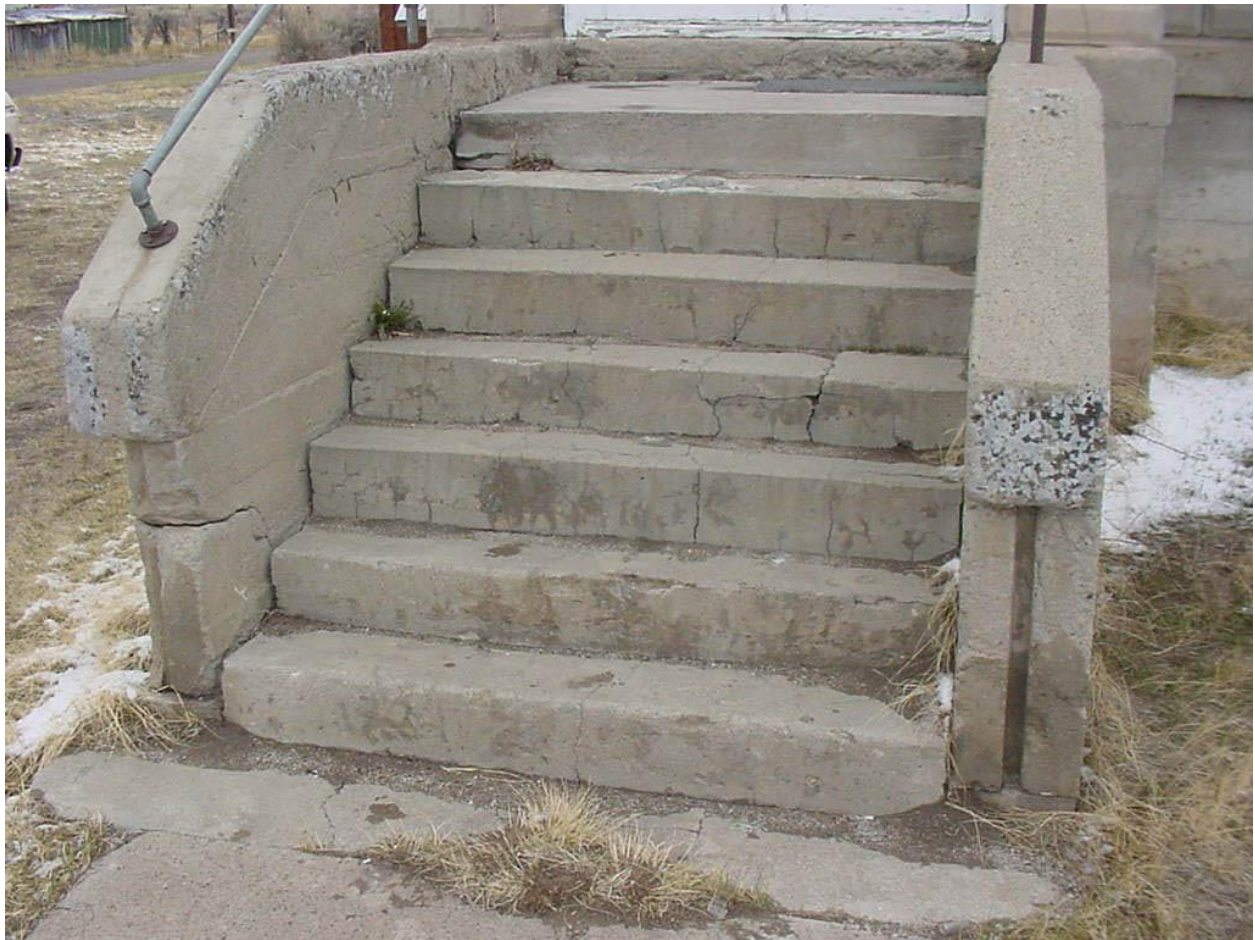
*Main entry concrete stoop.*

The main entry stoop should be entirely removed, to make room for a new stair. The doors for the gabled entry sheds should be replaced. This issue is further addressed under the DOORS AND WINDOWS section.

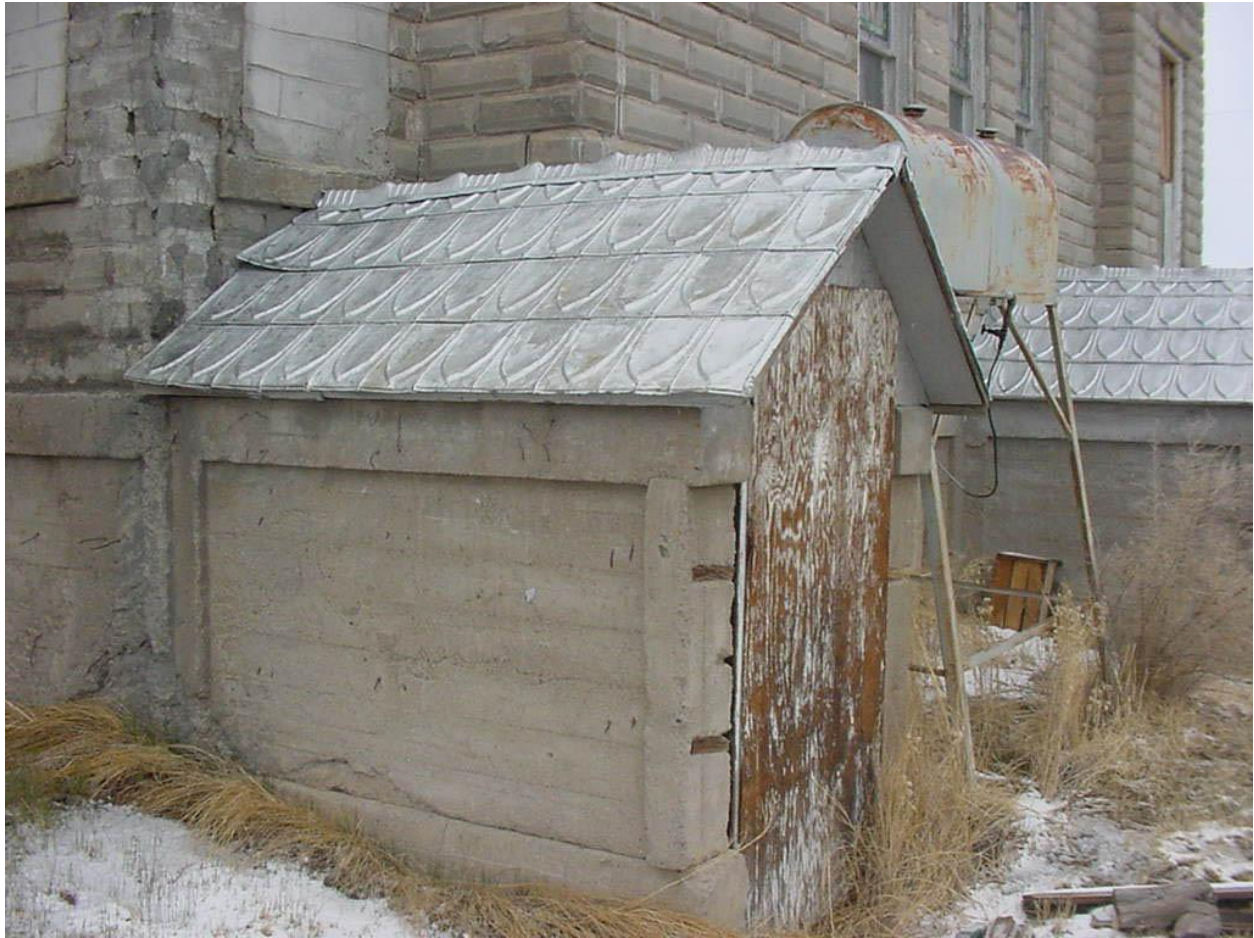
*Gabled shed entry at south side of building, typical of two.*

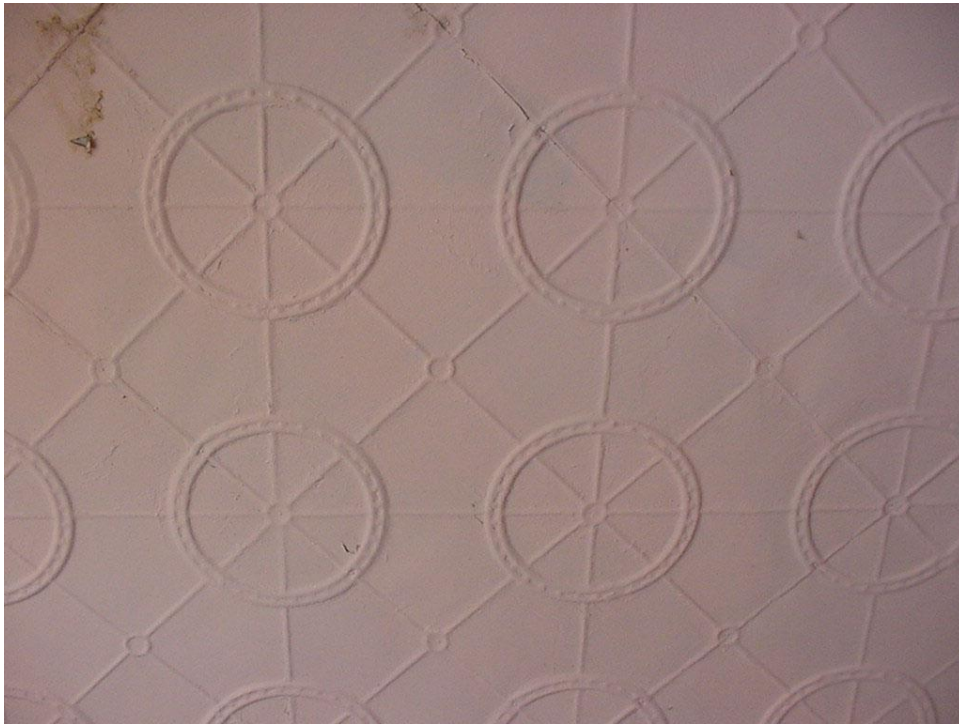
The former chancel area ceiling is in fair to poor condition. Some of the pinwheel-pattern tin ceiling tiles there have begun to rust and deteriorate. The plaster ceiling in the sanctuary is in fair condition. An unfortunate result of its installation was the piercing of some portions of the original tin ceiling above with suspension framing members. The overall condition of the original sanctuary ceiling cannot be assessed without complete demolition of the plaster ceiling beneath it. Presumably the condition of the original tin ceiling in this area ranges from fair to poor. The fiberboard ceiling in the upper room is worn and in fair condition.

*Pinwheel pattern tin panel ceiling in former chancel*

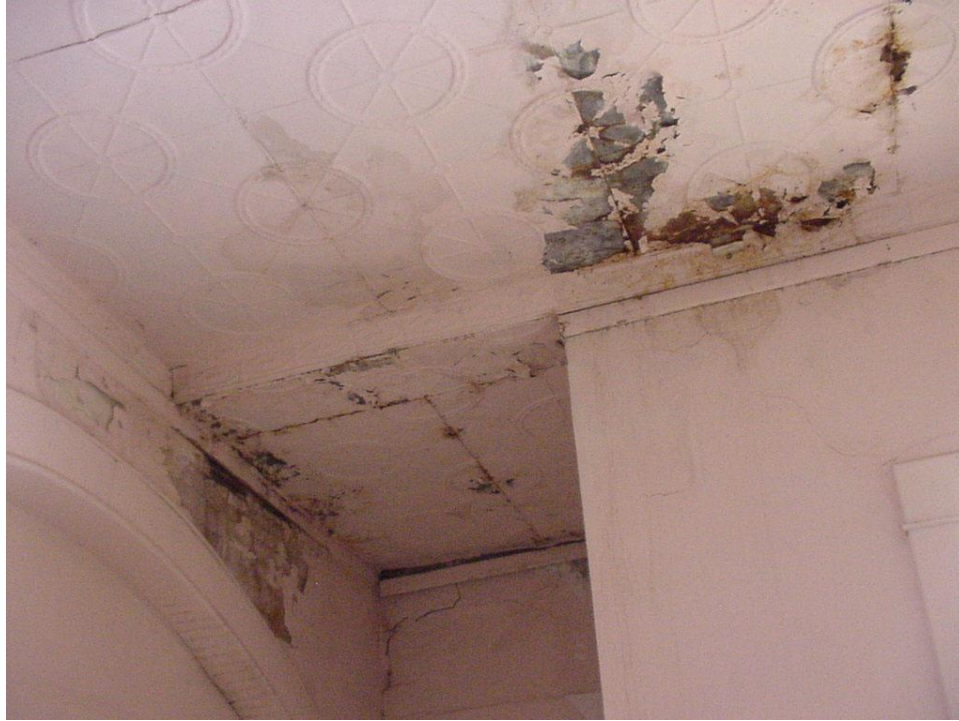
*Significant paint peeling, rust, and deterioration of tin panels at south end of former chancel*
