# HISTORIC STRUCTURE ASSESSMENT

## HOUGH BUILDING

CORNER OF THIRD AND SILVER STREETS  
LAKE CITY, COLORADO

HISTORIC STRUCTURE ASSESSMENT  
State Historical Fund Project #2003-HA-068  
June, 2004

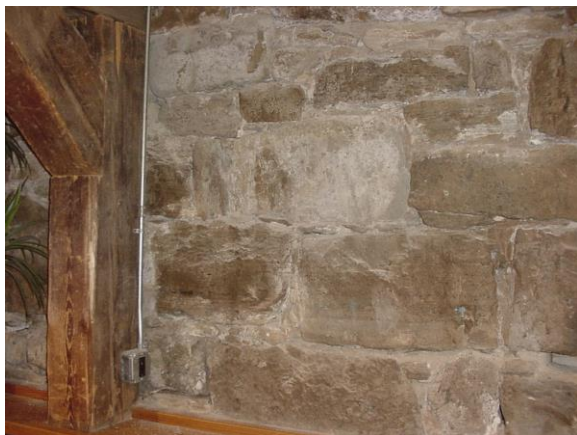
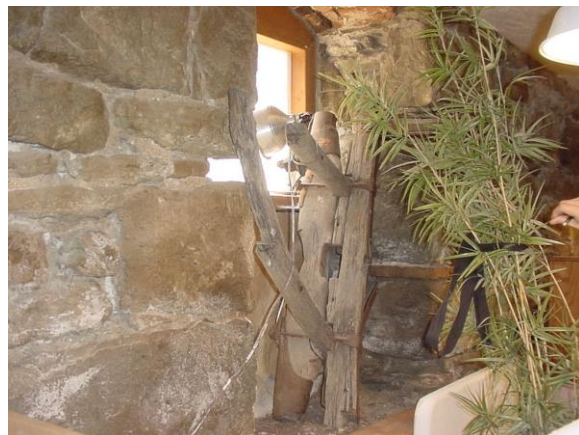
*Lower level stone wall*

*Lower level stone wall with lightwell.*

The foundations range between fair and good condition, and are sturdily holding the building in place. The integrity of the stone wall system is fair, having been damaged over time by significant water erosion. The water erosion has occurred at the west and south stone foundation walls. The later installation of sidewalks on the west and south elevation has apparently halted further erosion of the foundation elements at these locations.

For nearly the entire building perimeter, and the central demising foundation wall between building 1 and building 2, the foundations require no corrective work. The west and south foundation walls should be monitored for evidence of further erosion.

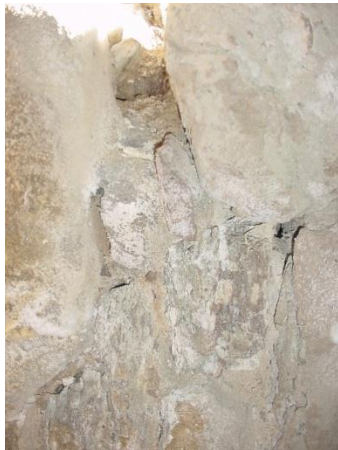
The area at the southeast corner is in poor condition. When this portion was jacked up, the workers were overly exuberant. They jacked the corner of the building up nearly two courses of brick too high. The jacking at this point caused the building to fail at and around its natural weak points at the easterly window and central window of the east wall. This has impacted the masonry walls and has set the window at the southeast corner askew. This window is no longer open to the inside. Instead the opening is infilled with concrete block. No leaks are apparent at the foundation, so apparently foundation drainage is not a problem.

Left: *Eroded area at south stone foundation wall.*

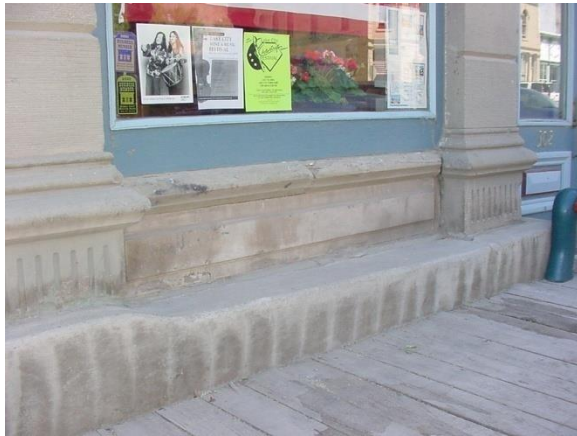
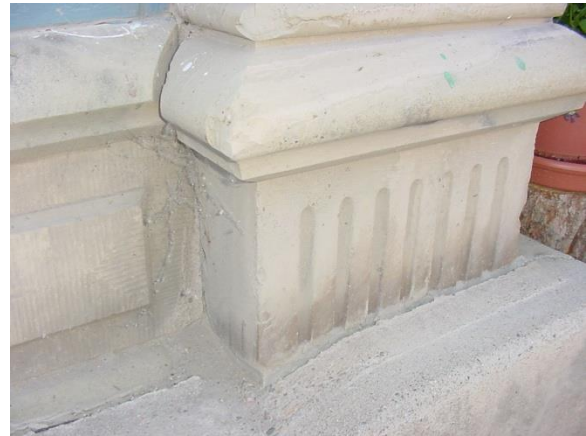
The concrete lower level slab appears to be in good condition. The only element of poor construction is the concrete curbs for the stone base on the west elevation of building 2. These curbs were an unnecessary addition, and hide the historic profile of the base.

*West elevation of building 2 with concrete curb at stone base. Detail at concrete curb.*

The concrete curbs should be removed carefully with hand tools, with care not to damage the original stone base. Once the bases are thoroughly clear of any concrete, they should be carefully cleaned with an approved restoration cleaner. Depending on the condition of the stone bases once the concrete has been removed, these may need to be replaced.

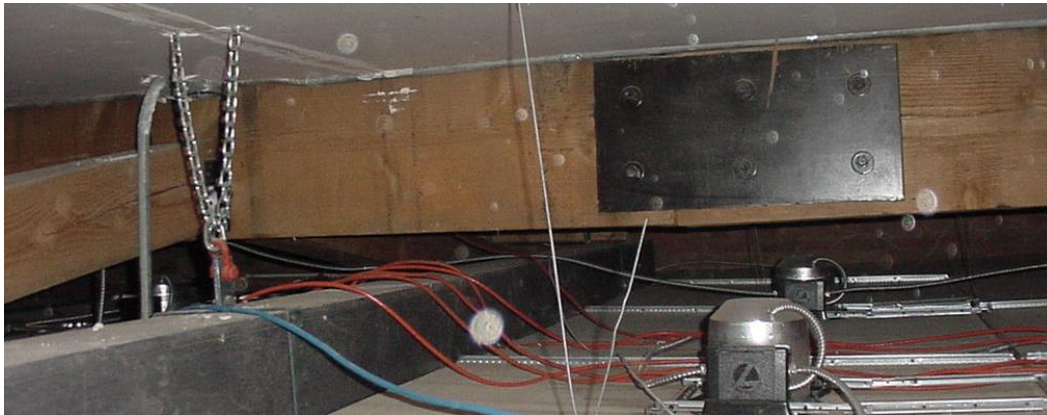
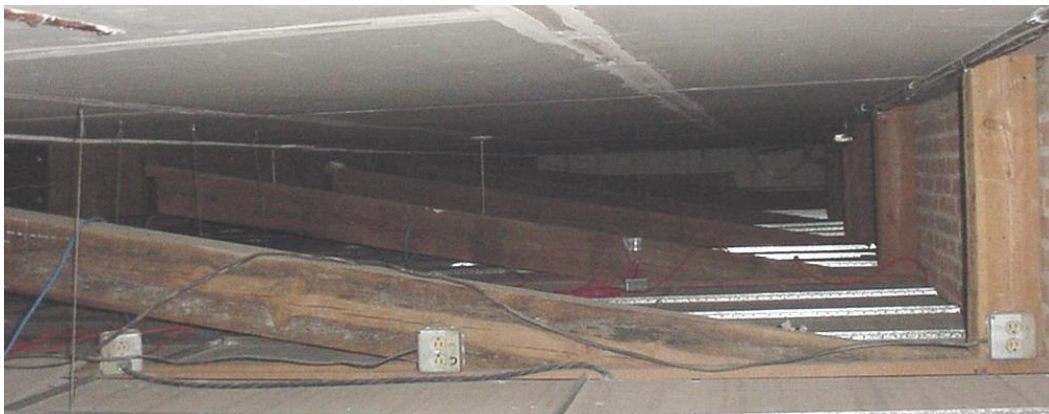
Above: *Structural retrofit showing central beam, strut and horizontal member.*

Below: *Structural retrofit, showing strut and vertical column.*

The second floor structural system in building 2 encounters slightly shorter spans, and is in good condition. The second floor structural system in building 1 is in poor to fair condition. The floor joists have deflected several inches. The retrofit supports are of no value.

The second floor structural system in building 2 requires no modifications. The second floor structural system in building 1 needs to be addressed. First non-original elements including the timber columns, the horizontal members, and the diagonal struts should be removed. The central timber beam should be kept in place. This beam should be shored until the floor joists above it are approximately level.

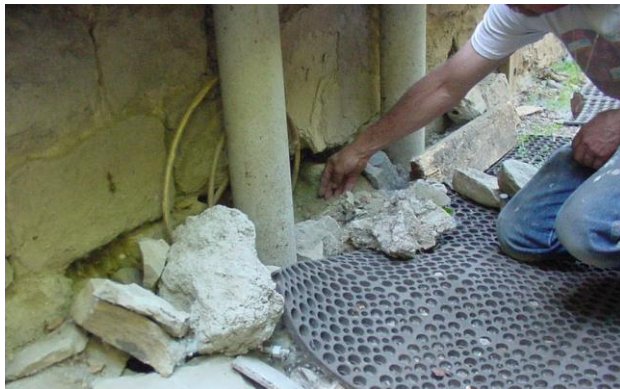
*Left: Crumbling stone masonry at base of northwest corner of building 2.*

The majority of the north stone wall does not require any structural work or retooling of joints. The exception is stone masonry at the northwest corner, which is crumbling. A portion of this stonework should be removed with new material replaced in kind.

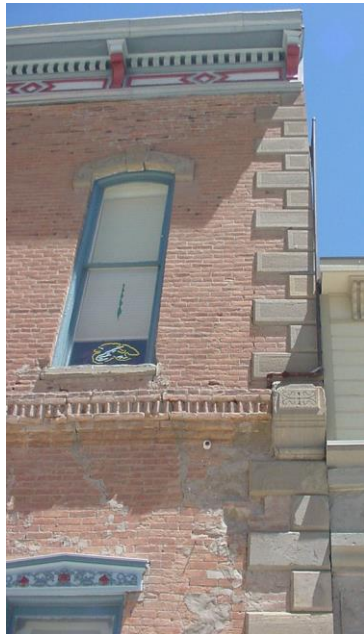
*Photos of damaged areas of southeast corner of Hough Building:*

*Upper level corner.*

The second option under consideration would primarily address the stabilization of the overall wall in its present structural condition and the outside appearance. In this measure, the physical configuration of the bearing masonry and the jacks embedded in concrete would remain untouched. The concrete block masonry behind the window would also be kept intact. The real corrective work undertaken would be at the outside wythe of brick. This wythe would be removed from the building up to the decorative band. The window would be removed, disassembled in a shop, reassembled square, restored, and reinstalled. Finally, the exterior wythe of brick would be rebuilt, using as much original material as possible, and using a mortar composition and color close to identical to the original.

Based on the factors previously mentioned: structural stabilization, historical accuracy, and cost effectiveness; the second option is recommended. This recommendation would offer greater structural stability, a historically accurate appearance, and less overall structural intervention, all for a lower total cost. During the course of the preparation of architectural and structural

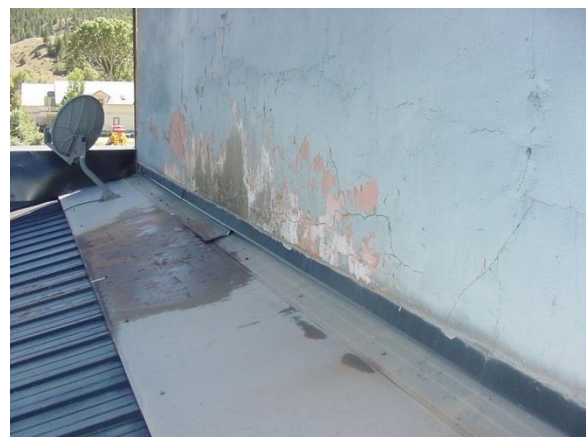
*Sheet metal flashing.*

The roof should be monitored for any signs of leakage. No roof replacement is recommended at this time. Approximately ten linear feet of sheet metal flashing at the wall-roof intersection should be removed and replaced.

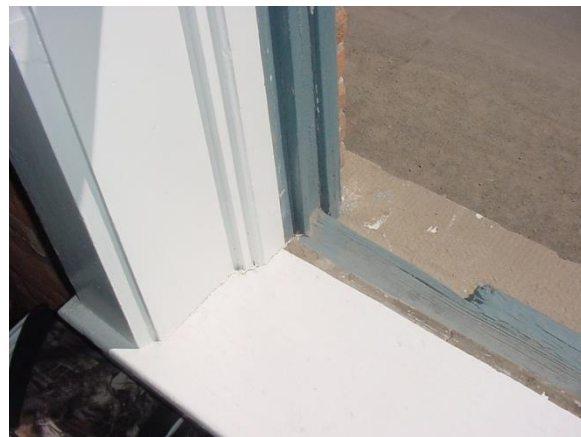
*Upper level window: damaged wood trim.*

Windows are all original, and appear to mostly contain their original glazing. Windows generally range from poor to good condition. Most of the windows have been well maintained and painted at the interior, but allowed to succumb to dry rot at the exterior, as depicted above. Paint on the interior of the windows is generally in poor to fair condition, and paint on the exterior of the windows is nearly universally in poor condition.

Determine through laboratory spectrographic analysis whether windows and trim were originally painted or stained, and if painted, what color. Refurbish windows as follows: Using gentlest means possible, remove all chipped and peeled paint from sash and frames only down to the next good paintable surface. Use epoxy filler to patch any damaged areas. Remove cracked glazing putty and re-putty. Prime the sash and frames. Use epoxy filler on cracked sills as needed.

Follow lead paint protocol. In all double-hung windows, replace all ropes and reset or replace any missing weights. Install new copper weather-stripping. Check all sash for proper operation. Replace any cracked panes with panes fabricated to match existing glass. Check inside finish. As appropriate to the original window treatment, reseal with paint or low sheen poly on any worn areas. Paint should be a close approximate of the original window color. Apply a poly finish coat. As an alternate, traditional varnish can be used, but would not be as durable as a poly finish.
