# **HISTORIC STRUCTURE ASSESSMENT**

## **MONTE VISTA UNITED METHODIST CHURCH MONTE VISTA, COLORADO**

PREPARED BY  
**MARK M. JONES ASSOCIATES, ARCHITECTS, LLC**  
1085 GRAND AVENUE  
DEL NORTE, COLORADO 81132  
(719) 657-2070 FAX (719) 657-2072

HISTORIC STRUCTURE ASSESSMENT  
State Historical Fund Project # 2003-HA-049  
September 12, 2003

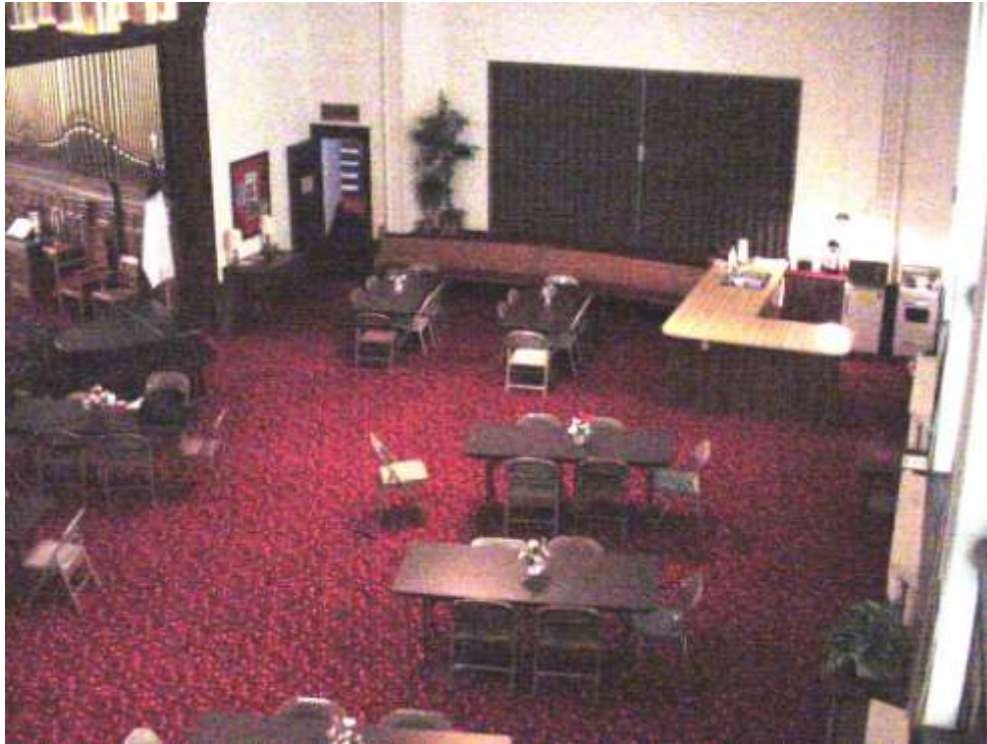
*Below: Dorcas Chapel, the adult Sunday School classroom.*

Floor framing and structural walls appear to be in good condition, except for the floor framing in the Dorcas Chapel, which is severely undulating. The reason for this condition is not evident, and will require opening up the framing for observation.

Corrective work is prescribed for the floor framing of the Dorcas Chapel only. In this room, all carpet must be removed and the floor system analyzed for flaws. As such, any flaws should be corrected either by sistering the floor joist members, or replacing them altogether if severely damaged.

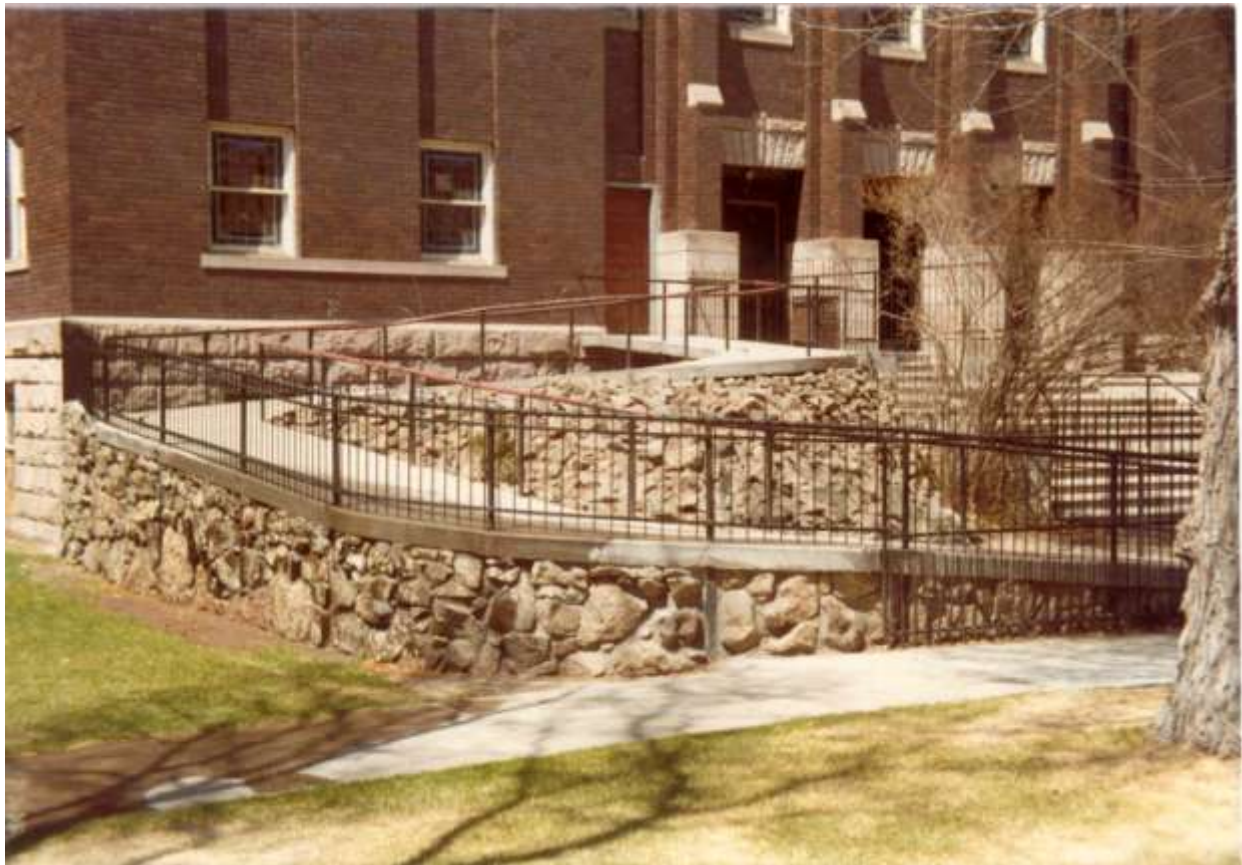
*The ramp, a challenge to navigate for even the ambulatory.*

The three additions made to the building, the serpentine ramp, entry vestibule, and carport, are all of poor design quality. None of these adequately relate to the design of their parent structure. The rubble stonework of the ramp does not match the rusticated or dressed stone or brick of the church. The north entry vestibule was designed for utilitarian purposes only, and was detailed with a limited palette of materials, including stucco, which are uncomplimentary to the church. The carport is a simple wood lean-to, and does not befit the stateliness of the church structure. Of the three additions, the ramp is in fair physical condition, while the vestibule and carport are in poor condition. The landscaping is poorly maintained, and not well composed.

The three additions should be removed. The serpentine ramp should be removed and replaced with a garden of well-maintained bush plantings and annual flowers. A new ramp with proper slope and landings should be designed at the northeast corner to allow better access to the building. Proposed plans for the ramp are located in Section 4.4. The north entry vestibule serves an important function as an entry and exit to the basement dining area, kitchen, nurseries and storage. It should be demolished in its entirety and rebuilt with purple tapestry brick and stone accents. The new entry addition should, in order to comply with the Secretary of Interior's Standards, be compatible with the existing historic fabric, but not imitative. A churchgoer should be able to discern that the addition was indeed built at a later time than the original construction. The carport at the southwest corner should be dismantled, and adjoining original fabric should be patched. Church leaders have spoken of replacing this carport with a solidly built carport or garage behind the parsonage. The design of the carport is not within the bounds of this Historic Structure Assessment. Once the exterior of the building has been renovated to its final form, beautifying landscaping should be designed and planted.

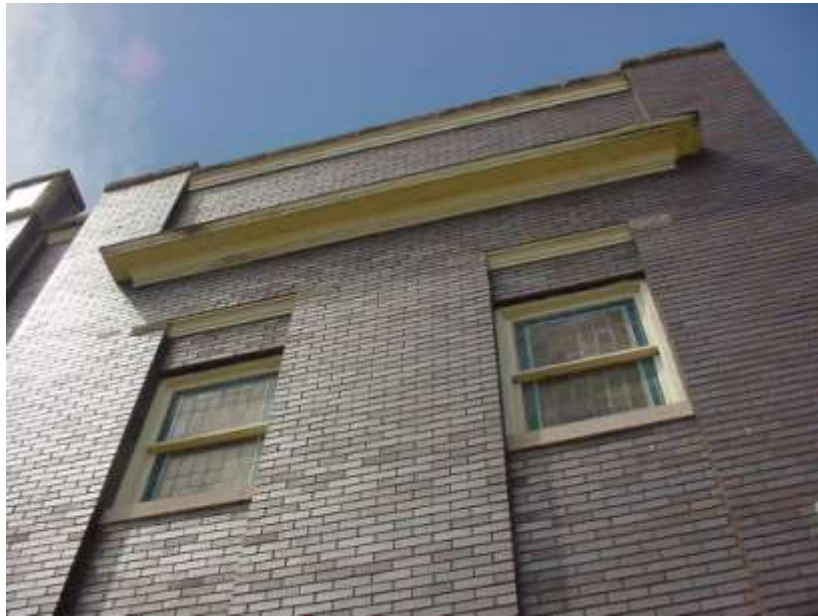
All decorative brick and stonework on the main body and the parapets of the building is in good condition. The wood cornices have begun to weather with time, and are sorely in need of a good paint job. Approximately twenty percent of the wood on the cornices has succumbed to dry rot.

*Typical view of wood cornice.*

A thorough cleaning with restoration cleaner is recommended for the decorative brick and stonework. The wood cornices have been critically examined for any signs of dry rot. Parts of these that have cracked or been overtaken by dry rot should be removed and repaired. Small holes or gaps in the woodwork should be filled with approved restoration wood filler. Samples of the cornice woodwork should be removed at several locations. These should be sent to a laboratory for spectrographic color analysis to determine original color. Scrape and clean old paint off down to the next good paintable surface. Observe lead paint protocol. Mill new pieces from kiln-dried lumber to match pieces too damaged to repair. Prime and paint with two coats using an oil-based exterior paint. The color should be a good approximation of the original color.

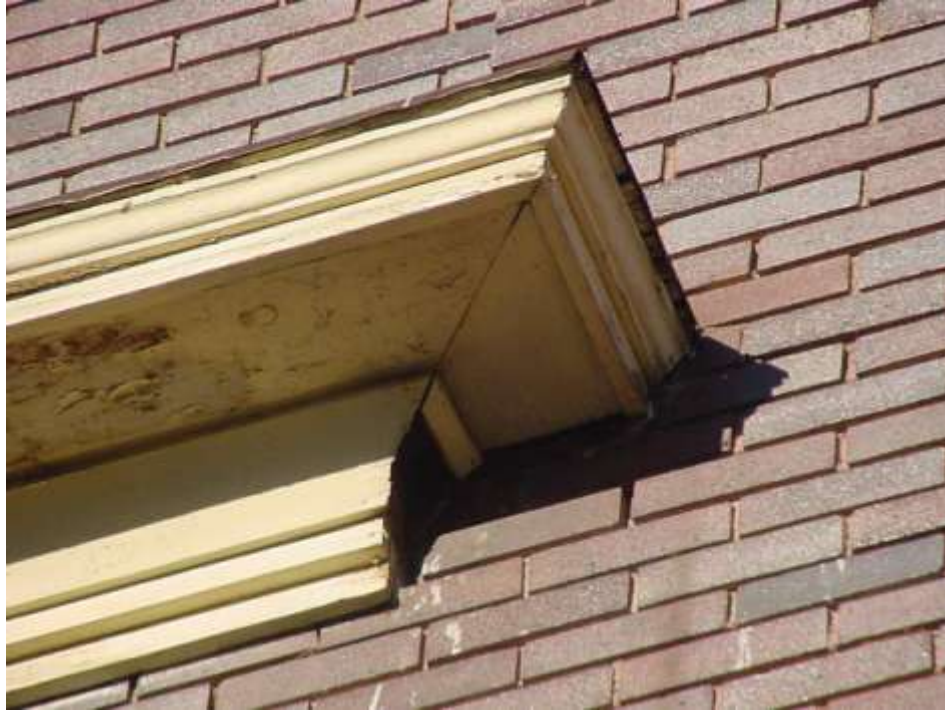
Above: *Detail at cornice edge.*

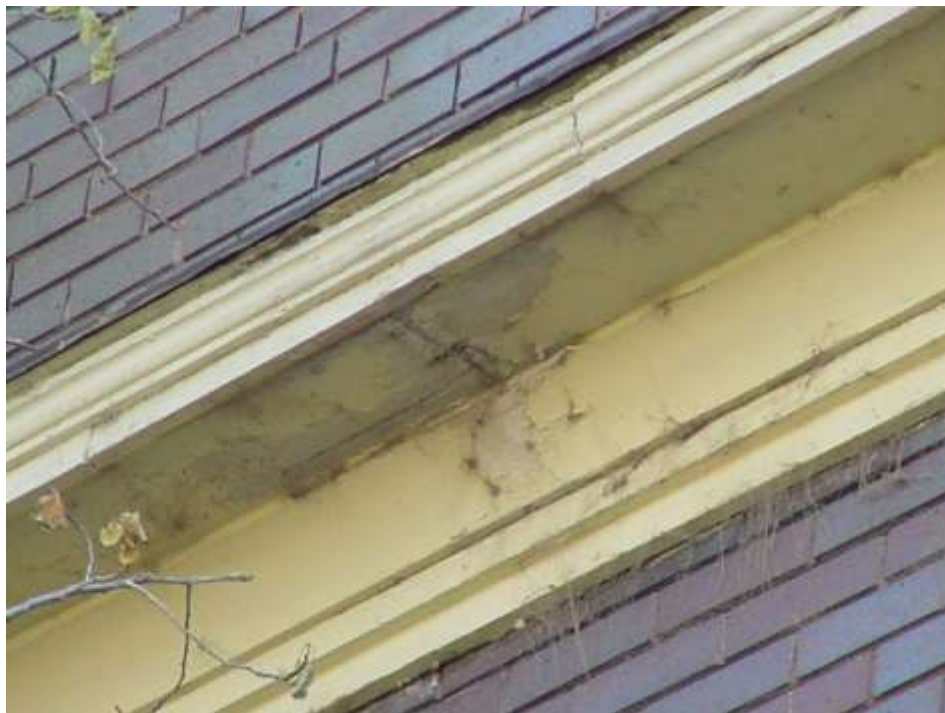
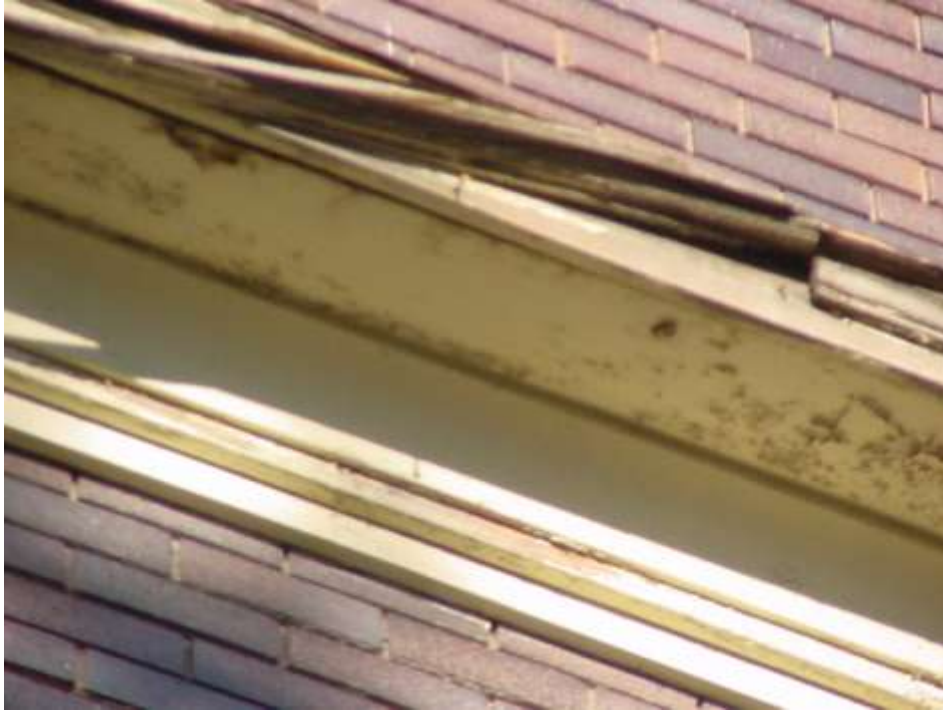
Below: *Extensive dry rot at wood cornices.*

*Extensive dry rot at wood cornices.*

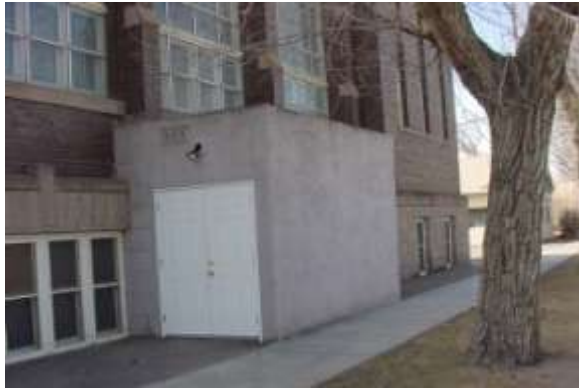
The entry stoop and its stairs and abutments are in fair to good condition. The entry vestibule is a purely utilitarian. Its construction is solid, but its appearance is poor. The ramp inside the vestibule is neither ADA conforming nor functional, and is unattractive. Mobility impaired parishioners usually need assistance from an ambulatory person to negotiate its turns and slope. The carport is a simple wood lean-to with a shed roof and wood siding. It is not in character with the main church.

*Exterior of entry vestibule.*

The north entry vestibule should be removed in its entirety and replaced with a more aesthetically appropriate design for an entry which coheres with the overall building design. Stone and brick materials could be chosen for this entry, which would also include doors more akin to those at the front, main entry. Once the new entry has been completely installed, original brickwork and stonework should be patched with severely damaged masonry units replaced in kind. Again, care should be taken in the new vestibule design to indicate a distinction between original and new construction. For example, the brick and stonework of the original façade and its arch could be maintained at the interior vestibule wall, indicating the original limits of construction.

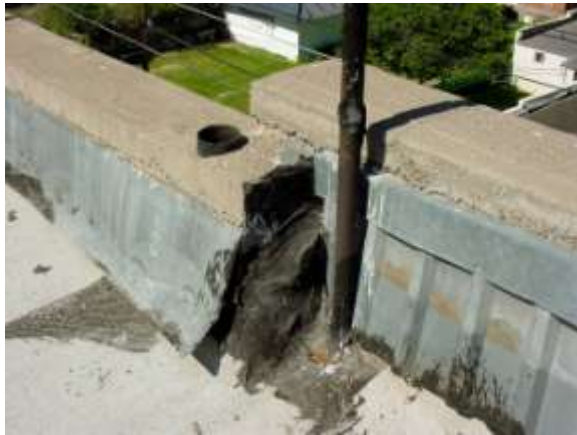
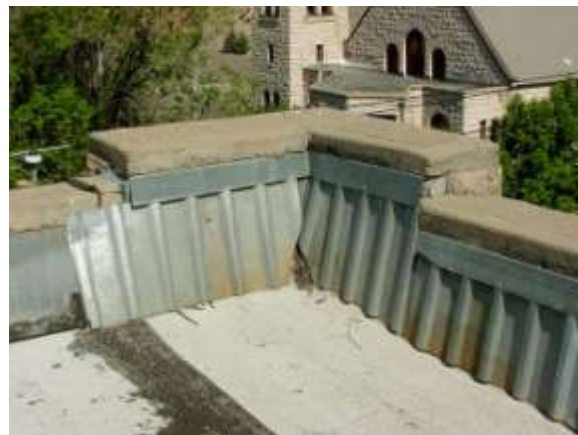
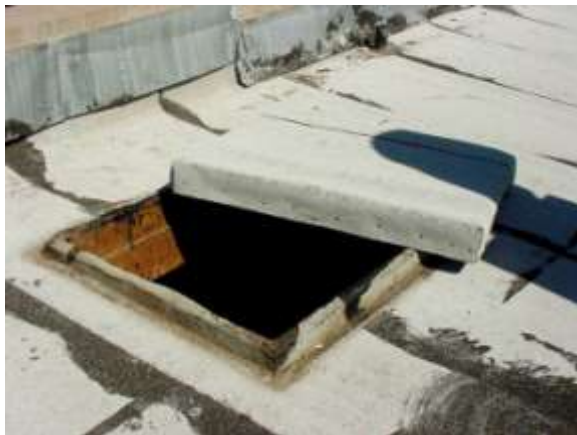
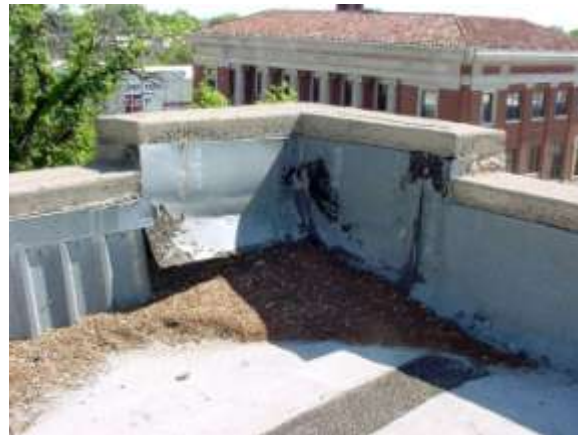
Clockwise from top: *Edge of roof showing concrete parapet cap and poor flashing, edge of roof with corrugated flashing, Edge of roof with vegetative material, Roof at roof hatch.*

The roof appears to be in good condition with no apparent leaks. The life expectancy of this roof is usually between ten and fifteen years, so this roof will endure for the time being. The flashing punctures through the roof envelope, and is incorrectly mounted at the parapet. Especially suspect are the corrugated metal flashing sheets. The sheet metal gutters and leaders are in fair to poor condition. Leaks have developed at the leaders on the south face of the building, causing erosion of the brick mortar and discoloring of the rhyolite stone.

As of the date of this report, no corrective work is advised for the roof membrane itself. The current roof could last another five years without replacement. The flashing should be removed where it is corrugated or improperly installed, and should be replaced with good quality sheet metal flashing. New leaders should be installed for the gutters at the north side of the building. These should match the leaders on the south side of the building. Completely failed sections of the galvanized metal gutters and leaders should be replaced in like kind. The gutters and leaders

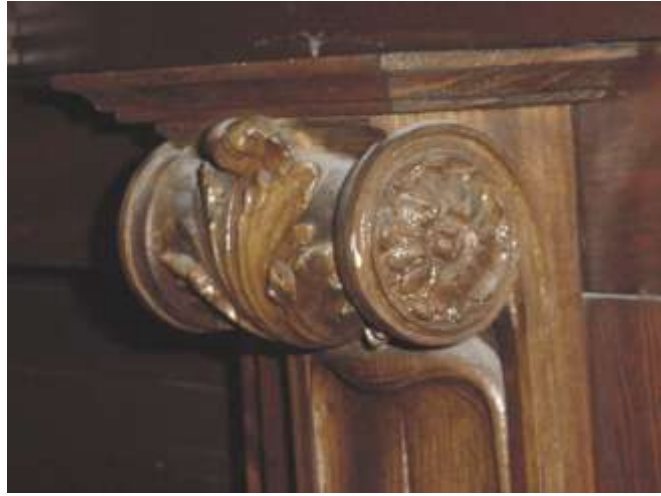
Above: *Failed plaster in upper level.*  
Right: *Plaster bracket at the ceiling of the sanctuary.*
