# **HISTORIC STRUCTURE ASSESSMENT**

## **SAGUACHE COUNTY COURTHOUSE SAGUACHE, COLORADO**

FOR  
**COUNTY OF SAGUACHE, COLORADO**

HISTORIC STRUCTURE ASSESSMENT  
State Historical Fund Project #2002-HA-043  
September 11, 2003

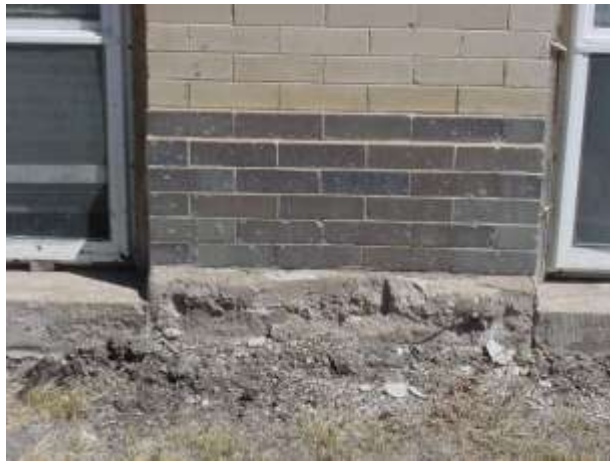
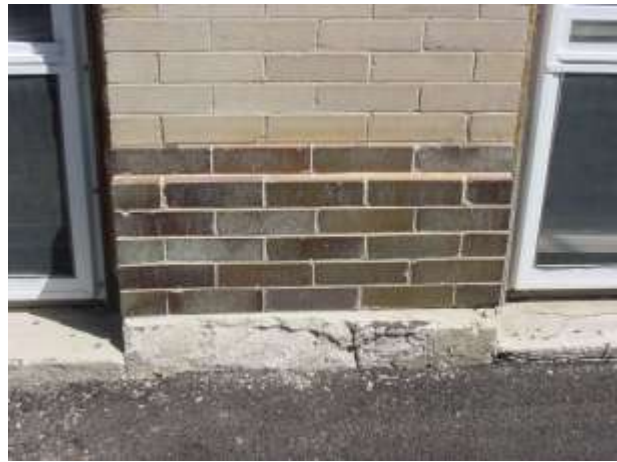
No foundation settlement is evidenced. The visible portion of the exterior basement walls forms a plinth on the exterior of the building. Portions of the north, west, and east plinth have eroded. This erosion, coupled with a lack of proper maintenance, has resulted in a deterioration of the plinth stonework. About 15% of the plinth is severely deteriorated and crumbling. About 30% of the plinth has suffered only mild erosion. In these cases the plinth is chipped and generally worn. About 20% of the eroded plinth has been covered with a Portland cement parging by

county maintenance workers. About 15% of the plinth has been painted by county maintenance workers.

*Crumbling plinth.*

The 15% severely deteriorated and crumbling stone should be removed until a solid surface is reached. Then, new stone should be keyed in with drilled metal rods. The 30% mildly eroded stonework should be patched with a quality stone patch product. Painted or parged stone is unacceptable. The paint and parging should be removed with Prosoco Restoration cleaner in a dilution recommended by the manufacturer, applied with a medium soft bristle brush and then washed off. No pressure washers or sandblasters should be used, nor should any abrasive products or tools be used. Apply no sealers to the basement walls. Once this work is complete, assure that enough soil is compacted around the foundation perimeter.

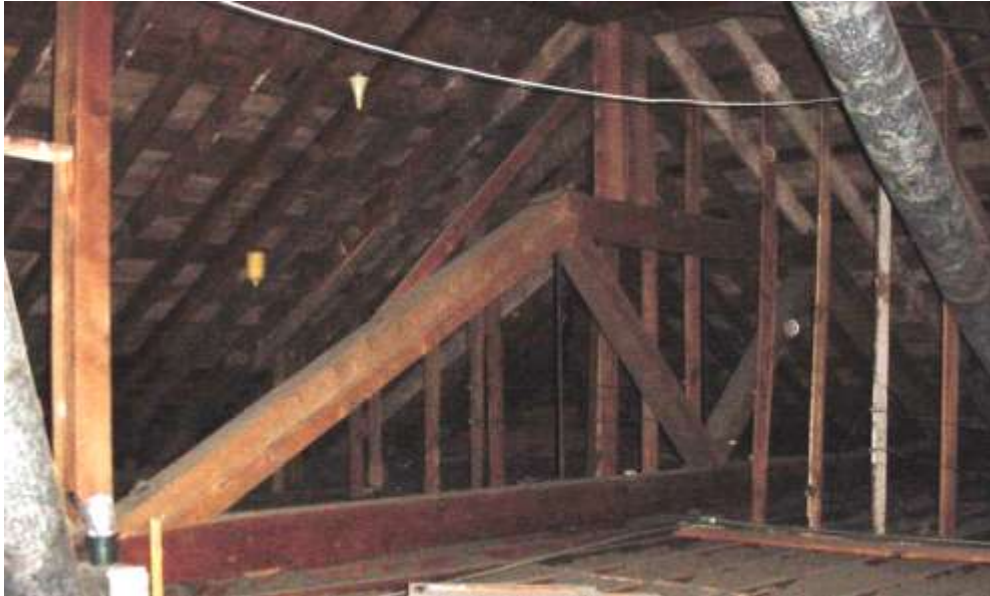
*One of four 8x10 construction girder roof trusses. Note vertical steel tension rods.*

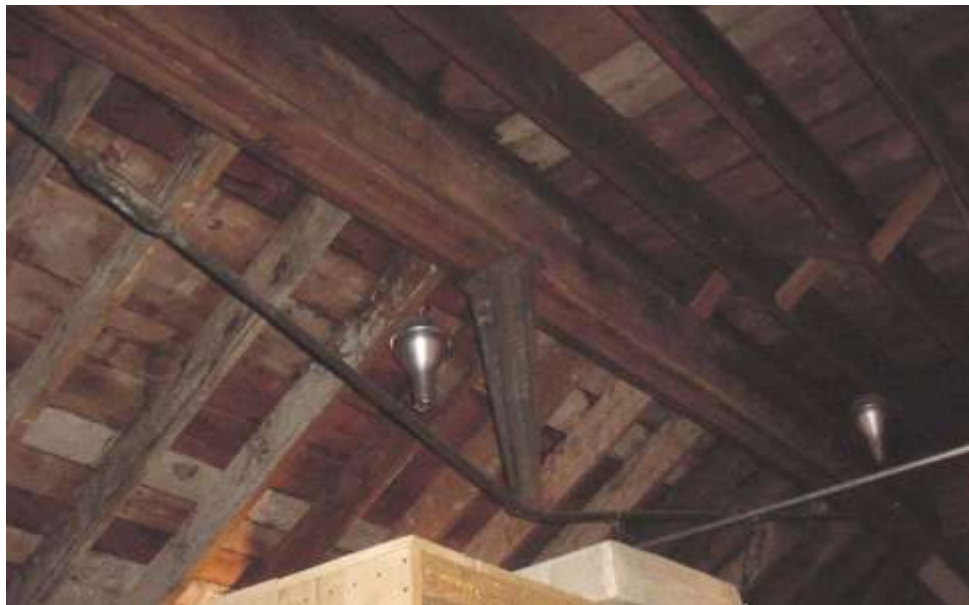
*Hog chain trusses in attic, supporting edge of flat roof and rafters.*

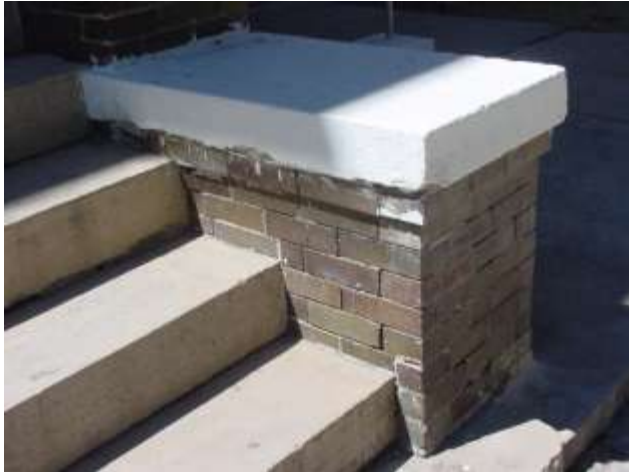
*Purple brick at stoop. Note improper painting of abutment.*

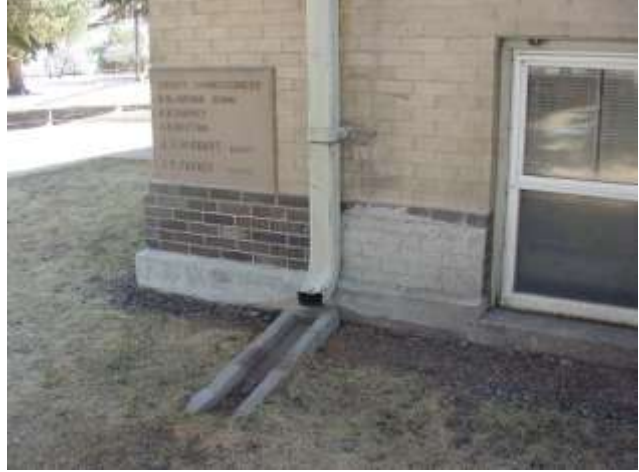
*Painted brick, to right of downspout.*

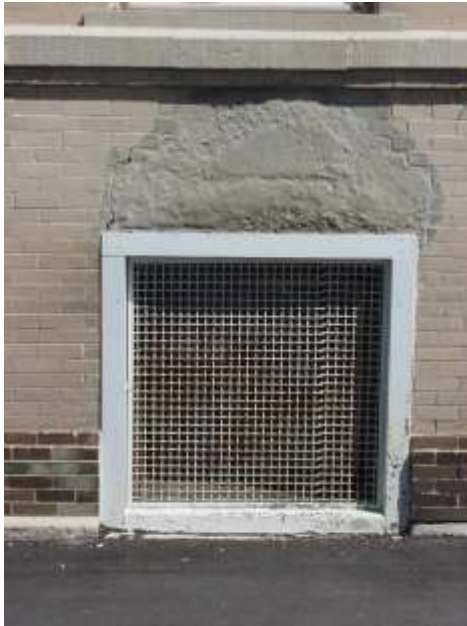
Left: Condition of area above vent grille on west face of building. This area must have all cement removed and replaced with brick to match its surroundings.

First of all, remove all cement parging from area above the grille on the west face. Clean this area completely, and install brick in a workmanlike manner, so as to show no distinction between new brick and existing brick field. See photograph below. The grill itself will be removed and replaced with a combustion air louver for the furnace. Please see the mechanical portion of this report, section 3.8, for further information about this louver.

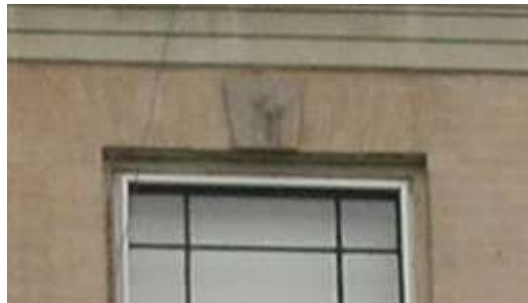
Below: Upper level window brick jack arch with brick key plastered with cement.

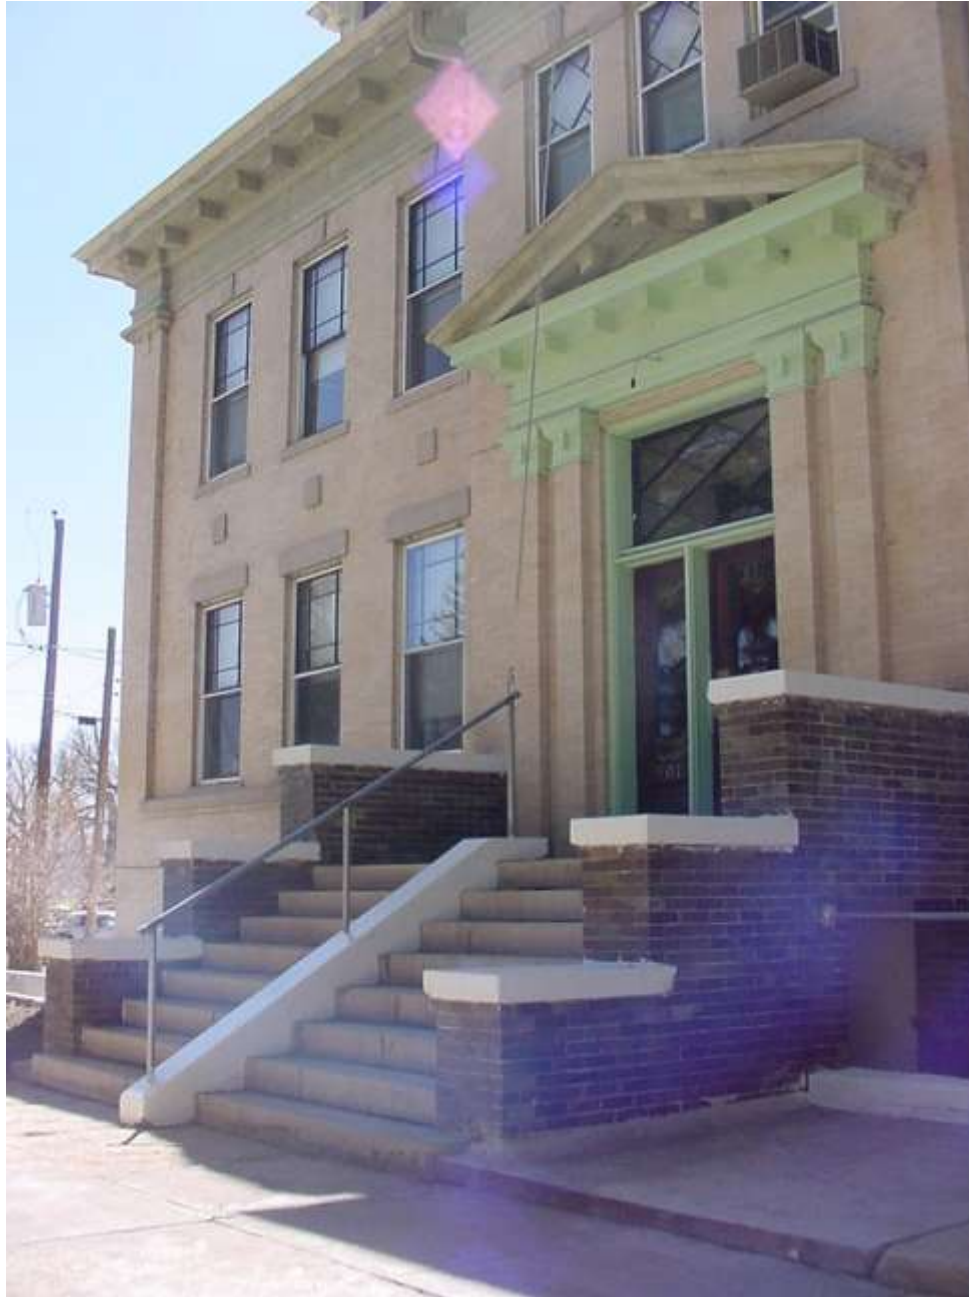
The stone stairs are in poor condition, having seriously worn due to weather and foot traffic, and having settled over time. The abutments have been inappropriately painted white. It appears as though the central stringer of the main entry stair is not original, as it does not appear on the architect's original drawings. No adequate, code-compliant railings are present on the main entry stair. In the installation of the sloping concrete walk, several bricks were damaged.

*Entry photo, showing front stair.*

Remove central steel pipe railing mounted on central stringer. Remove central stringer by hand with hammers and chisels, taking care not to damage the original stone steps beneath it. Remove all paint from concrete abutment caps, following protocol described under the category of Building Envelope. Again, do not apply any sealant over the cleaned concrete. Remove and reset all stone steps. Patch any holes or chips in stone steps with concrete patching compound. Install three new code-compliant period iron handrails, one on each side and one in the center. Clean all masonry composing the sidewalls on the east entry porch and stoop, as instructed under section 3.4. The brickwork on the south sidewall needs repair, by selective replacement of damaged brick. No recommendations are made for the west entry.

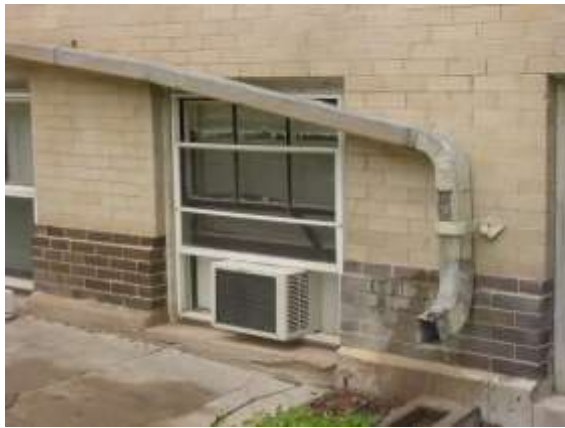
downspouts are in poor condition, and leak. One downspout in particular is unacceptably aligned so as to block a basement window.

*Left: leader (downspout) blocking basement window at front (east) elevation.*

The gutters and leaders should be repaired and sealed, and then should receive the same painting treatment as noted above. The leader blocking the basement window should be raised and remounted so as not to obscure this window. Insofar as possible other leaders should be kept in their original position, but water from these leaders should be collected and conducted away from the building on a hard surface device. Generally, water drained from the roof should be kept a minimum of eight feet away from the building at the entire building perimeter. The hard surface device should be accomplished by means of extended leaders, drain pans, or even trench drains leading away from the building. Once an appropriate remedy is installed, the area should be monitored for a prescribed period of one full year for signs of further leakage at rooms along the building perimeter, especially the land use offices and the furnace room.

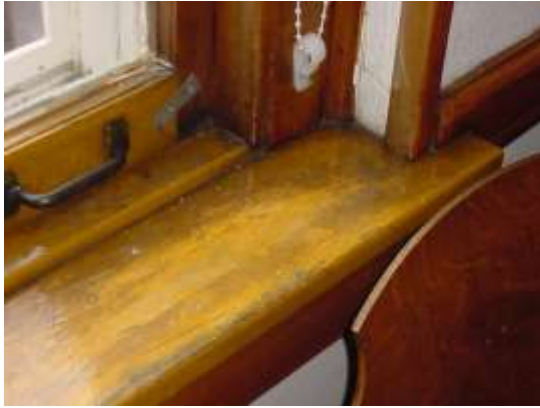
*Rotted window sill at second floor*

Forty percent of the interior window sills should be replaced, as they are significantly deteriorated. Mill new interior window sills to exactly match the profile of the original sills.

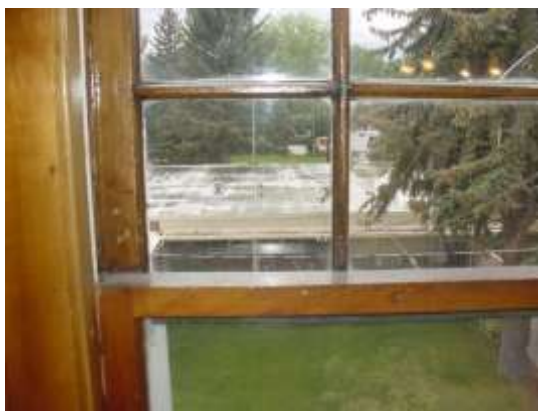
*Cracked panes and bowing rails at second floor window*

Approximately eight windows with rotted sash and bowed rails should be removed and restored off-site. The broken panes should be replaced with modern glass. All windows should have their ropes and weights removed and replaced. Seventy-five percent of the windows should have all glazing putty scraped off and replaced. All glazing putty should be painted. Approximately half of galvanized weatherstripping should be replaced.

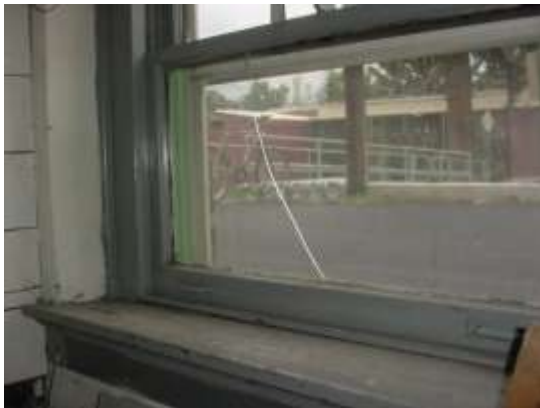
*Cracked window at basement level*

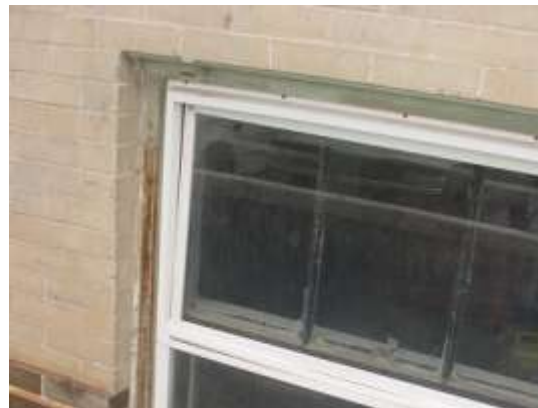
*Rotted exterior trim at basement window*

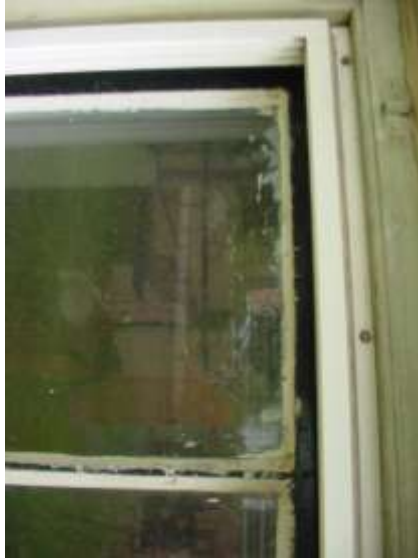
Left: Window at north elevation basement level. Note poor application of glazing putty on window.

Refurbish windows as follows: Remove and dispose of storm sash. Using gentlest means possible, remove all chipped and peeled paint from sash and frames only down to the next good paintable surface. All paint should be removed from basement windows. Use epoxy filler to patch any damaged areas. Remove cracked or poorly applied glazing putty and re-putty. Prime sash and frames. Use epoxy filler on cracked sills as needed. Follow lead paint protocol. Replace all ropes and reset or replace any missing weights. Install galvanized architectural sheet metal weatherstripping. Check all sashes for proper operation. Replace any cracked panes. Check inside finish and reseal with low sheen poly on any areas, especially sills, which are worn. As an alternate, traditional varnish can be used, but would not be as durable as a poly finish. Remove surface paint from any painted interior sash, frames, trim, and sills and restore original finish with stain sealer as needed, and poly finish coat. Lubricate all moving parts of window hardware, and clean all window hardware with a soft cloth.

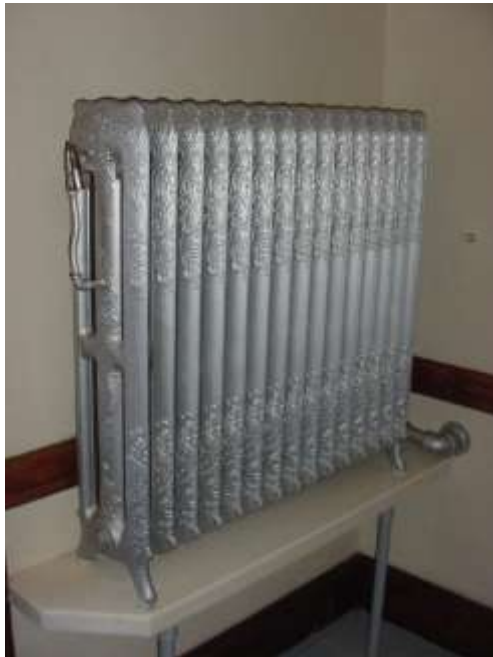
Left: *Cast iron radiator, typical throughout building.*
