HISTORIC STRUCTURE REPORT

# The William Bonner House

110 EAST MAIN STREET  
MIDWAY, UTAH

REPORT PREPARED BY  
CHRISTOPHER LOBAS ARCHITECTS, P.C.  
CLEVELAND, OHIO

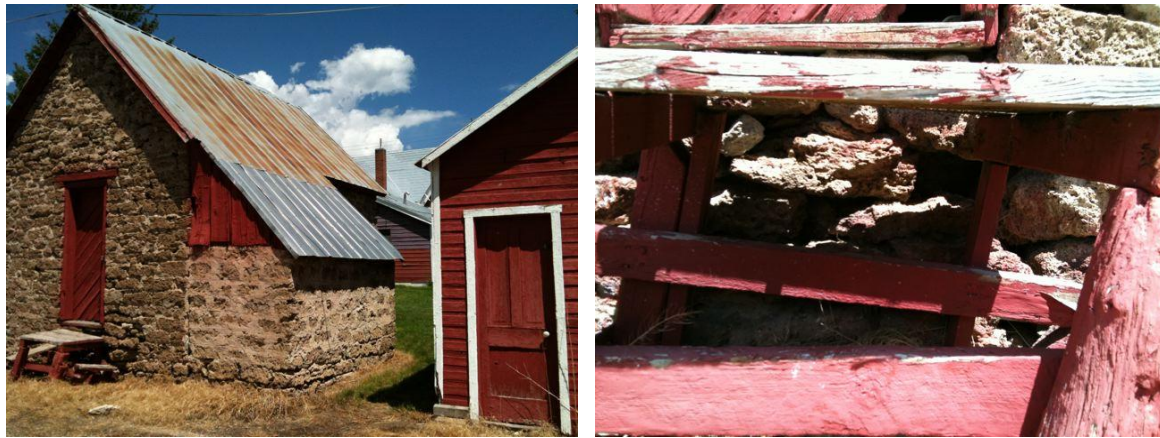
The foundations for the Granary range in condition from poor to satisfactory. It was observed in a few spots that the mortar joints have deteriorated to a point that the Pot Rocks have loosened and failed. See photos on following page.

Granary, with loose foundation stones and failed mortar. (Packer, 2010).

Repair any cracked and damaged areas of masonry foundations. All damaged mortar joints need to be repointed. Repointing is the process of carefully removing and replacing any damaged or deteriorated mortar joints. Care should be taken to redirect any surface drainage away from the Granary. Watering sprinklers should also be redirected so that they do not spray towards the structure.

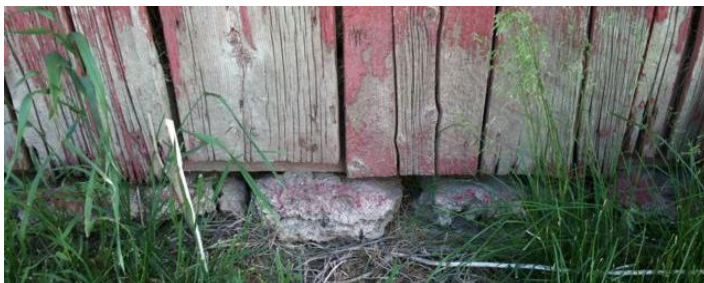
Barn foundation (cropped).  
(Packer, 2010).

The masonry foundations for the Barn are in poor condition. Mortared joints were not observed and the exterior foundations did not extend down for frost protection. Without mortared joints, the foundation system does not work together as a single unit and thus the structure is susceptible to differential vertical and some horizontal movement. Without frost protection, the structure is highly susceptible to vertical movement between seasonal temperature fluctuations. Knowing the above information however was probably of no concern to the original owners, since the structure still is and was used as a Barn.

Due to the lack of an adequate long term foundation system at the Barn, it is recommended that the existing foundations be removed and new reinforced foundations provided.

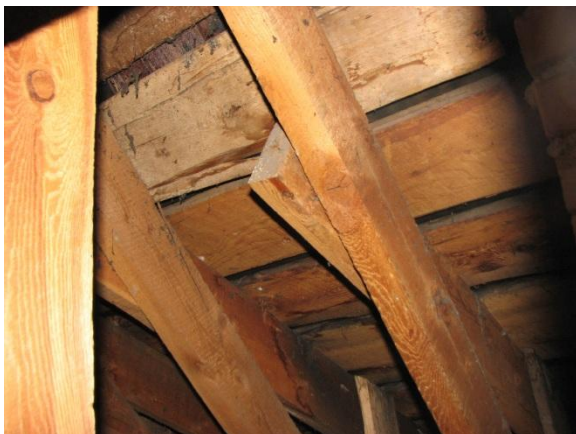
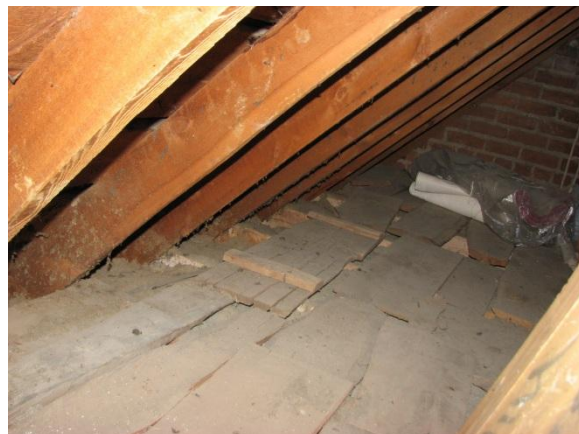
Attic trusses in Bonner House (Packer, 2010).

The overall condition of the Home's roof and floor system appears to be in good condition when considering the age of the structure and the environment in which it has been exposed to.

Observation indicates that the roof and floor framing shows no significant signs of failure or distress. However, due to the age of construction, it's anticipated that some damaged framing will be uncovered with further observations.

Any damaged roof and floor framing should be repaired or replaced. It's recommended that the roof shingles be removed from each structure and the roofs sheathed with ½" sheathing

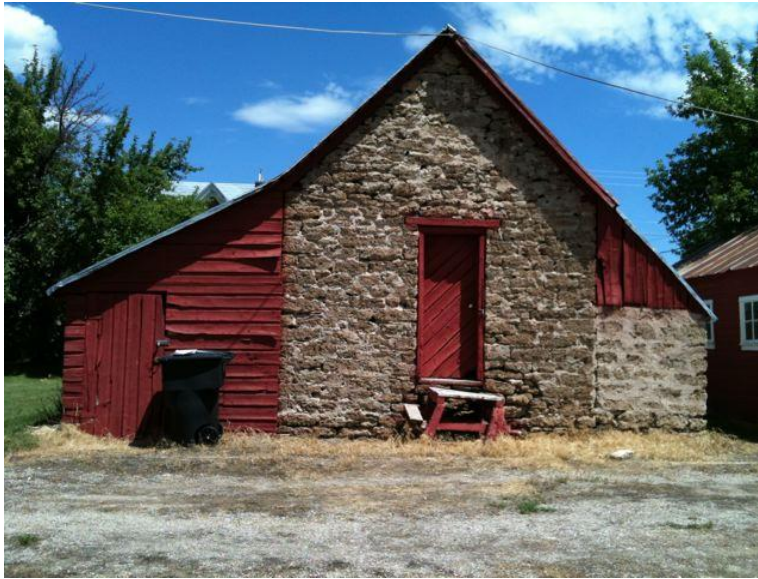
The Granary's roof and floor system appeared to be in satisfactory to poor condition. Much of the roof and floor framing is damaged and will need to be repaired or replaced. A mid bearing beam line had been installed later on in order to stiffen the floor joists. However, this beam line needs to be repaired or rebuilt. The siding on the west side addition is also in poor shape and needs to be replaced. See photo on following page.

Granary west elevation. (Packer, 2010).

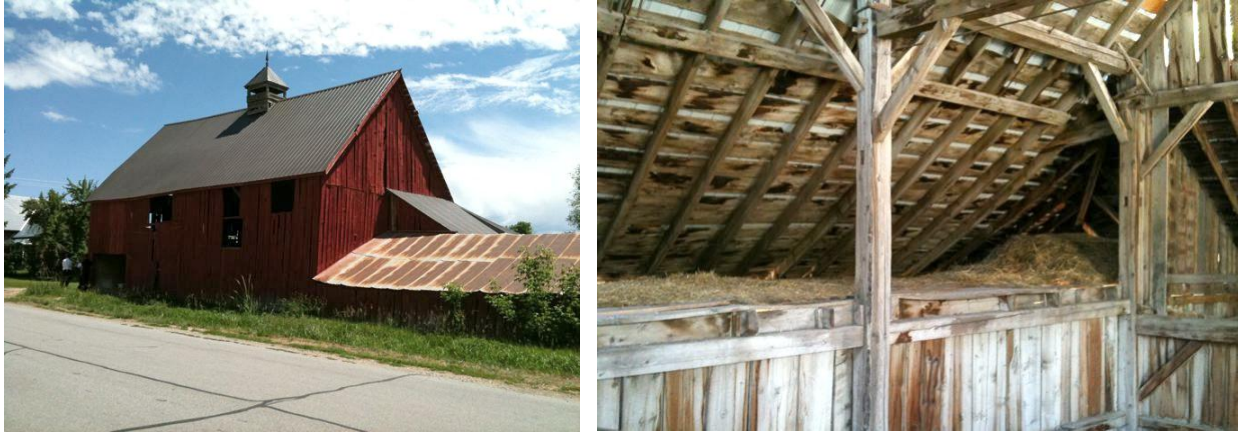
Barn, exterior view and interior showing post-and-beam structure. (Packer, 2010).

The condition of the large Barn appeared to be poor especially at its southern addition. It was observed in several areas that the post and beam connections have either failed or partially failed.

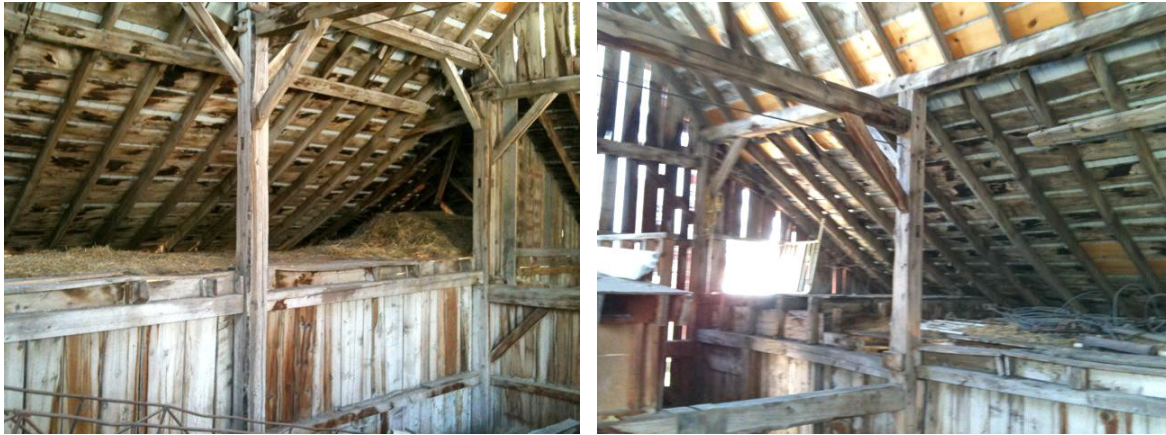
At some point in time, steel tie rods were installed to help tie/hold the original barn structure from side to side in order to resist bowing of the structure. The steel rods can be seen in the photos on the following page. The upper level floor and roof of the East addition has pulled away from its supporting beams and has been inadequately modified to try and keep the floor system in place.

Interior photos of barn, showing steel tension rods. (Packer, 2010).

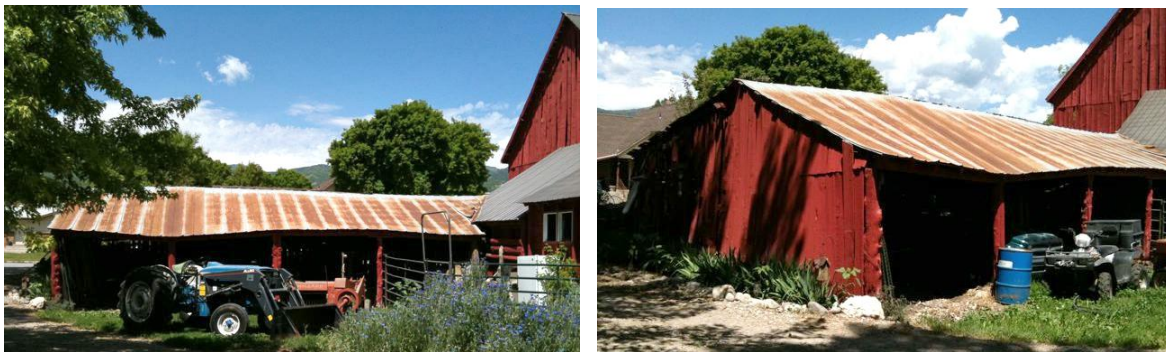
The Southern addition has also racked and many of the beams and columns appear under-sized. See photo below.

South barn addition. (Packer, 2010).
