**HISTORIC STRUCTURE ASSESSMENT  
MOFFAT COMMUNITY CHURCH  
MOFFAT, COLORADO**

FOR  
**THE TOWN OF MOFFAT, COLORADO**  
AND THE  
**MOFFAT COMMUNITY CENTER COMMITTEE**

PREPARED BY  
**MARK M. JONES ASSOCIATES, ARCHITECTS, LLC**  
1085 GRAND AVENUE  
DEL NORTE, COLORADO 81132  
(719) 657-2070 FAX (719) 657-2072

HISTORIC STRUCTURE ASSESSMENT  
State Historical Fund Project # 2003-HA-061  
September 24, 2003

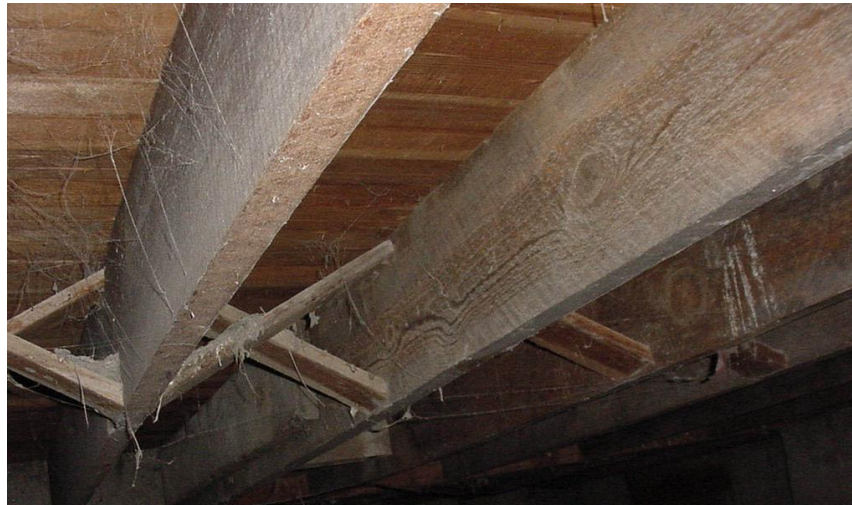
The majority of main floor framing appears to be in good condition, with no dry rot noted.

*Main floor framing joists and cross bridging.*

Corrective work entails the replacement of internal concrete stem walls with steel I-beams and columns, as described in section 3.2 Foundations above.

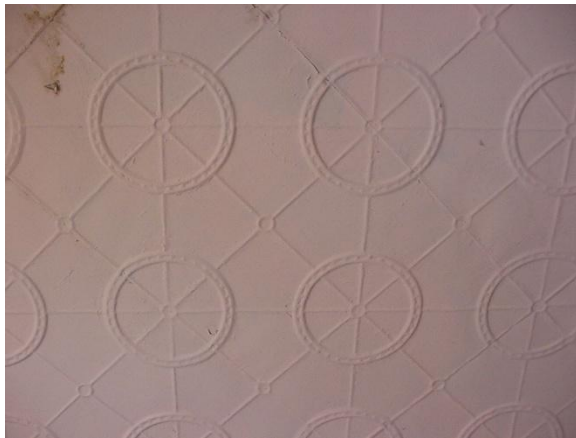
*Tin ceiling in chancel.*

The majority of the roof and ceiling framing is in good condition and has not succumbed to dry rot. The only damaged areas are at the ceilings at the northwest and southwest steeples. These have undergone water damage and extensive dry rot.

At that time, original ceiling framing should be evaluated from above for structural stability. Missing or damaged members should be replaced in kind. Keeping as many good tin ceiling panels in place as possible, the ceiling framing should be prepared to receive new panels as required.

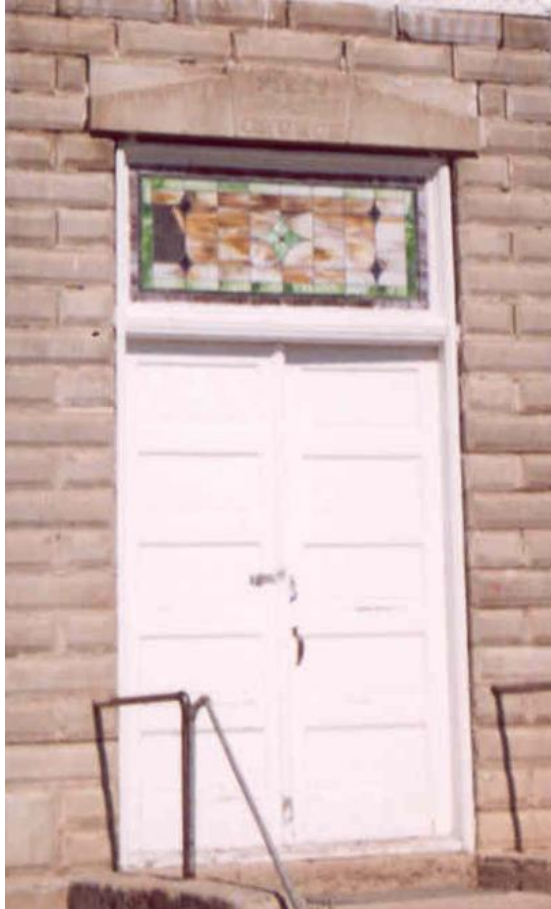
*Main entry doors.*

The main exterior doors and frames are in fair condition. The doors leading to the cellar through the sheds are in poor condition. Window condition generally ranges from fair to poor, given the age of the windows. Every surviving original window is intact with original hardware. Hardware consists of brass sash pulls and brass sash locks. The majority of the windows appear to have functional ropes and weights. Some of the sash of the original windows has undergone

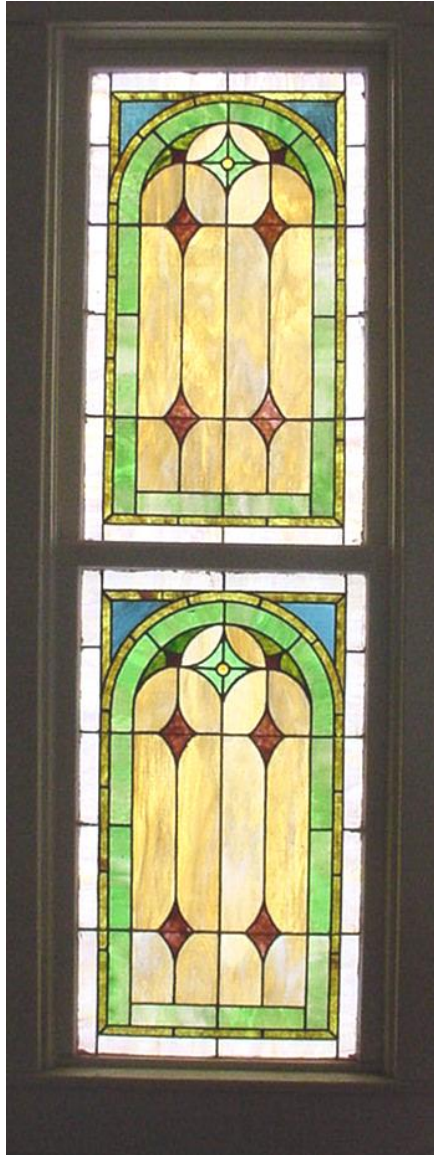
early stages of dry rot. Four windows are missing altogether from the two corner steeples and two windows are missing on the west elevation at the main level. These windows are filled in with concrete masonry units and covered with stucco. A pattern of masonry joints is roughly etched into the stucco. All seventeen windows on the lower level have been removed and replaced with concrete infill panels. On the main level, some glass panes have been broken and have been replaced with non-matching glass. Paint on the windows, both inside and out, is in fair condition.

*Above: Top window sash saved from steeple window.*

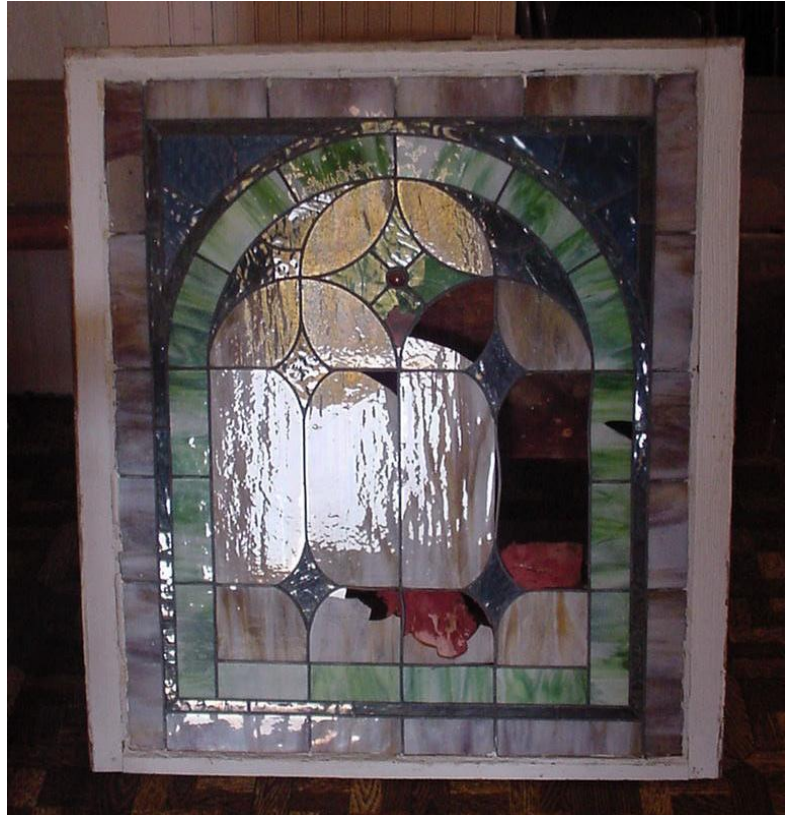
*Left: Sanctuary window, showing top and bottom stained glass sash.*

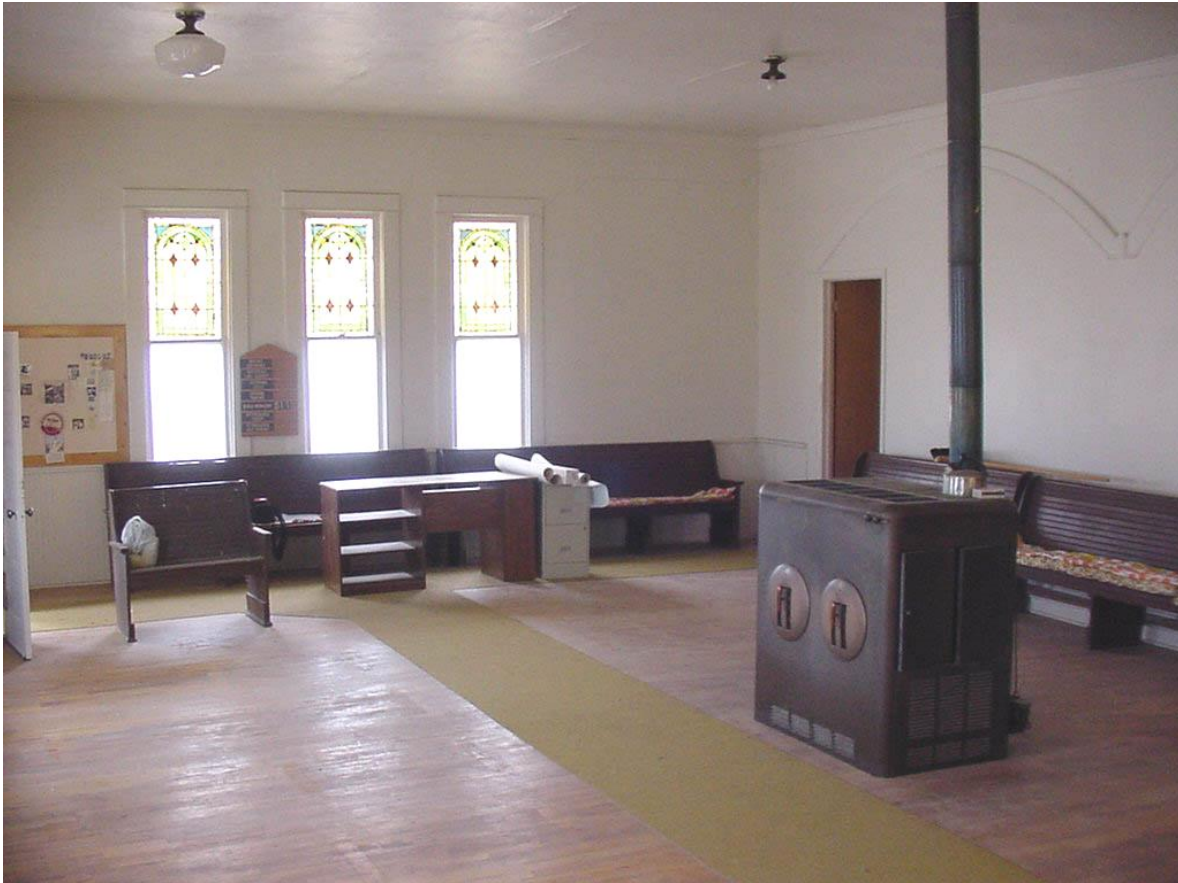
*View of sanctuary looking south. Note wood arch at west wall, hardwood flooring, plaster walls and ceiling, and wood bead board wainscot.*

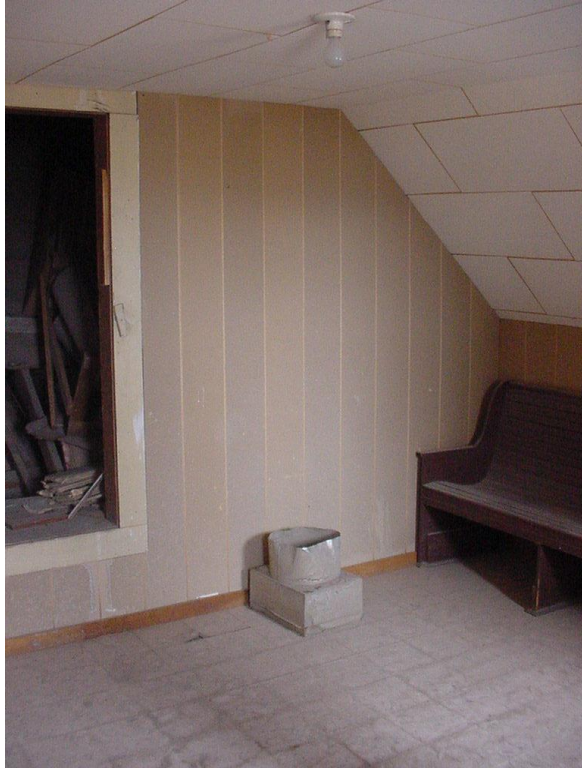
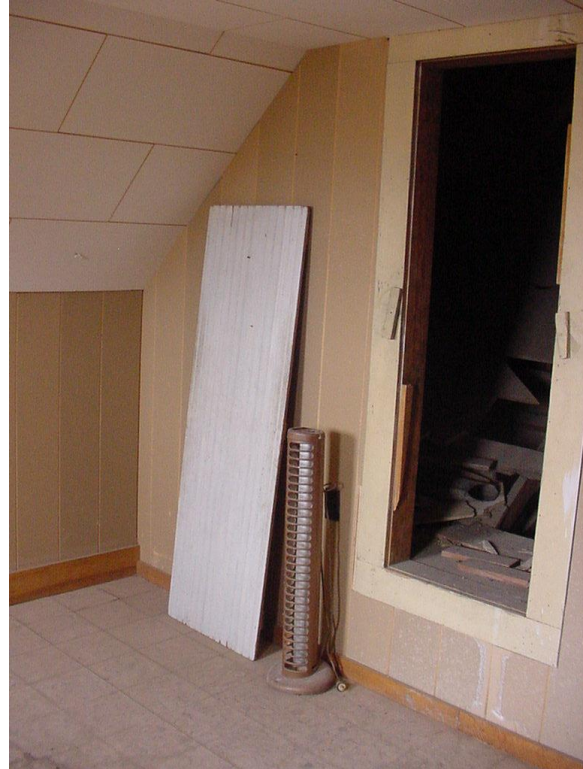
*Upper room area. Floors are finished with square vinyl asbestos tiles, walls are finished with wood paneling, and ceilings are finished with fiberboard panels. Door opening leads to attic space above sanctuary.*

The former chancel area ceiling is in fair to poor condition. Some of the pinwheel-pattern tin ceiling tiles there have begun to rust and deteriorate. The plaster ceiling in the sanctuary is in fair condition. An unfortunate result of its installation was the piercing of some portions of the original tin ceiling above with suspension framing members. The overall condition of the original sanctuary ceiling cannot be assessed without complete demolition of the plaster ceiling beneath it. Presumably the condition of the original tin ceiling in this area ranges from fair to poor. The fiberboard ceiling in the upper room is worn and in fair condition.

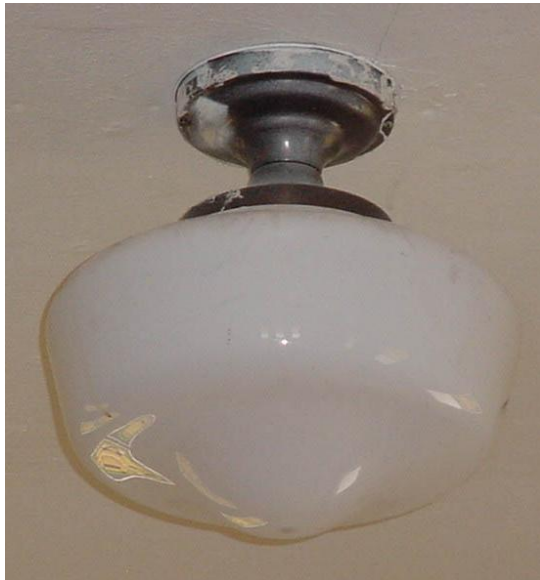
The existing lighting fixtures are in fair condition. None of the existing fixtures are original, as all were installed after 1932 when the flat plaster ceiling was built in the sanctuary.

Left: *Pendant light fixture in sanctuary.*

In general, it is recommended that the lighting throughout the occupied portion of the building be replaced with period type historical fixtures. The four pendant fixtures should be salvaged, cleaned, and used in flat ceiling portions of the building. Additional incandescent lighting should be installed in the cellar to provide for service access.
