# HISTORIC STRUCTURE ASSESSMENT

## HOUGH BUILDING

CORNER OF THIRD AND SILVER STREETS  
LAKE CITY, COLORADO

HISTORIC STRUCTURE ASSESSMENT  
State Historical Fund Project #2003-HA-068  
June, 2004

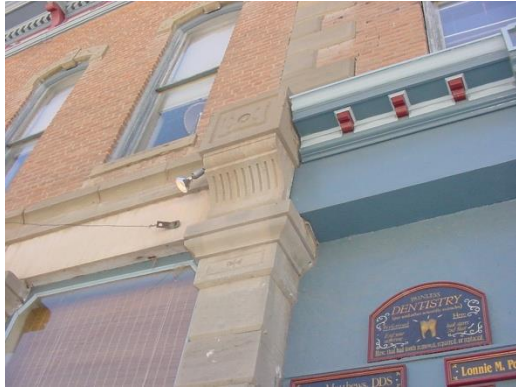
*Cornice at building intersection.*

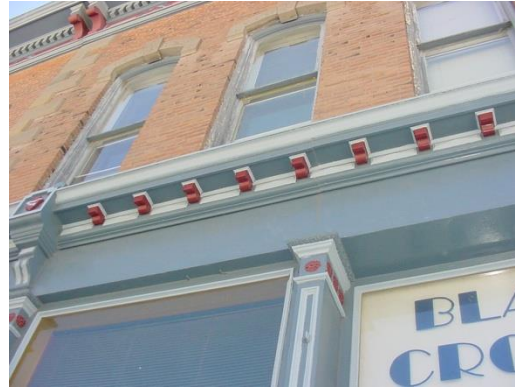
*Cornice at building 1.*

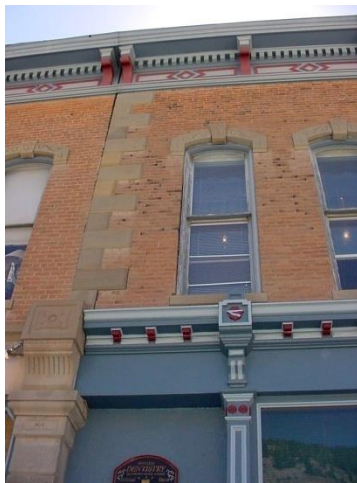
*Cornice and upper cornice.*

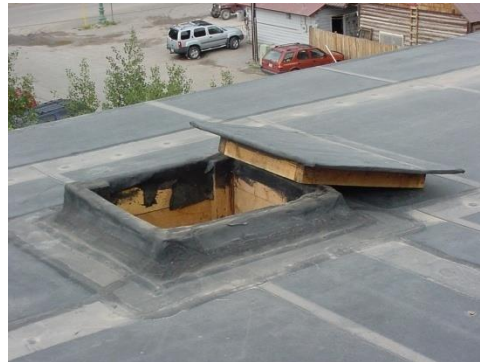
*Detail at east roof hatch.*

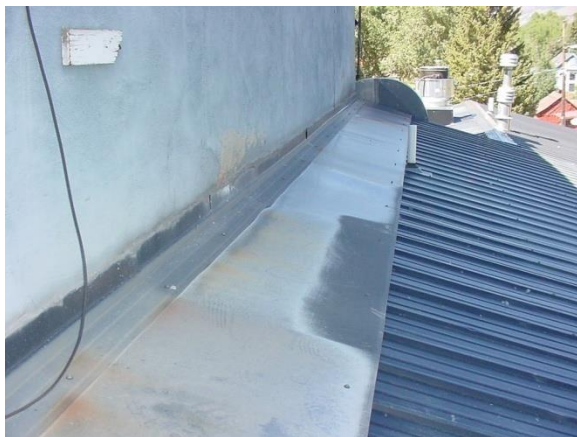
The rubber roofing system appears to be in good condition. All seems are intact and parapet flashing appears to be in good condition. The building maintenance worker, Mr. Charlie Curtis, reports that since this roofing system has been installed, no leaks have been reported. No signs of leakage were apparent on the second level, directly below this roof. The metal seamed roofing system appears to be in fair condition. The sheet metal flashing at the building edge is intact, but some has begun to rust from exposure to the elements.

*Sheet metal flashing at metal roof*

The roof should be monitored for any signs of leakage. No roof replacement is recommended at this time. Approximately ten linear feet of sheet metal flashing at the wall-roof intersection should be removed and replaced.

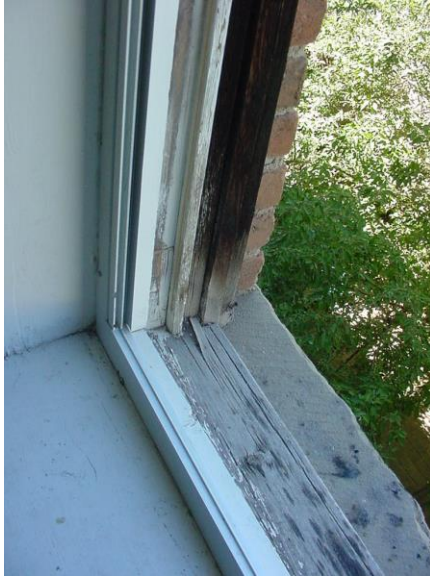
*Upper level window: rotted sill.*

Windows are all original, and appear to mostly contain their original glazing. Windows generally range from poor to good condition. Most of the windows have been well maintained and painted at the interior, but allowed to succumb to dry rot at the exterior, as depicted above. Paint on the interior of the windows is generally in poor to fair condition, and paint on the exterior of the windows is nearly universally in poor condition.

Determine through laboratory spectrographic analysis whether windows and trim were originally painted or stained, and if painted, what color. Refurbish windows as follows: Using gentlest means possible, remove all chipped and peeled paint from sash and frames only down to the next good paintable surface. Use epoxy filler to patch any damaged areas. Remove cracked glazing putty and re-putty. Prime the sash and frames. Use epoxy filler on cracked sills as needed.

Follow lead paint protocol. In all double-hung windows, replace all ropes and reset or replace any missing weights. Install new copper weather-stripping. Check all sash for proper operation. Replace any cracked panes with panes fabricated to match existing glass. Check inside finish. As appropriate to the original window treatment, reseal with paint or low sheen poly on any worn areas. Paint should be a close approximate of the original window color. Apply a poly finish coat. As an alternate, traditional varnish can be used, but would not be as durable as a poly finish.

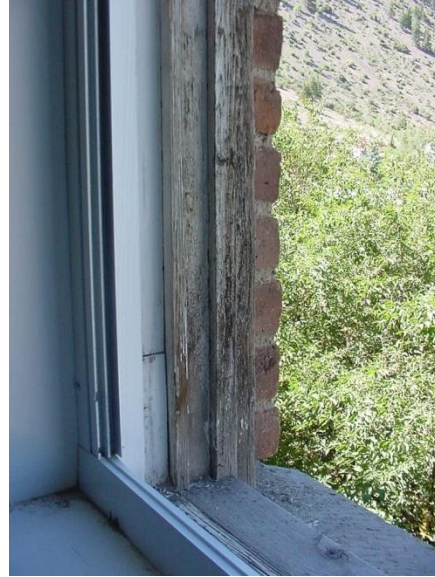
*Upper level window: rotted trim.*

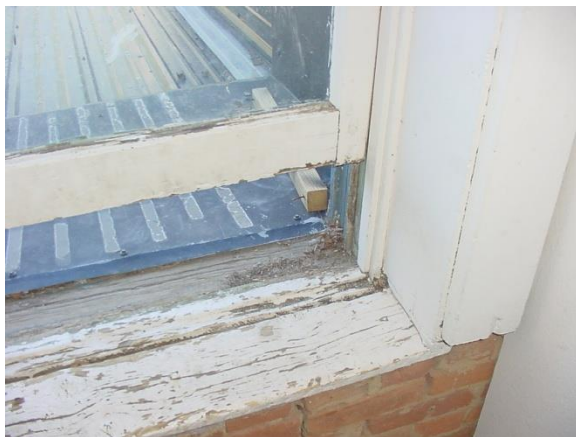
*Upper level window: rotted sill*

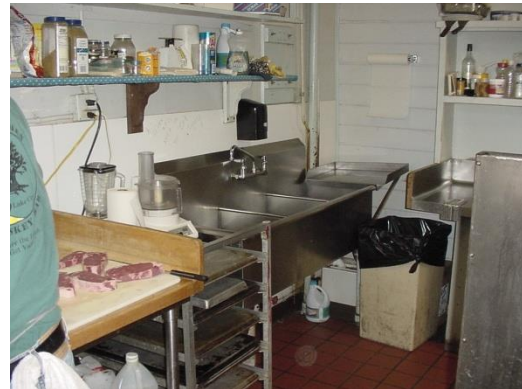
East wall of kitchen with 3 comp. sink.

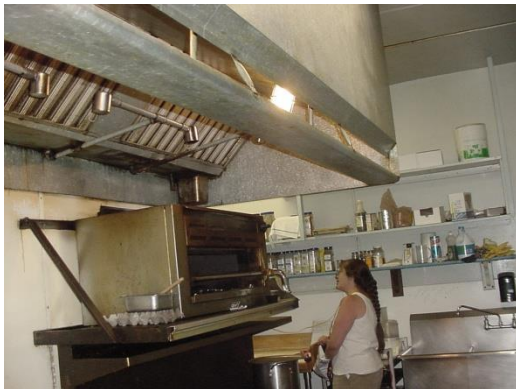
Kitchen, looking east.

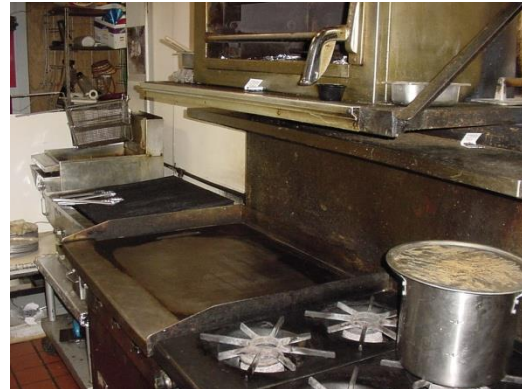
Kitchen, stove and fry top.
