# **HISTORIC STRUCTURE ASSESSMENT**

## **MONTE VISTA UNITED METHODIST CHURCH MONTE VISTA, COLORADO**

PREPARED BY  
**MARK M. JONES ASSOCIATES, ARCHITECTS, LLC**  
1085 GRAND AVENUE  
DEL NORTE, COLORADO 81132  
(719) 657-2070 FAX (719) 657-2072

HISTORIC STRUCTURE ASSESSMENT  
State Historical Fund Project # 2003-HA-049  
September 12, 2003

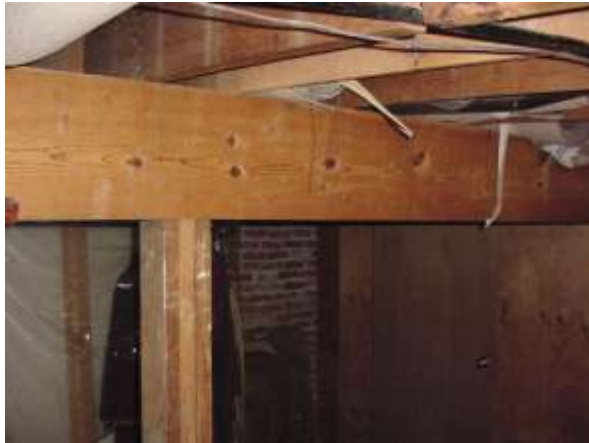
*Composite beam in storage room below chancel.      2 x 12 joists below chancel.*

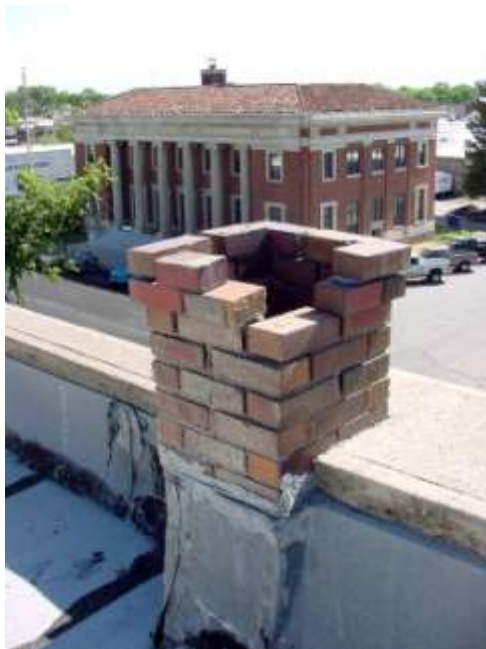
*Chimney at east battlement. Note potentially perilous placement of bricks.*

The chimneys at the southwest corner and the east battlement, for the pastor's office fireplace and the Dorcas chapel gas heater respectively, should be disassembled and restacked with proper mortar by a qualified mason. This work should be undertaken immediately.

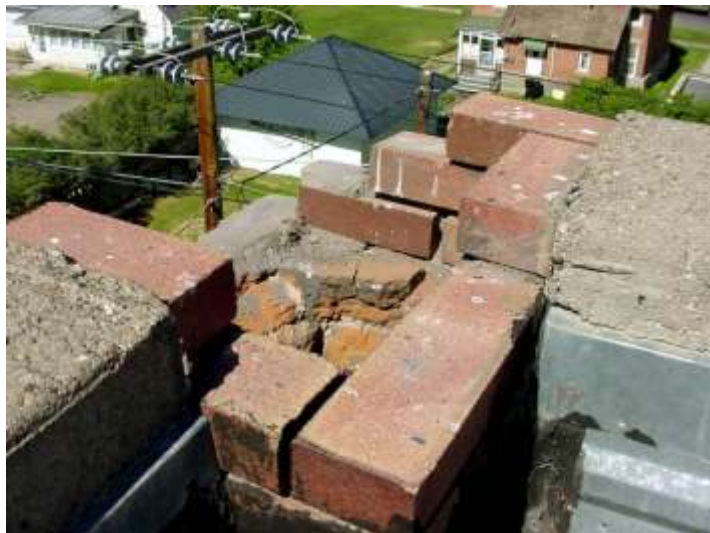
*Chimney at southwest corner.*

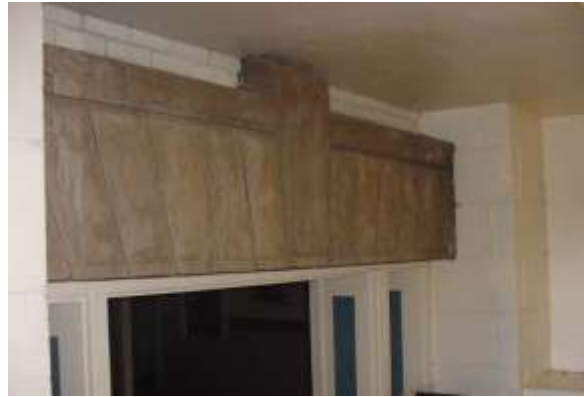
The entry stoop and its stairs and abutments are in fair to good condition. The entry vestibule is a purely utilitarian. Its construction is solid, but its appearance is poor. The ramp inside the vestibule is neither ADA conforming nor functional, and is unattractive. Mobility impaired parishioners usually need assistance from an ambulatory person to negotiate its turns and slope. The carport is a simple wood lean-to with a shed roof and wood siding. It is not in character with the main church.

*Arch at entry vestibule interior, looking in to dining room*

The north entry vestibule should be removed in its entirety and replaced with a more aesthetically appropriate design for an entry which coheres with the overall building design. Stone and brick materials could be chosen for this entry, which would also include doors more akin to those at the front, main entry. Once the new entry has been completely installed, original brickwork and stonework should be patched with severely damaged masonry units replaced in kind. Again, care should be taken in the new vestibule design to indicate a distinction between original and new construction. For example, the brick and stonework of the original façade and its arch could be maintained at the interior vestibule wall, indicating the original limits of construction.

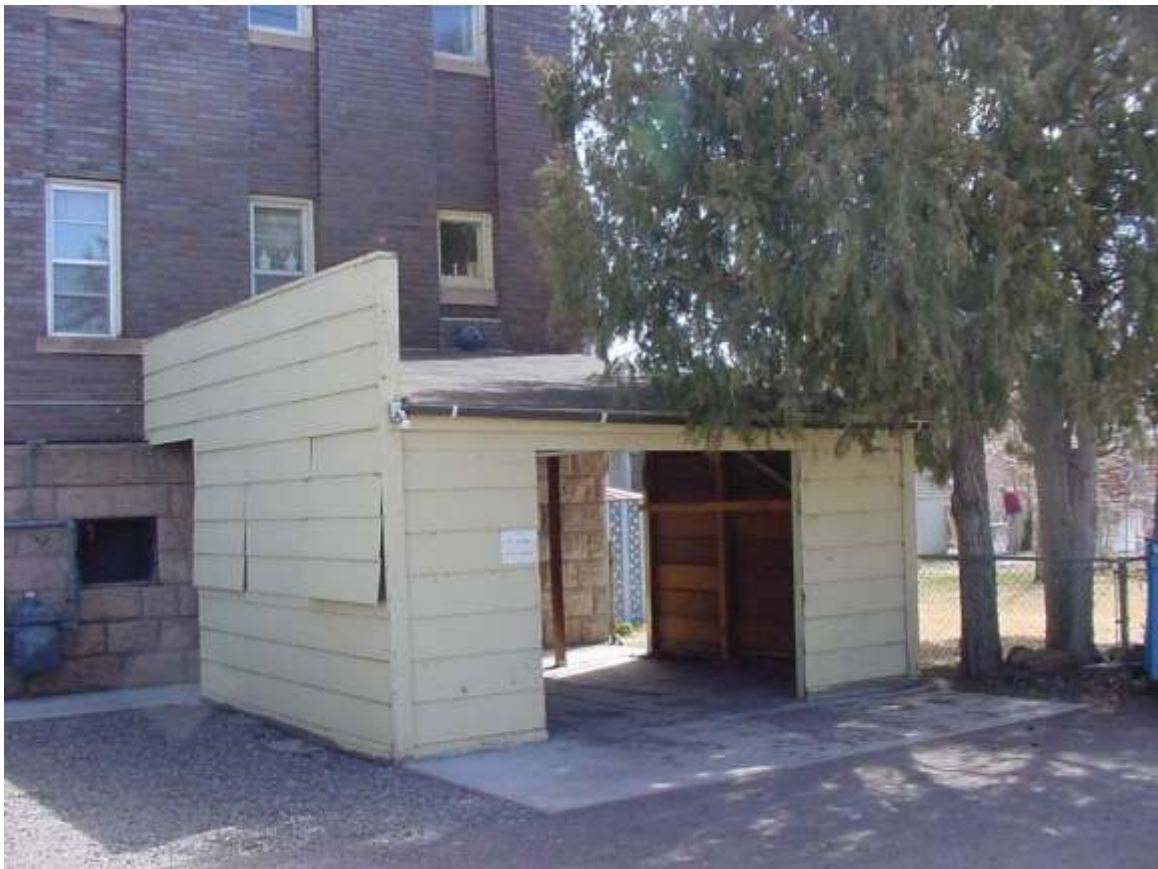
*Southwest carport*

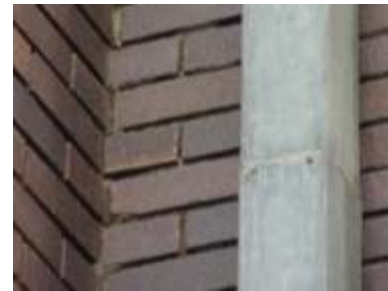
The roof appears to be in good condition with no apparent leaks. The life expectancy of this roof is usually between ten and fifteen years, so this roof will endure for the time being. The flashing punctures through the roof envelope, and is incorrectly mounted at the parapet. Especially suspect are the corrugated metal flashing sheets. The sheet metal gutters and leaders are in fair to poor condition. Leaks have developed at the leaders on the south face of the building, causing erosion of the brick mortar and discoloring of the rhyolite stone.

*Leader at west side of south elevation. Note loss of mortar at brick.*

As of the date of this report, no corrective work is advised for the roof membrane itself. The current roof could last another five years without replacement. The flashing should be removed where it is corrugated or improperly installed, and should be replaced with good quality sheet metal flashing. New leaders should be installed for the gutters at the north side of the building. These should match the leaders on the south side of the building. Completely failed sections of the galvanized metal gutters and leaders should be replaced in like kind. The gutters and leaders

should also be inspected to assure that they are securely fastened. Additional fasteners should be installed where required. All gutters and leaders should be given fresh coats of rustoleum metal primer and paint, or equivalent.

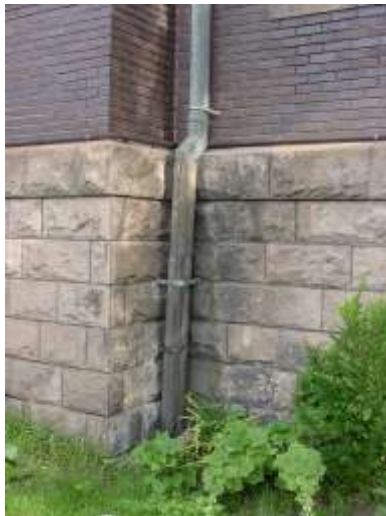
*Leader at west side of south elevation. Note the dark, discolored rhyolite stone.*

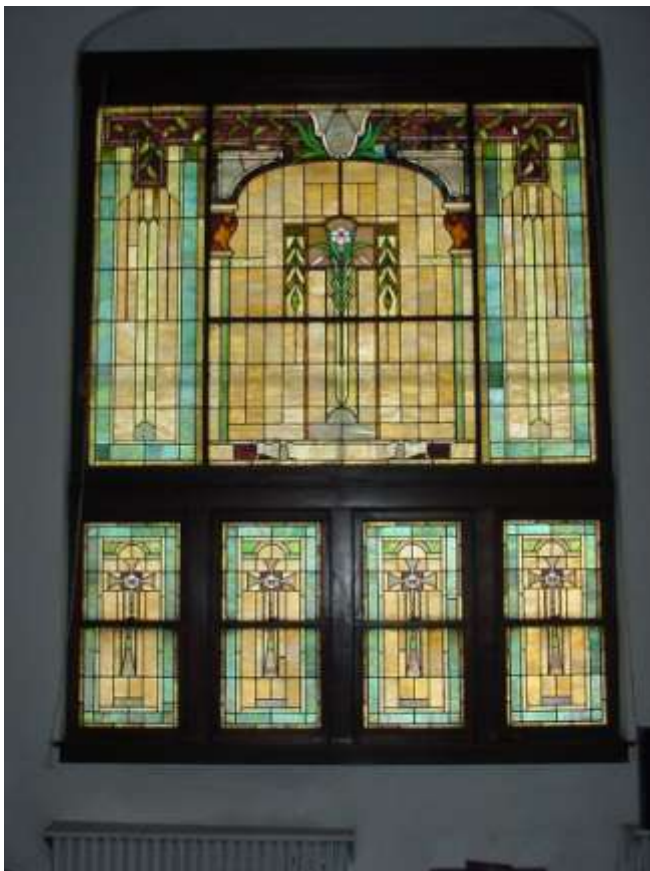
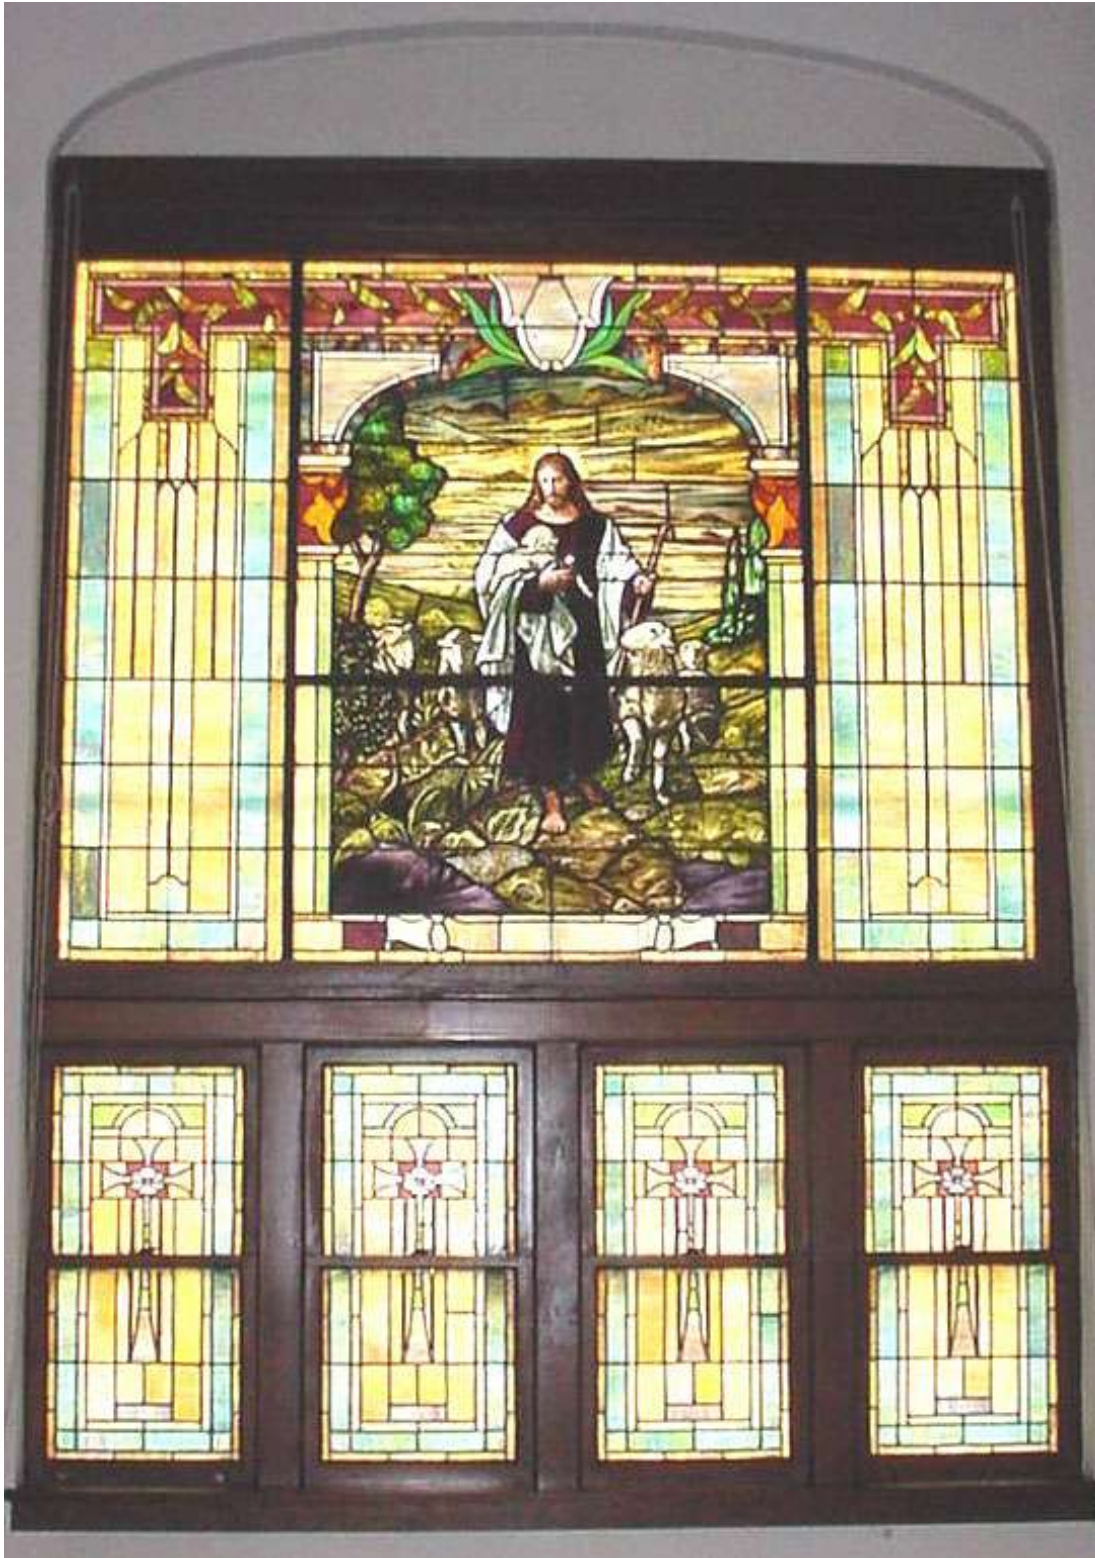
The showpiece stained glass windows are six in number, and contain very few broken or replaced panes. These windows had lexan protective covers added at the exterior in 1973.

*Stained glass window on north wall.  
Above: Exterior with storm windows visible.  
Below: Interior view.*

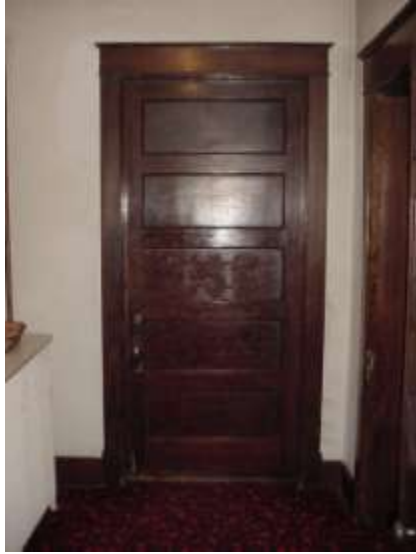
*Interior five panel door with dark stain.*

Remove the first layer of varnish from all varnished exterior doors and restore original finish with stain sealer as needed. Add a poly finish coat over the stain sealer. On the approximately twenty original stained interior doors, follow the same protocol. Those doors that access secondary spaces, and the doors to the Sunday school classrooms, should be maintenance painted as recommended by architect. No work is recommended for the large overhead doors and the iron railing dividing the sanctuary from the assembly area.

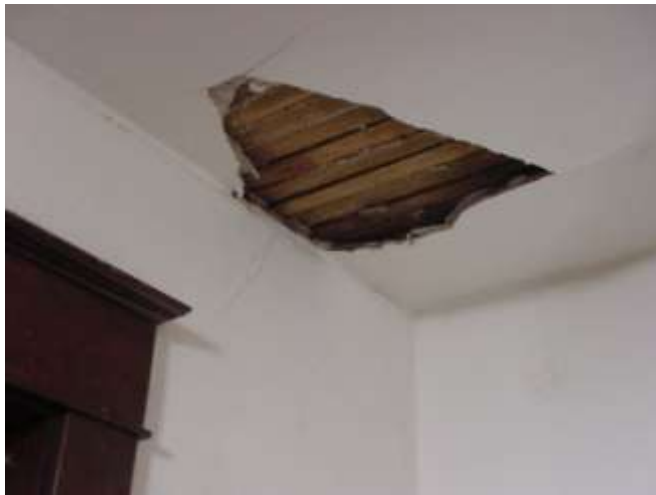
Above: *Failed plaster in upper level.*  
Right: *Plaster bracket at the ceiling of the sanctuary.*

Interior finishes range from fair to good. Most plaster areas have been well-maintained and painted at regular intervals. Some failed plaster has been noted, especially in the Sunday school classrooms. The walls, ceilings, windows, and trim in the young adult room have been painted in bright pastel colors. Nearly all the finely crafted trim remains intact. The mezzanine classroom walls above the sanctuary were not part of the original construction. Originally, this area was designated for seating. Neither stair to the mezzanine meets code for egress of the number of Sunday school attendants that occupy this space. The railings at the edge of the mezzanine, though well-detailed, do not meet code standards for railing height. The kitchen cabinets and counters are in fair condition. The back entry stair is in good condition.

Some walls have begun to acquire a faded appearance, and should be painted. Any failed plaster and lath areas should be reconstructed using similar lath to what is found, and a coat of lime plaster. Ceilings in these rooms should be painted upon completion. Oak partitions and trim should be carefully inspected for burnishes or signs of wear. Any lackluster elements and pieces should receive a coat of poly finish or paint, as is required. The young adult room should remain painted brightly, as the décor creatively suits its purpose. The walls forming the mezzanine classrooms above the sanctuary were not original. However, because of present needs of the church, these should stay in place. The walls are reversible; that is, at a later date they could be removed. At that point in time, pews could be reintroduced to the sanctuary mezzanine, and the area could be used for seating.

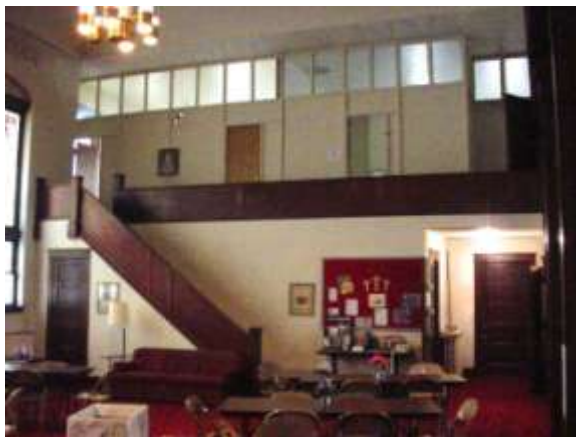
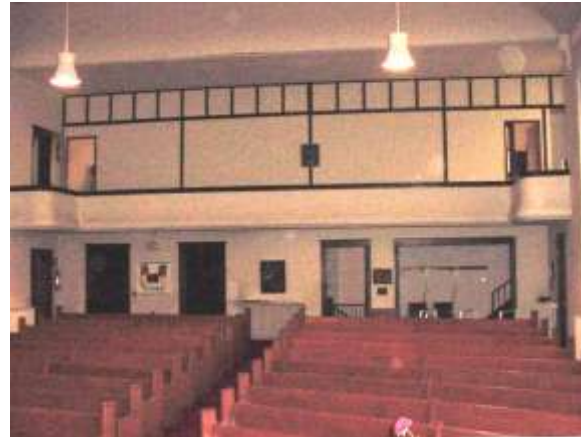
*View of mezzanine overlooking assembly hall. View of mezzanine overlooking sanctuary.*

The two-part mezzanine railing should be addressed at the same time the stair is reworked. The portion of the mezzanine overlooking the assembly space should receive a forty-two inch tall railing with a wood top rail. The bottom portion of the railing should be solid, as the original rail was. The upper portion (above two feet) could possibly be solid as well, or could receive balusters with code compliant spacing, to allow a visual connection between both floors at this point. The portion of the mezzanine overlooking the sanctuary presently has a wide railing approximately two feet in height. This existing, original railing should be retained and preserved in its entirety. An additional railing system should be securely fastened to the top molding of this original rail, in order to obtain the proper height (forty-two inches from finished floor). The railing could possibly consist of regularly spaced balusters or glass, to allow a visual connection between both floors. The construction for this portion of railing should be reversible, so that if the church leaders ever decide to expand seating back to the mezzanine level, the new upper portion of the railing could be removed.

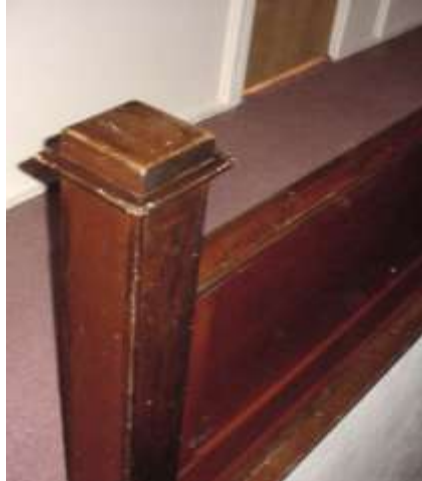
*Mezzanine newel and guardrail (overlooking assembly hall)*

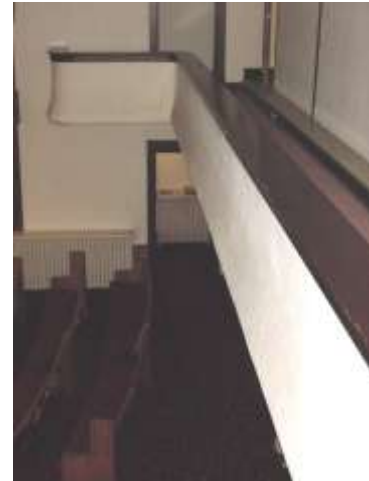
*Mezzanine guardrail. (overlooking sanctuary)*

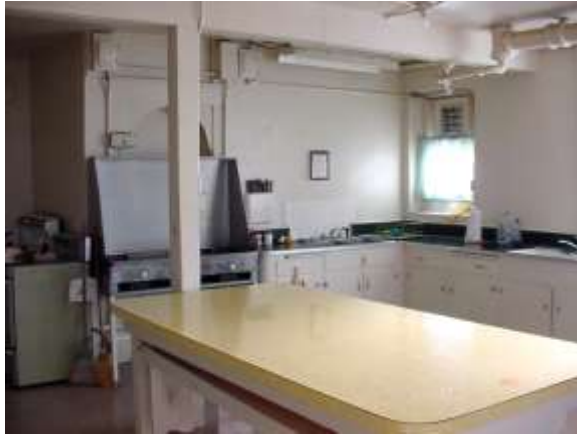
*Kitchen, view looking south.*

A remodeling and redecorating is recommended for the kitchen. This should take place at the same time the kitchen area is brought into code compliance by relocating the refrigerators inside the main kitchen area, providing a hand sink and a three-compartment sink, and providing a kitchen hood with makeup air and an exhaust (see VENTILATION below). The redecorating should consist of new countertops and refurbished and repainted cabinetry.

It is recommended that the kitchen layout be reviewed with regard to the best overall use of space and that a standard commercial kitchen exhaust hood be installed. The rated exhaust duct should then be routed vertically in a chase at the back of the stage and stage loft areas above to a roof mounted exhaust fan. Make-up air should be returned to the kitchen through the same chase, ensuring that code requirements for a serving kitchen are met.

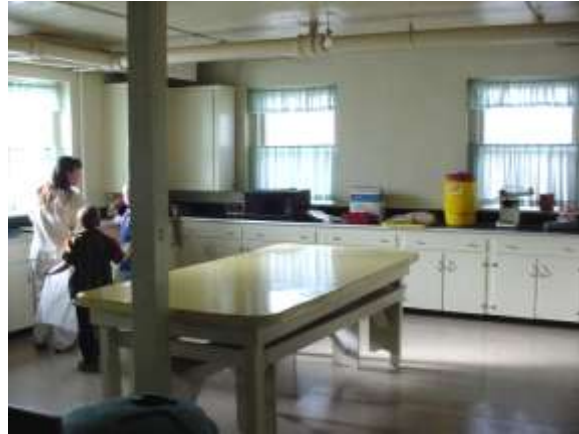
*Kitchen, view looking north.*

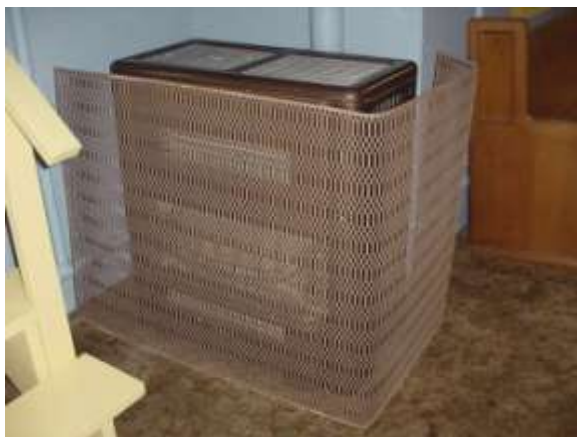
The nursery is divided along an east/west axis into two spaces. The south nursery has an older 1950's style gas space heater which was apparently used to heat the space without firing the overall heating system (probably for weekday daycare of some type). This unit and a steam unit heater which appears to be part of the original construction are both available for use in the existing nursery.

*Nursery space heater.*

Both of the units serving the nursery appear to be in relatively poor condition and should be replaced with an alternate system.

There is not a heat source for the north nursery area. In addition, the overall nursery area is poorly ventilated. There are a limited number of operable windows in the south space and no windows or ventilation source at all in the north space. As the nursery space backs up to the storage space on the east, a hydronic fan coil heating unit in the storage space is recommended to supply both heat and ventilation to both nursery spaces.

This unit could be attached to the existing steam system, or alternatively, could be connected to the small hot water boiler system noted previously. It is further recommended that this system be extended to serve the pastor's offices, effectively allowing improved heating space control for the smaller spaces which are more continuously heated.

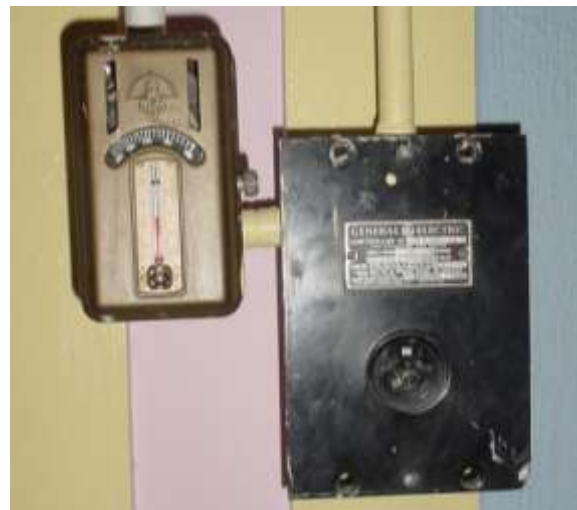
*Nursery separate thermostat.*

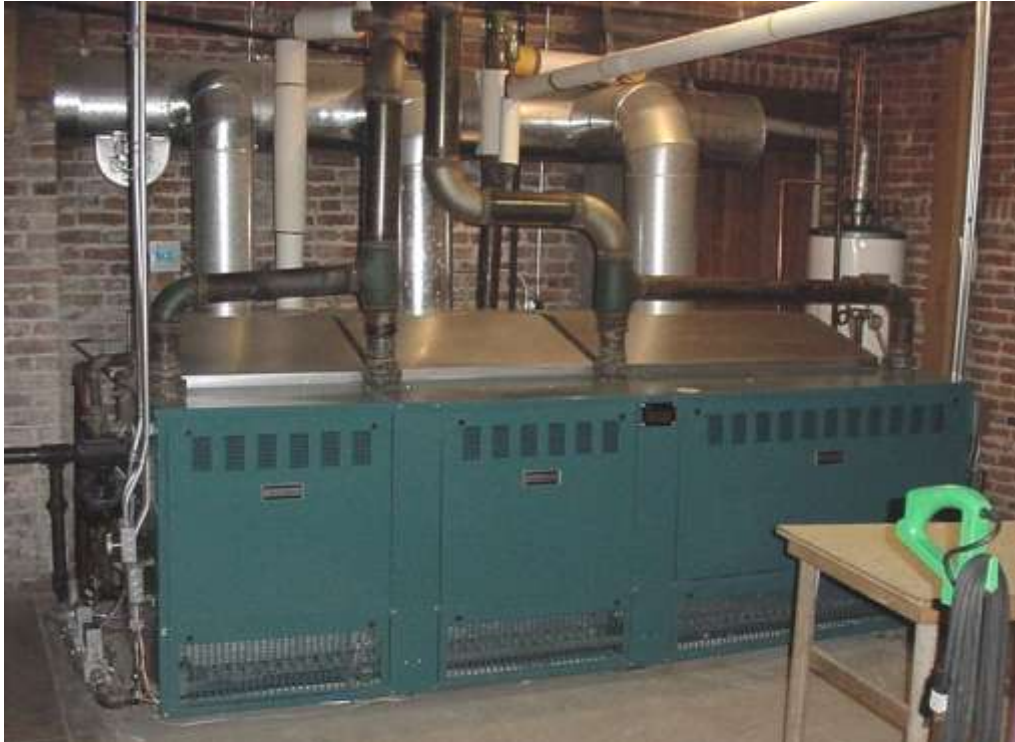
The steam boiler is relatively new, having been replaced with a Burnham 1.560 MBH input single stage atmospheric cast iron boiler in 1996. The boiler room does not have an adequate source of combustion air, resulting in non-compliance with current building codes. Most of the radiators appear to be in good condition and should continue to be usable for the foreseeable future.

*Burnham boiler. Note hot water tank at right.*

The use of a single stage boiler of this size is questionable, because it cannot effectively heat zones separately. Consideration should be given to changing the boiler controls to allow either two-stage or modulating firing. Much of the piping in the lower level is un-insulated, leading to uncontrolled heat gain to the spaces. It is recommended that all of the exposed steam piping in the lower level be insulated.

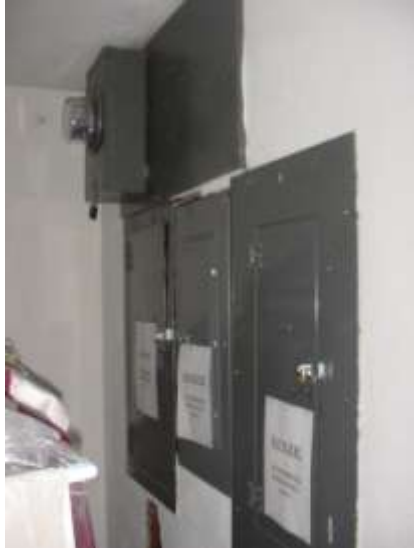
*Electrical meter and panels.*

The location of the service disconnect does not meet current code requirements and should be replaced with either an exterior disconnect or if allowed by the local utility company, or a disconnect directly inside the lower level alley entry.

It is recommended that a single 400 amp, 1 phase panel board be installed in the rear entry hall. Working with the local utility company, it may be possible to avoid an exterior disconnect by having the panel exposed to view upon first entering the building. From this point, new sub-panels should be installed in the Kitchen and south Stage area. From these locations, the building should be re-wired with using exposed conduit in the lower level and concealed conduit in the main level ceiling / attic space. The conduit above the sanctuary and assembly hall should be in flexible conduit, to allow for flexibility in the later placement of historic light fixtures.

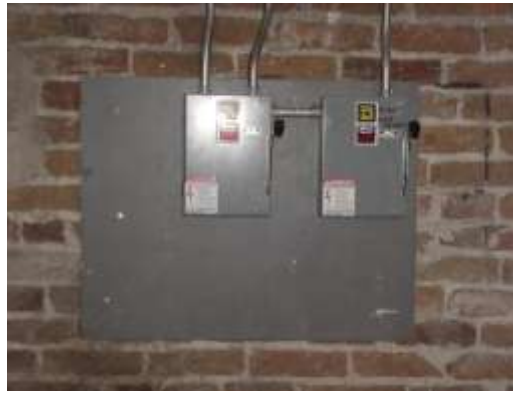
*Electrical subpanels in boiler room.*

From the interior meter noted previously, the electrical service is extended to two 100 amp load centers which appear to be overloaded. Service is extended from one of the load centers to a fused panel in the kitchen. Most of the observable building wiring was cloth covered.

In general, the building electrical service is dated and undersized for the needs of a modern facility. The existing service is also nearly a century old, and is a potential hazard.

Given that there is a desire for modernization of the audio/visual systems, it makes sense to replace the overall electrical infrastructure. This will ensure that any new systems have an adequate foundation and will not cause a hazard by overloading the existing system.

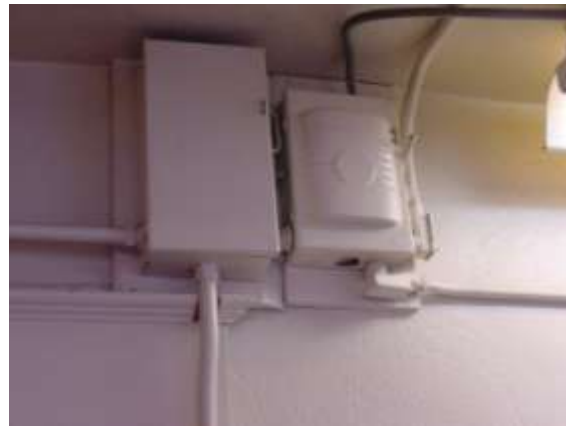
*Electrical subpanel and shutoff in kitchen.*

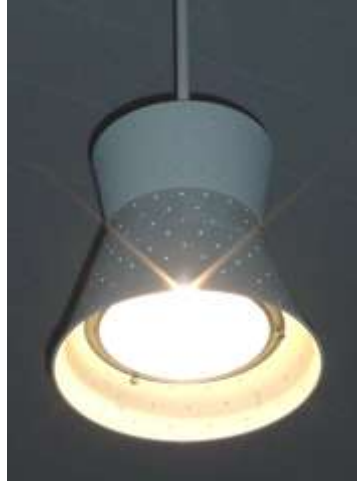
*Light fixture in sanctuary.*

In general, it is recommended that the lighting in all of the Main and Upper Level areas be replaced with period type fixtures to re-establish the historical appearance of the building. In addition, consideration should be given to the installation of a stage lighting and control system for the Assembly Hall. A new, attractive outdoor light fixture could also be chosen and installed at the rear elevation at that time.

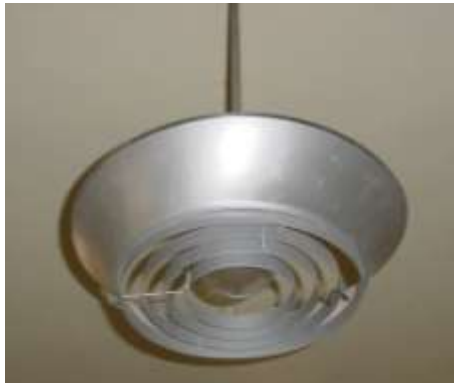
*Light fixture in hall.*

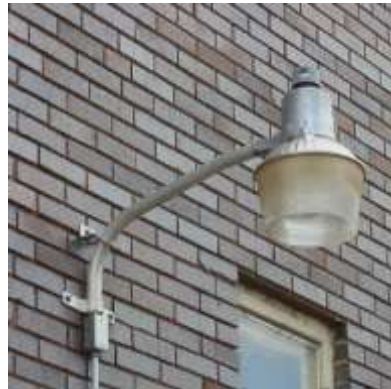
*Exterior light fixture on west elevation.*
