# **HISTORIC STRUCTURE ASSESSMENT**

## **SAGUACHE COUNTY COURTHOUSE SAGUACHE, COLORADO**

FOR  
**COUNTY OF SAGUACHE, COLORADO**

HISTORIC STRUCTURE ASSESSMENT  
State Historical Fund Project #2002-HA-043  
September 11, 2003

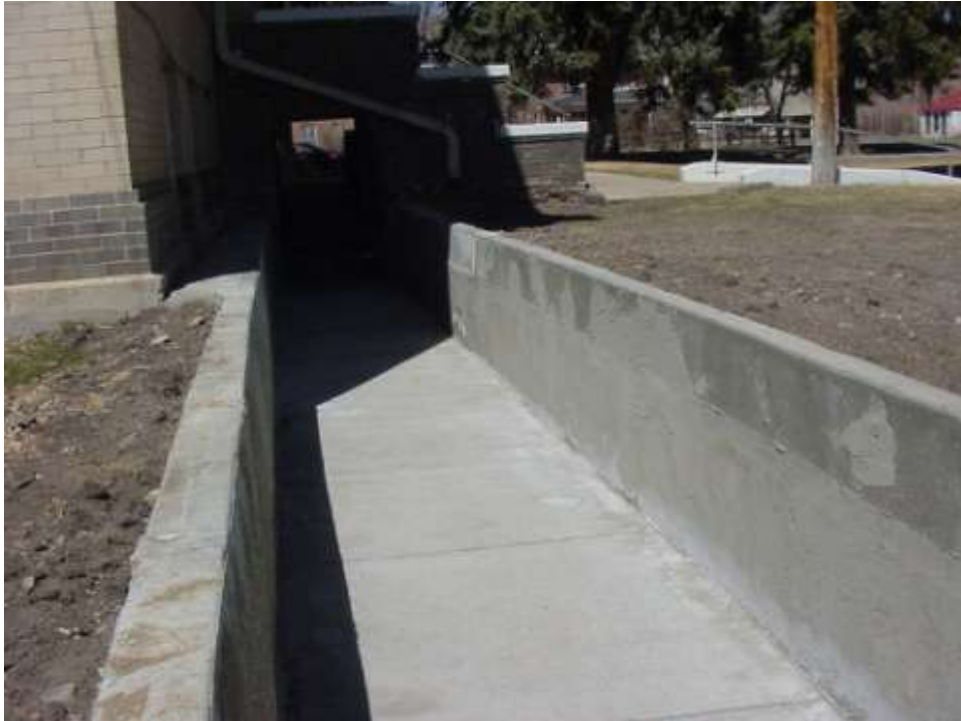
*Sloped concrete walk on east elevation, constructed by county crew in 2002, with retaining walls on each side.*

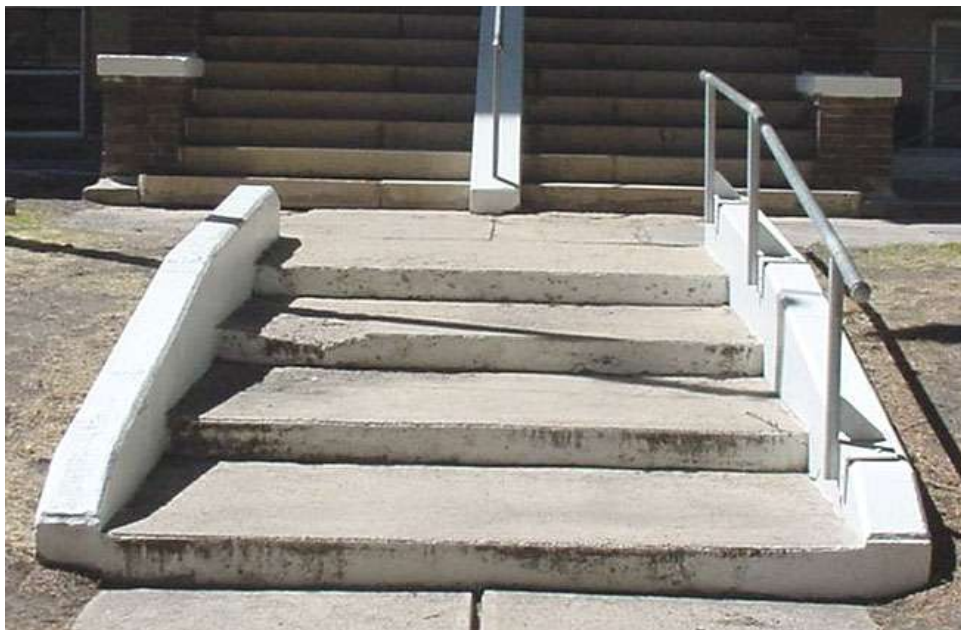
*Front (east) site stair. Date constructed unknown.  
Note crumbling on third tread and non-original pipe rail.*

Site conditions are generally good, with several exceptions noted. The overall experience of the building is enhanced by its lovely setting, amidst a stand of tall spruce trees and a carpet of their soft needles. No floral planting areas are evident around the building perimeter. Some lawn areas have no grass. Spruce needles are acidic and kill any grass below the trees. The retaining walls on each side of the long sloped concrete walk are bowing and finished unevenly. The front sidewalk stair is crumbling, and has no adequate railing. The sidewalks northeast of the building are hewing and spalling.

On the site stairs, paint should be cleaned from the stringers with Prosoco restoration cleaner. The stairs should be repaired by patching with special concrete patch compound. New A.D.A. compliant iron handrails of a period style and design compatible with the 1910 courthouse should be installed on either side of the stairs. For the long sloped walk, the retaining walls should receive a coat of cement parging on all exposed sides. This should be smoothed until all surfaces are level and even. The portions of the flat sidewalks that are hewing and spalling should be removed and replaced with new concrete sidewalk slabs.

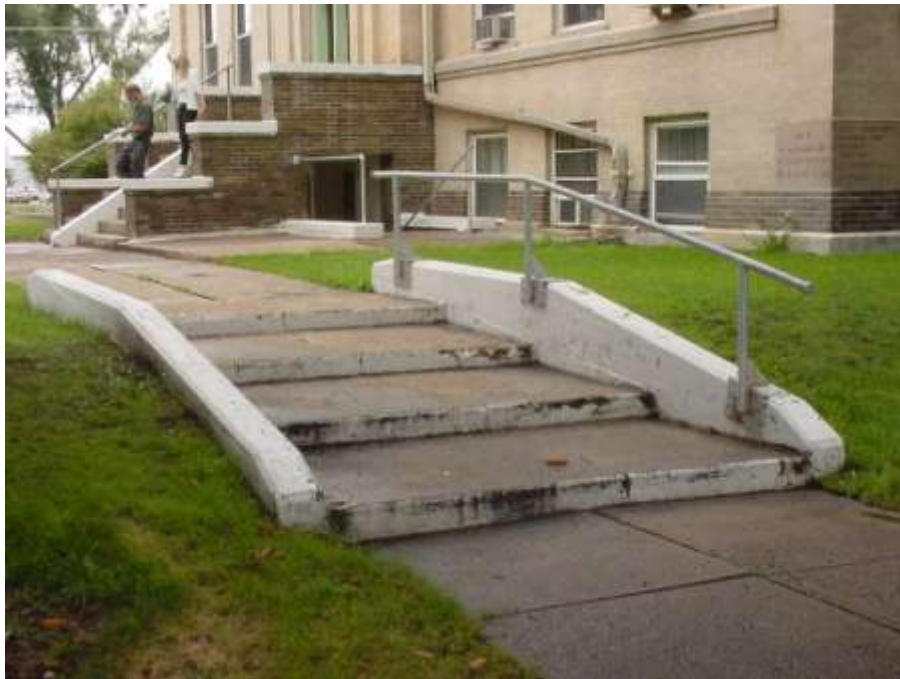
*Side (northeast) site stair.*

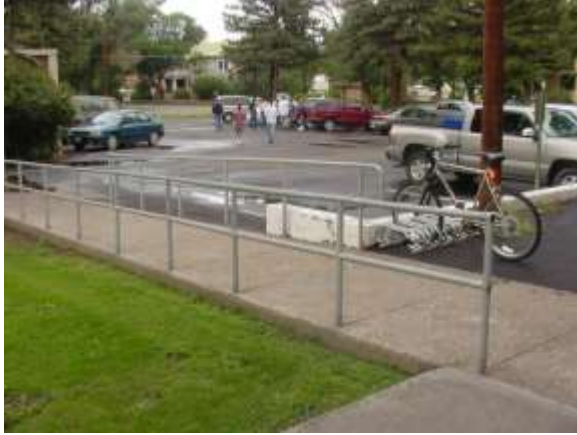
*Walk from west entry towards the west.  
Note slight slope (<1:20) and handrails.*

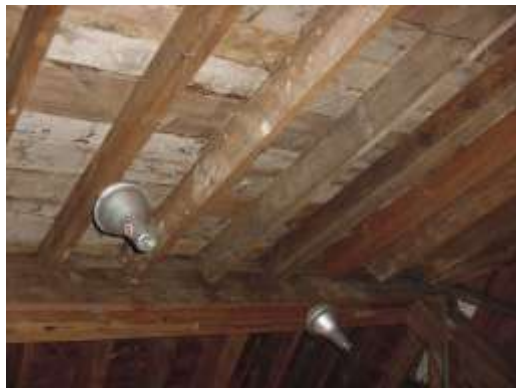
*2x8 wood rafters and 2x12 decking, with cement-covered faces. Note primitive fire suppression units.*

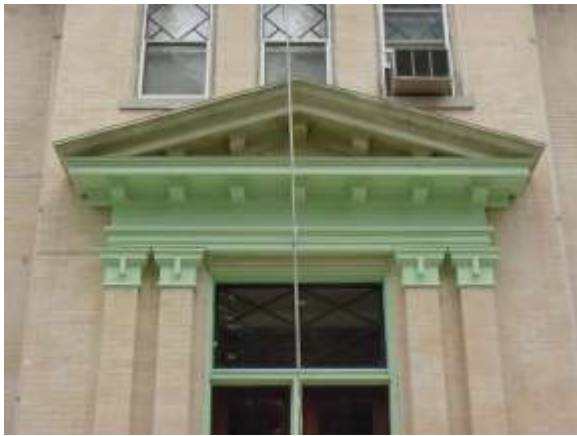
*Front (east) entry pediment*

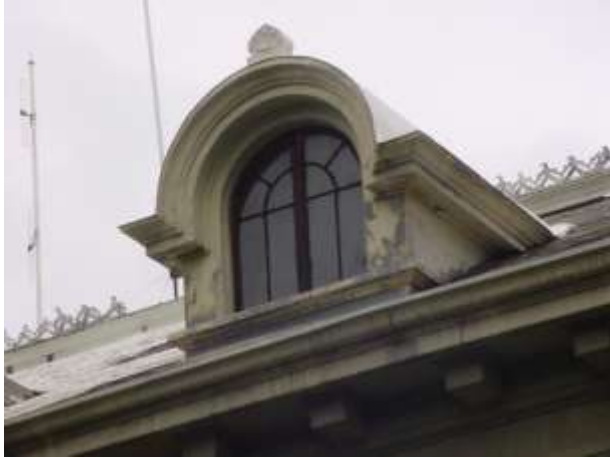
*Dormer exterior, with galvanized sheet metal detailing.*

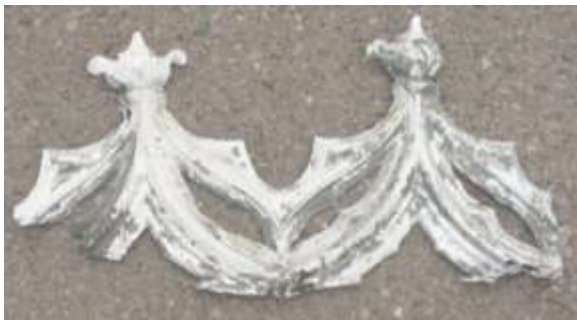
Cement plastered sills, horizontal band copings, lintels, and decorative elements are in good condition. Some galvanized sheet metal pieces have worn quite well, while others are in poor condition. The capitols and pediment have been painted a non-original lime green color. The flat raised cornices appear to be in fair condition, but are also painted an improper color. The white painted cresting has deteriorated and is entirely missing from some parts of the roof.

*Portion of original iron cresting.*

Cleaning work of cement-plastered elements should be undertaken at the same time as the cleaning of the adjacent masonry. Samples of the galvanized sheet metal work should be removed at several locations. These should be sent to a laboratory for spectrographic color analysis to determine original color. All galvanized sheet metal pieces should be scraped and cleaned to the next good paintable surface. Assure all pieces are sturdily mechanically attached to the building. All metal should be painted in approximately their original color, ascertained by laboratory analysis. The W.H. Mullins Company of Salem, Ohio was responsible for the fabrication of the iron cresting. However this company is long since defunct, so the cresting will need to be custom ordered from another fabricator, such as the W.F. Norman Company of Nevada, Missouri. Send a portion of the original cresting for this company or an equivalent manufacturer to copy exactly. Upon fabrication of missing pieces, install and paint all in an approximation of their original color.

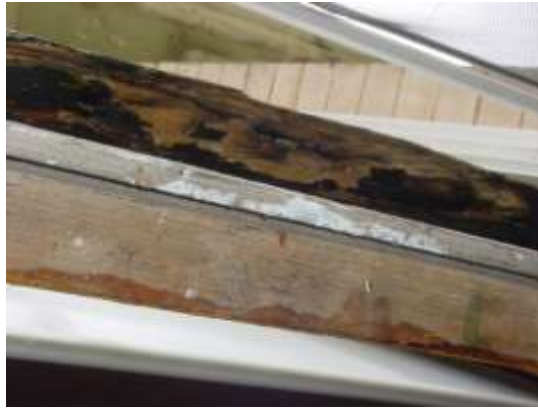
Window condition generally ranges from fair to poor. Most original windows are intact and contain their original glass. Some window sills are significantly rotted. Most sash locks and sash lifts are present and in good condition. Some windows have rotted sash, and several have bowed rails. Several window panes are broken in windows on the south elevation. The glazing putty on the majority of the windows was hastily and poorly applied, and never painted. Interior condition of most windows is fair. Stain and varnish on these windows appears to be in good condition. The exterior doors are in good condition, but along with their frames are painted an inappropriate lime color.

*Rotted sash at stair landing window*

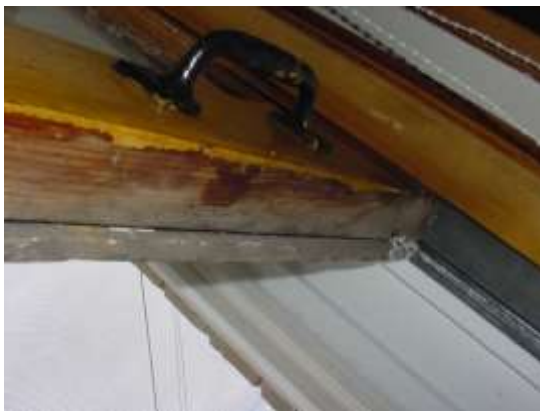
*Rotted sash at second floor window*

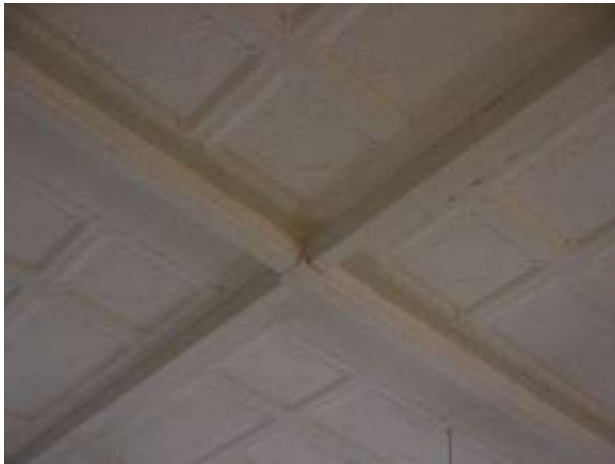
Interior finishes range from fair to good. Plaster walls are largely intact and without any protuberances or loss of integrity. Wood paneling where it occurs is of low quality. Wood wainscots are not original; rather, they are made of 1/4" plywood and installed much later. The decorative stamped tin ceiling in the courtroom is fair, with some blemishes and signs of wear. Built in casework and clerk's desks is also in fair condition. These have been for the most part well-maintained. Some have unfortunately had electrical and communications lines mounted in conspicuous places directly on their surfaces.

*Tin ceiling in courtroom.*

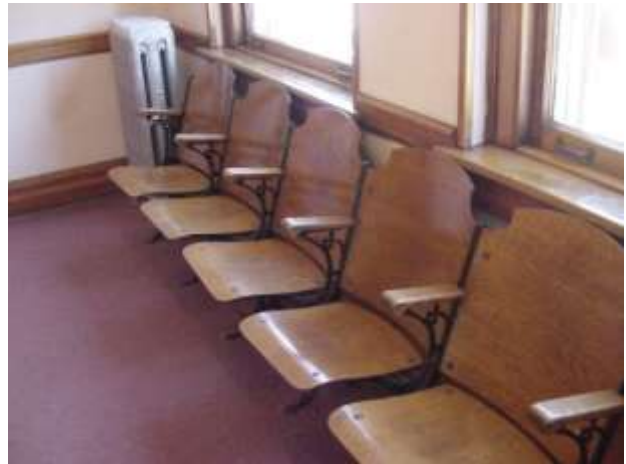
The built-in theater-style seating is in good condition. This was the original seating used in the courtroom. Some rows of this same seating have been dissembled, and can be recovered from the attic. Also discovered in a reconnaissance to the attic were antique wood voting boxes, which should be saved.

*Original courtroom fixed seating.*

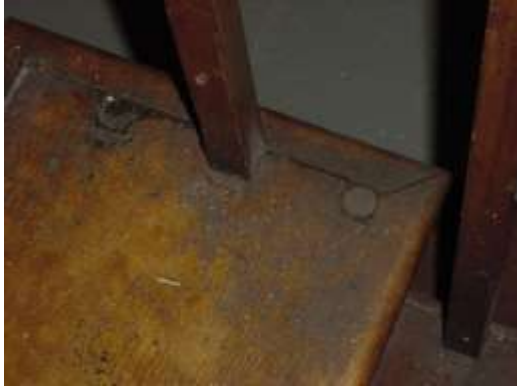
The stairs have generally been well-preserved, and are in fair condition. Woodwork on these stairs is exemplary, and matches the fir woodwork of the interior doors and trim. The newels are an example of fine wood craftsmanship. Nosings for these stairs are worn in some areas. Some stairs, especially on the lower level, are severely deteriorating, with trim separating from the stairs and stair treads splitting.

*Stair with split tread at lower level.*

The stairs and balustrade should be cleaned and varnished if necessary. Any completely worn nosings should be replaced. Cracked or broken stair trim, treads, or risers should be removed and replaced by milled pieces. New pieces should be firmly mechanically attached to the stairs.

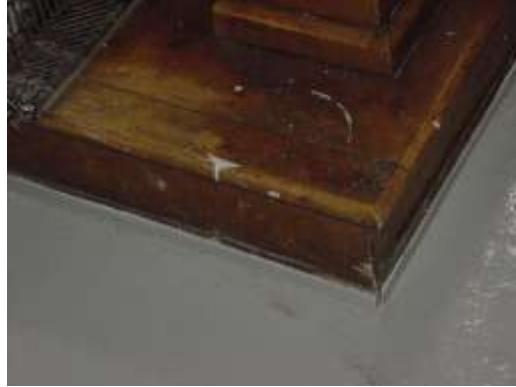
*Stair with separating edge trim at lower level.*

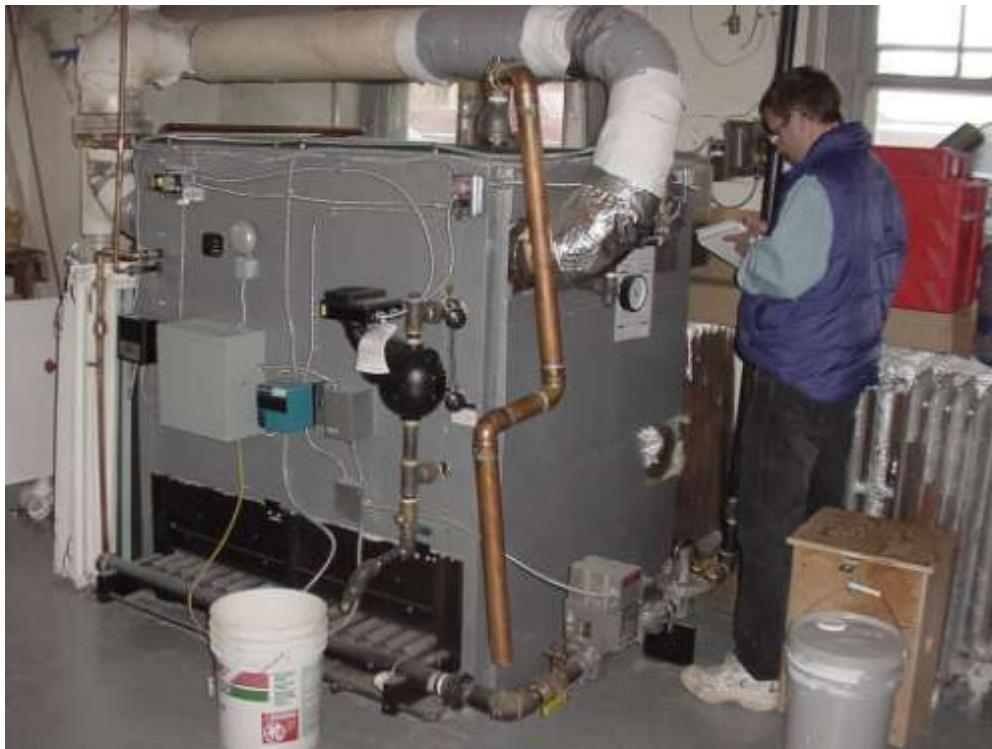
The heating system for the building is the original low pressure steam system supplying cast iron radiators. The system is somewhat unique in that it uses a combination of single pipe steam and condensate return for the main and upper levels and a more standard steam piping with separate condensate return for the lower level. The steam boiler is relatively new, having been replaced with a Peerless one thousand six hundred and eighty thousand British thermal units per hour (1680 MBH) input single stage cast iron boiler in 2001.

*Peerless cast iron boiler, 2001*
