# HISTORIC STRUCTURE ASSESSMENT

## HOUGH BUILDING

CORNER OF THIRD AND SILVER STREETS  
LAKE CITY, COLORADO

HISTORIC STRUCTURE ASSESSMENT  
State Historical Fund Project #2003-HA-068  
June, 2004

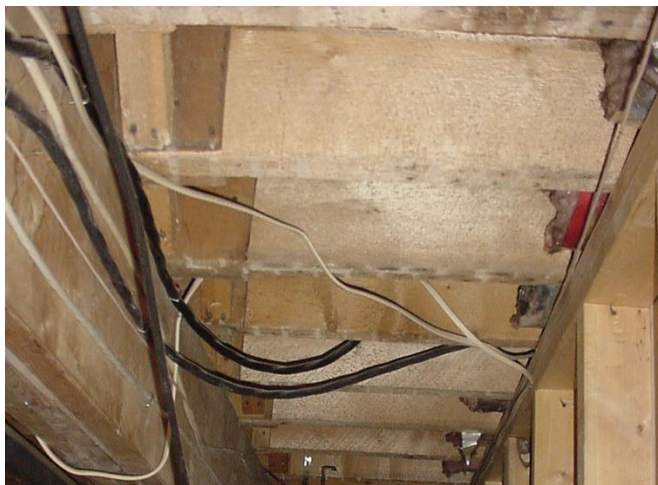
The first floor framing appears to be in good condition. The additional timber framing in the basement is in good condition, and substantially assists in the bearing of first floor loads. The stage appears to be adequately framed to support the live loads of musicians or a drama troop.

Left: 2x10 first floor framing visible at Building 2 kitchen crawl space. Note 2x6 knee wall at right.

No corrective work is recommended for the first floor structural system.

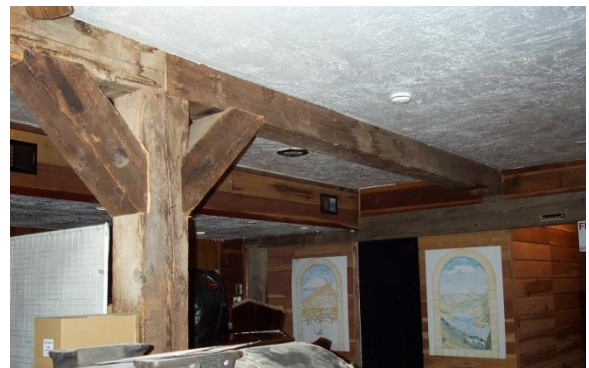
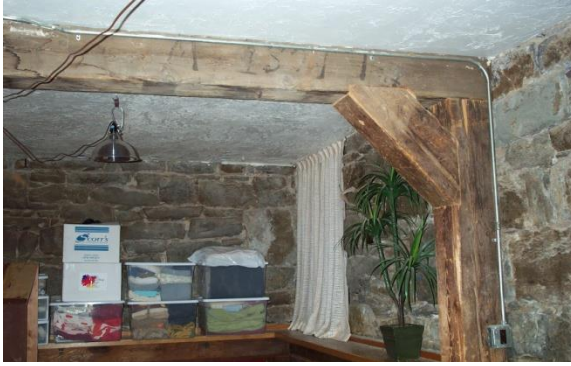
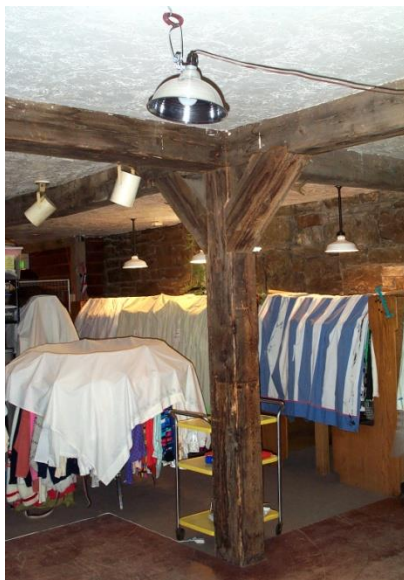
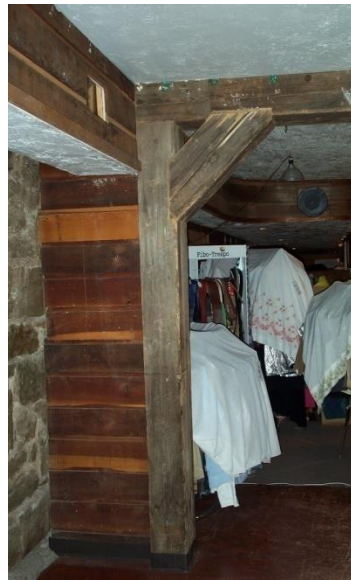
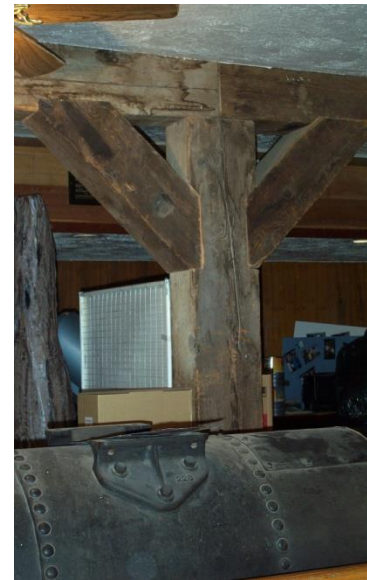
*Photographs of timber reinforcement construction beneath main floor.*

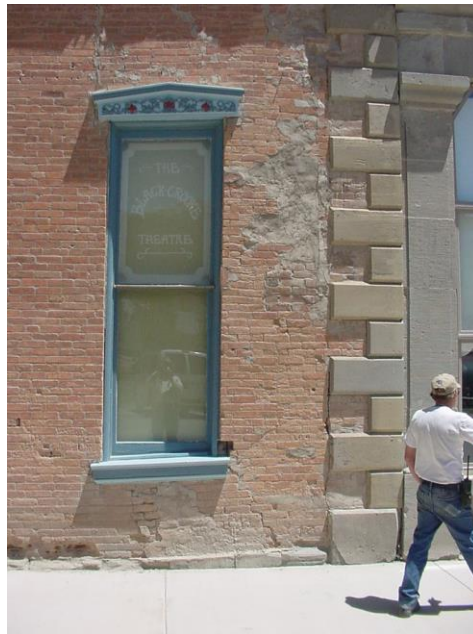
*Photos of damaged areas of southeast corner of Hough Building:*

*Main level with window.*

The broadest corrective measure considered would entail the removal of the concrete and lowering of the jacks at the lower level, the internal and external shoring of the second story masonry at the southeast corner, and the painstaking and careful dismantling of the southeast corner of brick masonry up to the decorative band. This process would also involve the removal of the window at this location and the concrete block wall behind it. (The window would be refurbished at an outside shop and reinstalled). The wall would then be rebuilt with as much original material as possible and with replacement bricks in kind where necessary. The exorbitant costs for this measure and the potential for unforeseen complications would potentially outweigh the benefit.

The second option under consideration would primarily address the stabilization of the overall wall in its present structural condition and the outside appearance. In this measure, the physical configuration of the bearing masonry and the jacks embedded in concrete would remain untouched. The concrete block masonry behind the window would also be kept intact. The real corrective work undertaken would be at the outside wythe of brick. This wythe would be removed from the building up to the decorative band. The window would be removed, disassembled in a shop, reassembled square, restored, and reinstalled. Finally, the exterior wythe of brick would be rebuilt, using as much original material as possible, and using a mortar composition and color close to identical to the original.

Based on the factors previously mentioned: structural stabilization, historical accuracy, and cost effectiveness; the second option is recommended. This recommendation would offer greater structural stability, a historically accurate appearance, and less overall structural intervention, all for a lower total cost. During the course of the preparation of architectural and structural

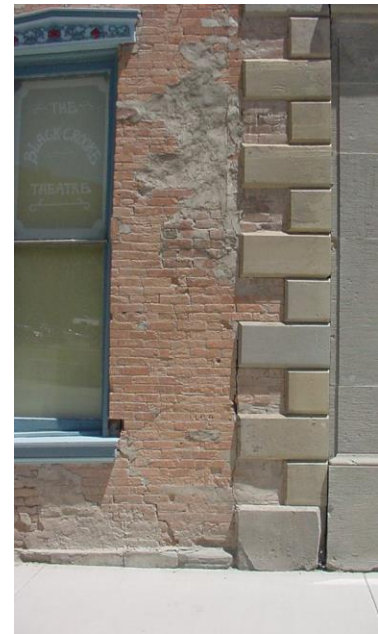
*Main level detail.*

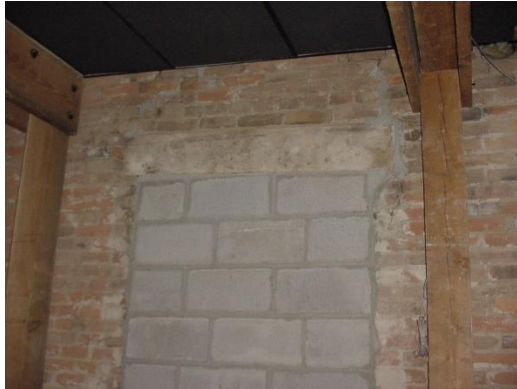
Left: *Hadite cinder block behind south elevation window.*

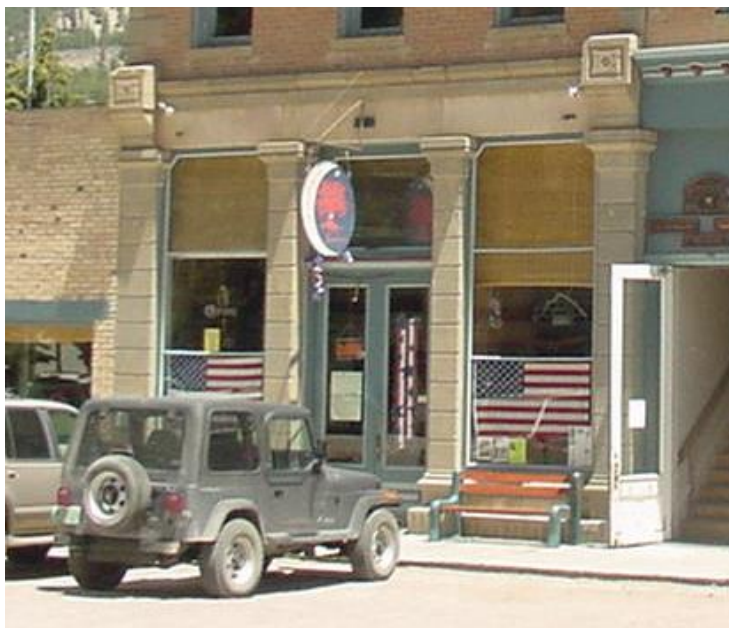
Building section 2: *stone pilasters and storefront system*

No corrective structural work is recommended for the cast iron and stone storefront systems.

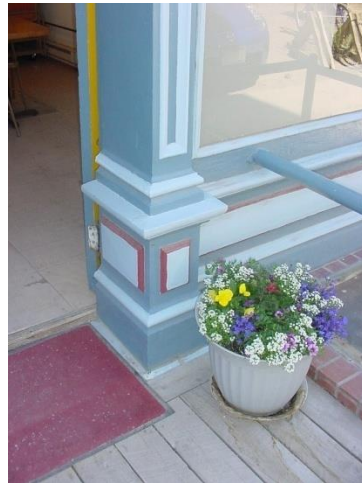
*Cast iron storefront at building 1, and detail at pilaster base.*

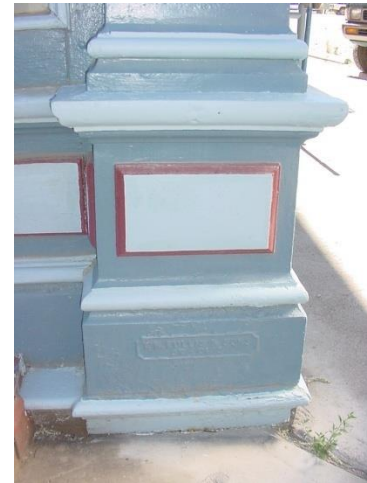
*North elevation views, showing stone masonry below and brick masonry above.*

The exterior brick, for the most part, is in good condition. The brick is relatively soft and at the south elevation has been subject to graffiti carvings. Some of these carvings include dates, as early as the mid-1880s. The dull red painted sections of the south wall detract from the overall appearance of the wall. The cast iron and architectural sheet metal elements of the building are painted in an attractive palette, but without laboratory analysis, it is impossible to discern whether these colors are original. The sandstone and limestone storefront elements of building 2 are weathered, but generally appear to be in good condition. The stone at the north elevation is also in fair to good condition.

It has been determined that attempts to remove the graffiti carvings would cause more damage than the carvings themselves. The dull red paint should be removed with a mild solution of Prosoco paint remover. Sand or water blasting should not be undertaken on the building, nor should the brick be painted. Consideration should be given to restoring the historic painted signs, since they are valid historic fabric. The presence of these signs would pay tribute to an earlier time in the history of Lake City. If the owner opts to restore the signs at any one of their historic periods, a layered paint removal process would need to be employed. Samples should be carefully removed at the cast iron and architectural sheet metal, and should be sent to a laboratory for spectrographic analysis. Once the original colors have been determined, these portions of the building should be cleaned down to the next good paintable layer. The cast iron and architectural sheet metal should then be painted in a close approximation of their original colors. The sandstone and limestone storefront elements of building 2 should be cleaned with a mild solution of restoration cleaner. No finish work is recommended to the stone masonry at the north elevation of the building.

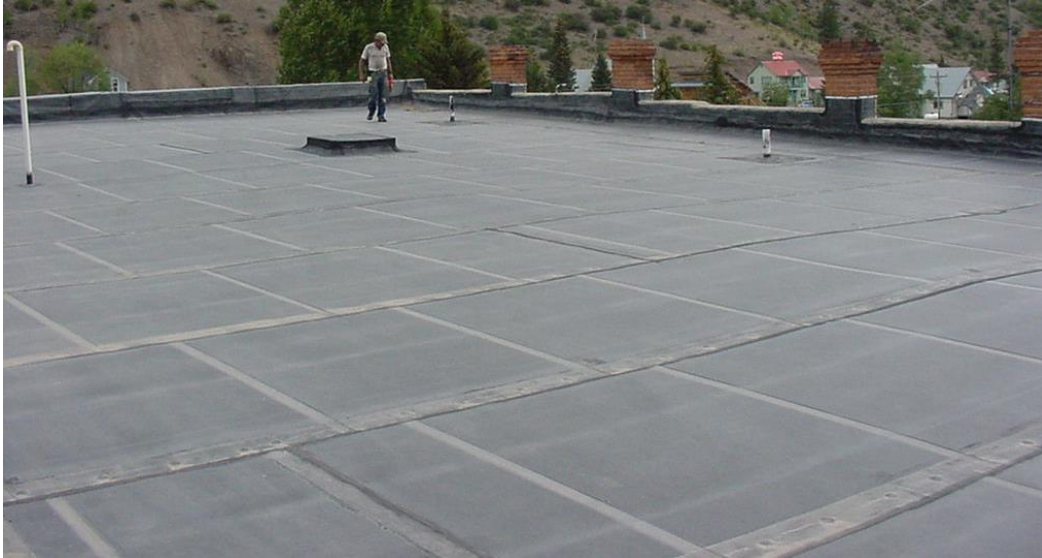
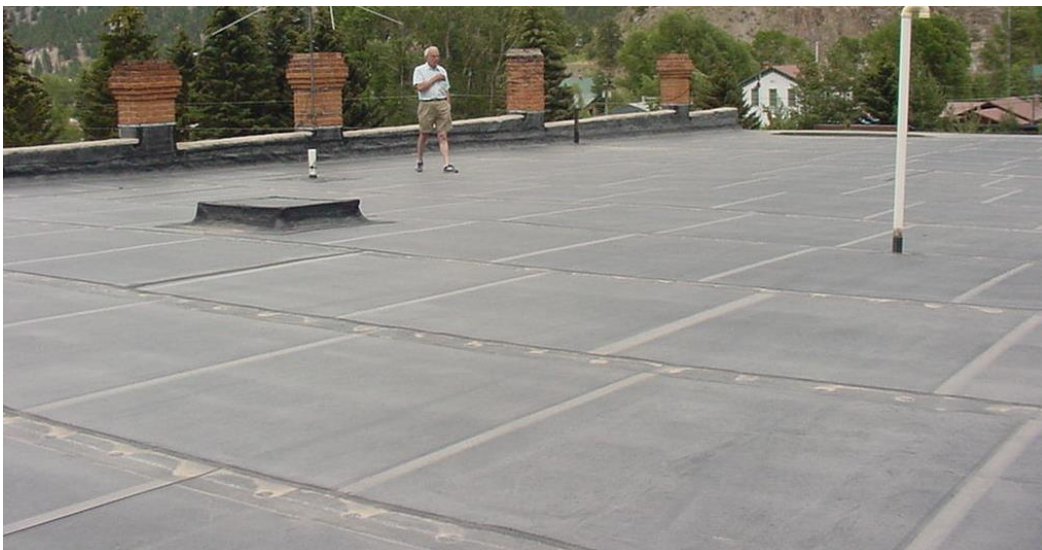
The rubber roofing system appears to be in good condition. All seems are intact and parapet flashing appears to be in good condition. The building maintenance worker, Mr. Charlie Curtis, reports that since this roofing system has been installed, no leaks have been reported. No signs of leakage were apparent on the second level, directly below this roof. The metal seamed roofing system appears to be in fair condition. The sheet metal flashing at the building edge is intact, but some has begun to rust from exposure to the elements.

*Above: Rubber roofing system, looking west. Below: Looking east.*

The roof should be monitored for any signs of leakage. No roof replacement is recommended at this time. Approximately ten linear feet of sheet metal flashing at the wall-roof intersection should be removed and replaced.

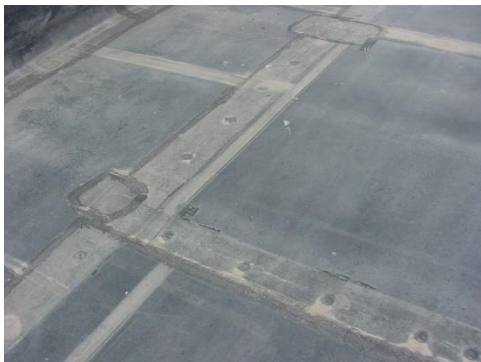
*Detail at seam.*

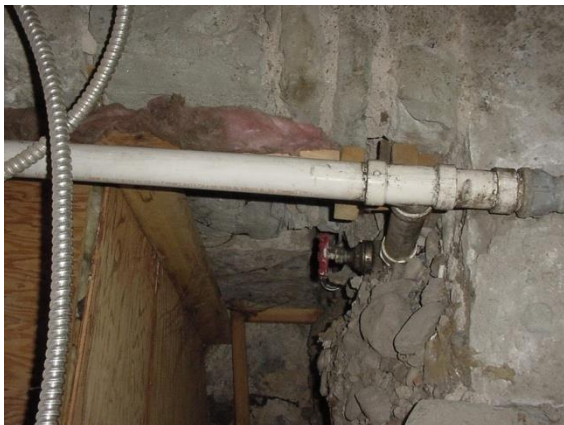
The water service from the street is galvanized steel. After the shut-off valve in the building, it is run in schedule 20 PVC pipe for a short distance. The use of PVC pipe does not meet the requirements of the existing plumbing code. While the use of PVC pipe does not pose a health hazard, it does have significantly less strength than comparable copper pipe, leading to the possibility of a rupture and subsequent flooding of the basement level of the building.

Above: Domestic water service entry.  
Right: Lower level pump station.

The water service should be replaced with a 2" type AK copper pipe. At the time of the replacement, consideration should be given to the installation of a larger 4" service which would allow the building to be fire sprinkled in the future

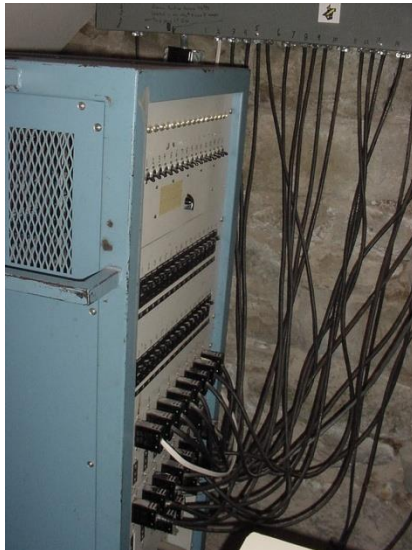
Left: *Theatre load center, currently in men's dressing room.*

In the case of the Theater Lobby, the Dentist office, and the upstairs apartments except for Apartment 204, the load centers are relatively new and are in good condition. The two load centers serving Apartment 204 are acceptable, but combining the loads into a single load center would reduce confusion as to which circuits are served from which panel. The kitchen panel is full with no space for any remodel work. While the remaining panels serving the Theater, Theater Lobby, and Basement / Bar are serviceable, the overall wiring distribution systems do not appear to have been appropriately planned, either for the loads that are being served or for the method in which they relate to sub-panels.

Given that there is a desire for adding to the theater lighting system, it recommended that a single 400 amp service panel be installed. This panel should be used to sub-feed both the existing mezzanine panel and a new 200 amp lighting panel (located either in the mezzanine or behind the stage area). All lighting power should be re-routed from the existing lighting control unit to the new lighting power panel. Given the use of the theater lobby and lower level bar by the theater, consideration should be given to serving these panels from the 400 amp serving panel as well. This would reduce the metering requirements and associated billing costs.
