# **HISTORIC STRUCTURE ASSESSMENT**

## **SAGUACHE COUNTY COURTHOUSE SAGUACHE, COLORADO**

FOR  
**COUNTY OF SAGUACHE, COLORADO**

HISTORIC STRUCTURE ASSESSMENT  
State Historical Fund Project #2002-HA-043  
September 11, 2003

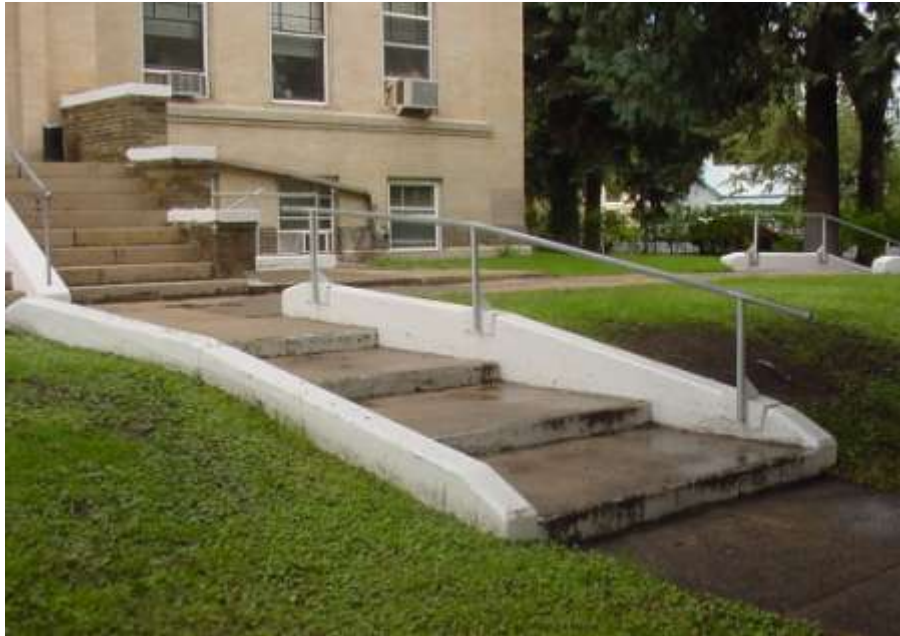
*Front (east) site stair, perspective view*

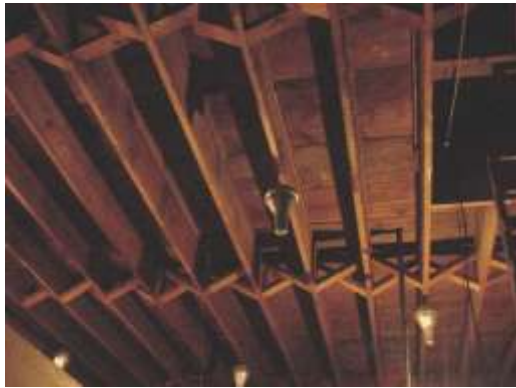
*2x12 deck joists with 2x4 bridging*

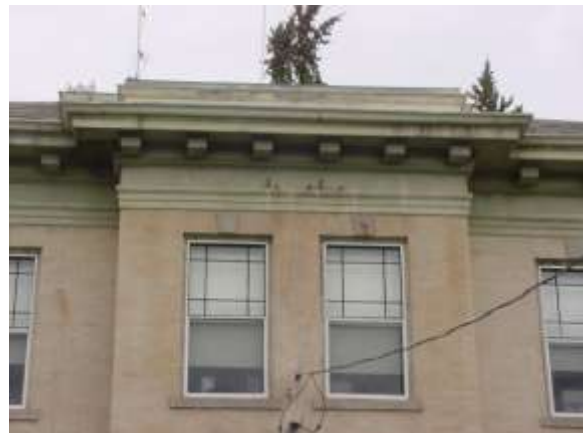
*South raised cornice, north side similar.*

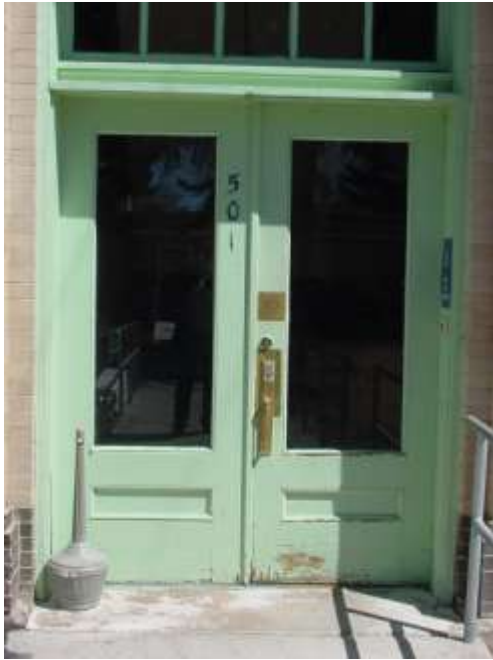
*West entry doors, exterior view.*

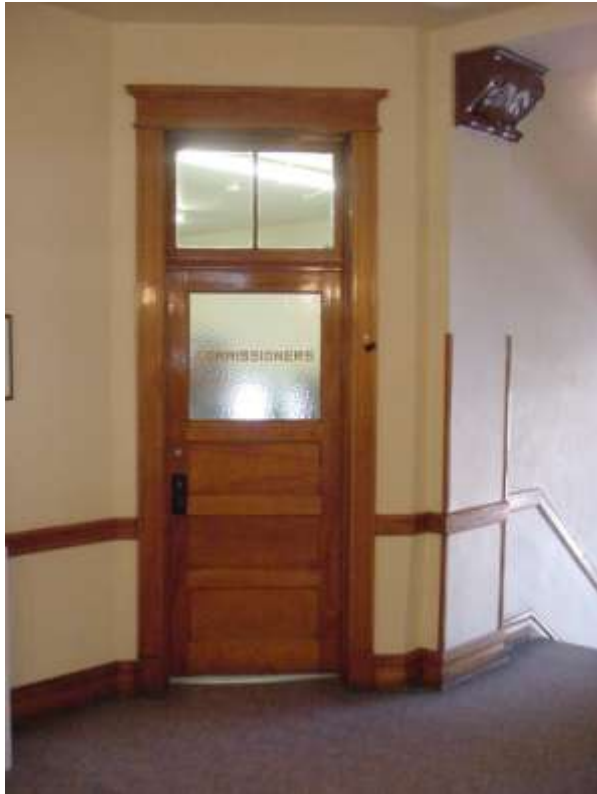
Left: Typical interior three panel door with lite and two lite operable transom. Note base and chair rail moldings and acanthus leaf bracket at upper right.

Determine original color of doors through laboratory spectrographic analysis. These tests will also reveal whether the doors were in fact painted originally. If doors were originally not painted or stained, all paint and stain should be removed. All doors should then be cleaned and lightly sanded. Then doors should receive a low-sheen protective coat of polyurethane. If doors were originally painted, only surface paint should be removed from exterior doors down to next good paintable surface. Then doors should be stained or painted an appropriate historical color, as confirmed by the architect.

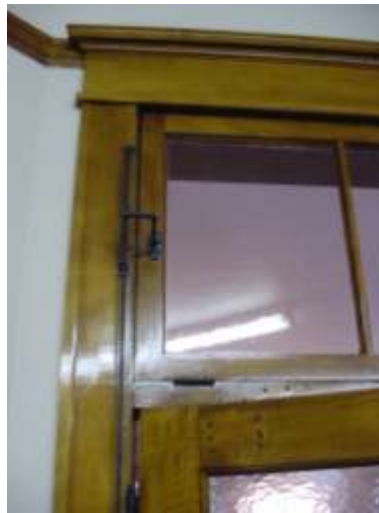
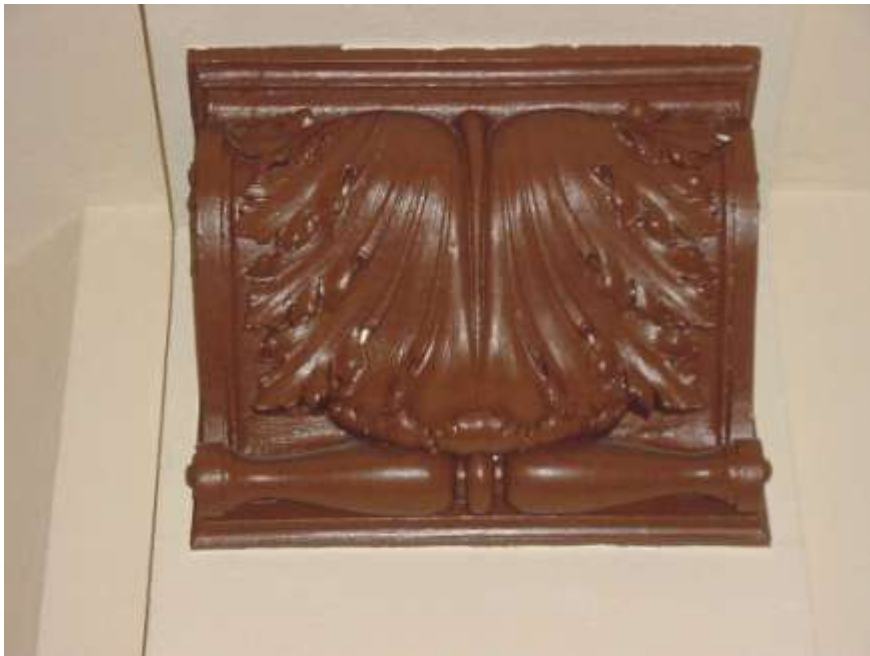
Below: Operable transom mechanism. Note picture rail near head casing.

*Plaster acanthus leaf bracket.*

Determine original color of plaster brackets through laboratory spectrographic analysis. Clean plaster acanthus leaf molded brackets and strip paint down to next good paintable surface. Repaint these brackets in a close approximation of their original color. Clean all interior wood doors and all base, chair rail, picture rails, and crown molding trim. Coat all these with a low-sheen polyurethane finish product or varnish.

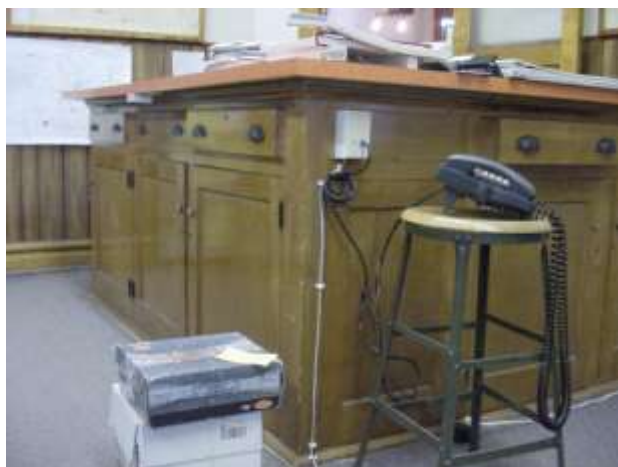
Interior finishes range from fair to good. Plaster walls are largely intact and without any protuberances or loss of integrity. Wood paneling where it occurs is of low quality. Wood wainscots are not original; rather, they are made of 1/4" plywood and installed much later. The decorative stamped tin ceiling in the courtroom is fair, with some blemishes and signs of wear. Built in casework and clerk's desks is also in fair condition. These have been for the most part well-maintained. Some have unfortunately had electrical and communications lines mounted in conspicuous places directly on their surfaces.

*Original desk and counter in clerk's office. Note non-original plywood wainscot, which should be removed.*

All retrofit wall wainscot paneling should be removed to expose original plaster. Throughout the courthouse, any damaged or cracked plaster should be patched and all wall and ceiling surfaces should be cleaned. Once all surfaces are repaired and cleaned, paint should be applied where necessary.

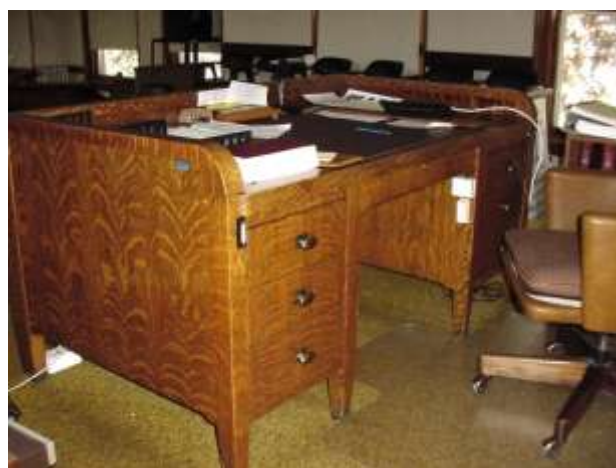
*Judge's desk, free standing.*

The courtroom itself is a pastiche of late twentieth-century built-in and free standing furnishings. These include the wood-paneled jury box and chairs. Chairs and tables in the courtroom are not original or in a consistent style. One original element remains: the rail separating the public seating area from the court area proper. The judge's desk is actually a well crafted piece of oak furniture with a handsome finish.

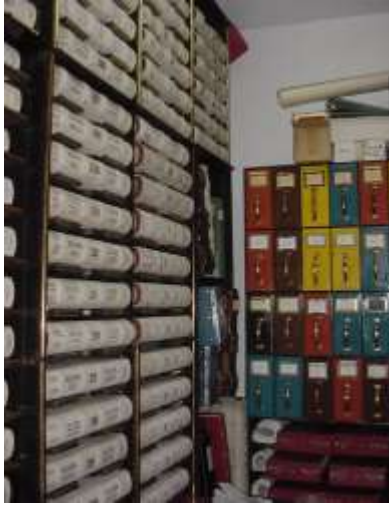
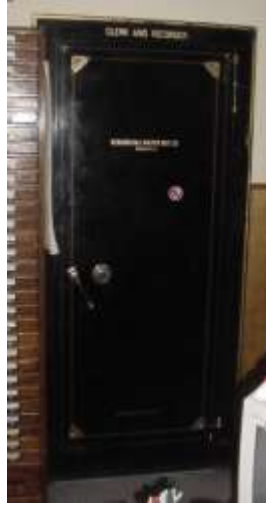
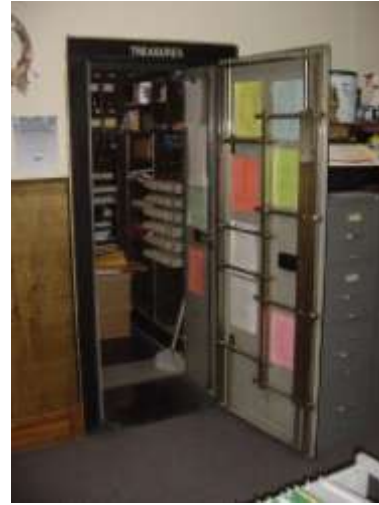
The vaults are in good condition, and most are well organized. The vault doors and hardware are in good, operable condition.

*Typical vault interior.*

*Vault door, exterior. Vault door with cylinder lock.*

No corrective work is recommended for the vaults, nor their doors and hardware.

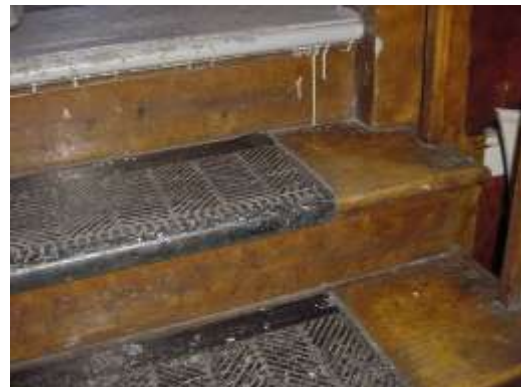
The stairs have generally been well-preserved, and are in fair condition. Woodwork on these stairs is exemplary, and matches the fir woodwork of the interior doors and trim. The newels are an example of fine wood craftsmanship. Nosings for these stairs are worn in some areas. Some stairs, especially on the lower level, are severely deteriorating, with trim separating from the stairs and stair treads splitting.

Right: *Rubber nosing at stairs descending to lower level. Note poor application of paint at riser.*

The stairs and balustrade should be cleaned and varnished if necessary. Any completely worn nosings should be replaced. Cracked or broken stair trim, treads, or risers should be removed and replaced by milled pieces. New pieces should be firmly mechanically attached to the stairs.

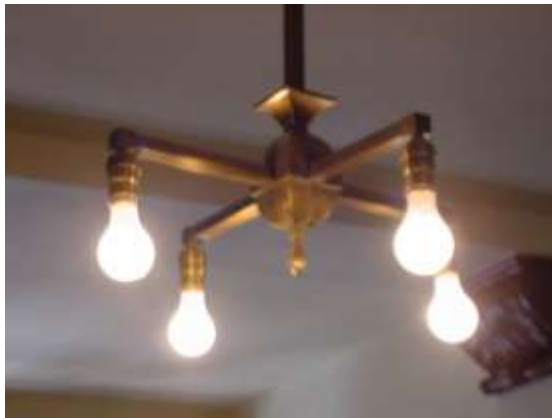
*Four-bulb suspended fixture in upper level central space.*
